**Daily Diary Report by Bid Item**

Diary #: 019 Const Calendar Day: 518 Date: 08-Feb-2011 Tuesday  
 Inspector Name: Wright, Doug Title: Transportation Engineer  
 Inspection Type: Continuous  
 Shift Hours: 07:00 AM 06:00 PM Break: 00:30 Over Time: 02:00

04-0120F4  
 04-SF-80-13.2/13.9  
 Self-Anchored  
 Suspension Bridge

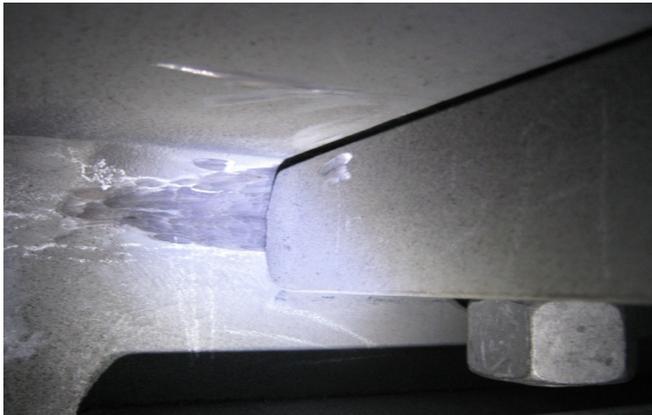
While snug tightening the bolts on the top flange of strut A-East-Outer (adjacent to the East shaft), a conflict was noticed between the top flange half splice plate and the strut weld between the web and the top flange. This conflict prevented the splice plate from coming into firm contact with the flange (see attached photo). The gap created was 5mm. The crew pulled the bolts, and slid the plate back to get access to the weld. The reinforcing fillet weld was larger than the required 10mm minimum. ABF ground on the weld to see if they could get the plate to fit. I monitored this work closely while the grinding was being done, and measured the amount of reinforcement regularly. When the weld was ground down to only 11mm of reinforcement, both ABF Engineer Dan McNichol and myself agreed it was best to stop grinding. They explored the option of removing the splice plate, but there was not sufficient room inside or outside the shaft to remove it without removing the entire strut. Dan said that they would explore other options, such as adding a shim plate so that the chamfer on the edge of the splice plate would clear the weld.

Conflict between flange splice plate & strut weld on A-East-Outer at East shaft
