**Daily Diary Report by Bid Item**

Contract No.: 04-0120F4

04-0120F4  
 04-SF-80-13.2/13.9  
 Self-Anchored  
 Suspension Bridge

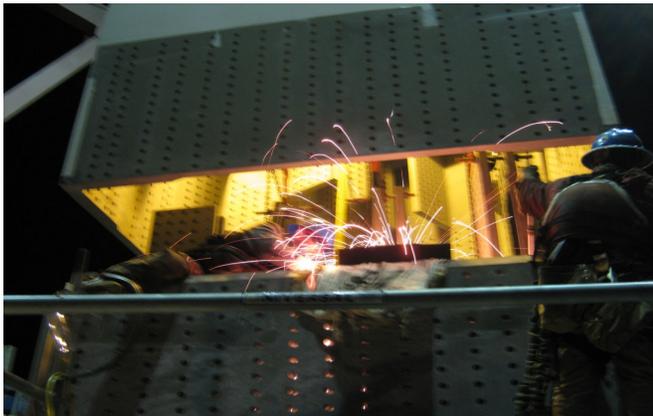
Cutting away a portion of the shim plate to clear the interference

the splice plates to separate them apart, and cut away a small portion of the shim that was sticking above the splice plate (see attached photo). This was necessary at each of the three longitudinal stiffener locations on Skin C.

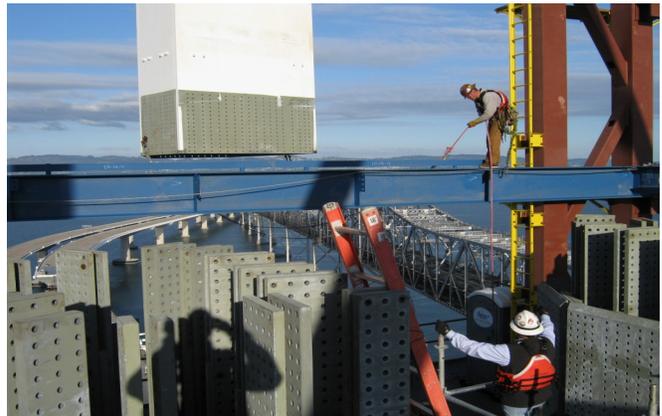
- At 16:45, the shaft was at 120m, and started moving laterally
- At 18:00, the shaft had cleared all stiffeners, and was only about 20mm above lift 3
- They used through hole jacks to suck plates 'A' & 'E' together

Lift 4 South shaft ready to start moving laterally above Lift 3

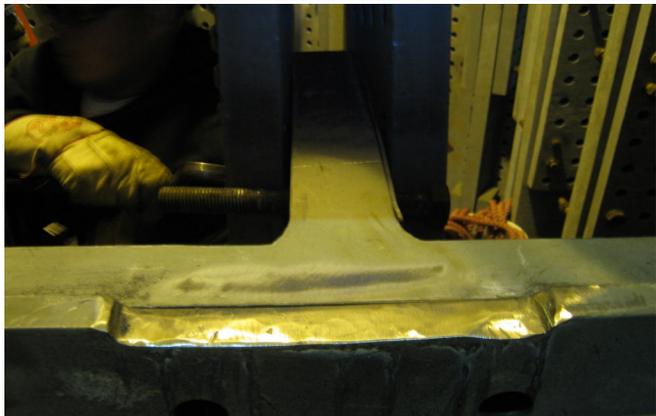
- After the portion of the shim was cut out and ground smooth, I inspected each of the 3 areas for damage. No damage was noticed (see attached photo).

Area of shim plate after cutting and grinding smooth (1 of 3 areas)

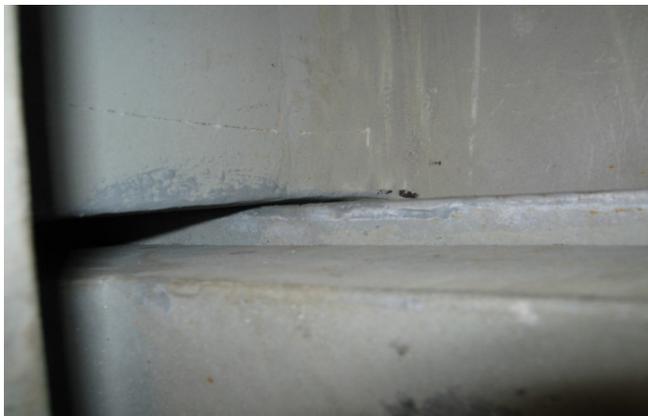
- At 18:30, they tried to lower the shaft the last 20mm. Corners A-B, A-E, & D-E came down, but corners B-C & C-D did not come all the way down. There was a gap of about 5mm between the Lift 3 & Lift 4 skin plate mill-to-bear surfaces. The cause was that a Lift 4 longitudinal stiffener was hitting the shim plate (between the skin and the internal splice plate) on Skin C (see attached photo). The shim plate was sticking above the internal splice plate by 10mm. The solution was to raise the shaft back up, lean back

Interference between Lift 4 stiffener & Lift 3 Skin C shim plate
