SAS Superstructure

Daily Diary Report by Bid Item

Contract No.: 04-0120F4

04-0120F4
04-SF-80-13.2/13.9
Self-Anchored
Suspension Bridge

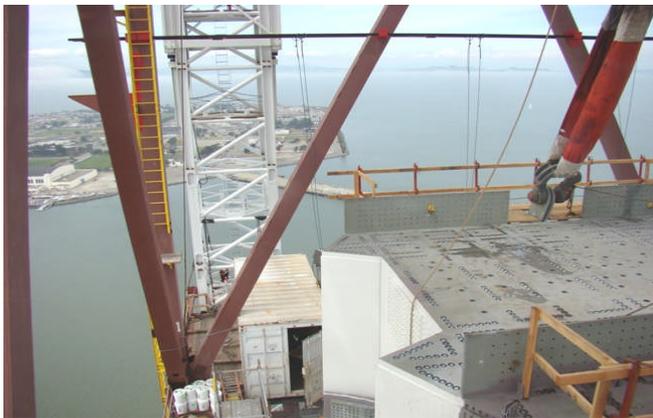
The top of the Tower grillage looking north.

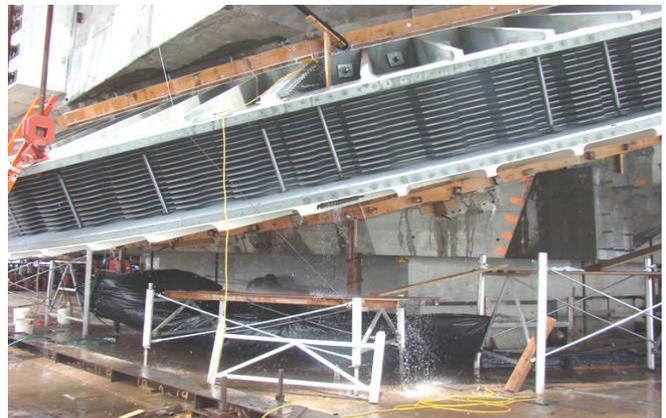
Water test in progress on the W2E west deviation saddle formwork to identify areas where there are leaks.

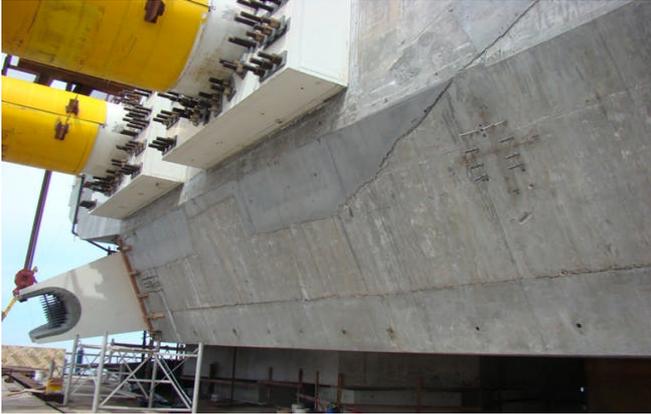
Anchor bolts drilled into the west face of the W2 cap beam for the cable tramway support frames.

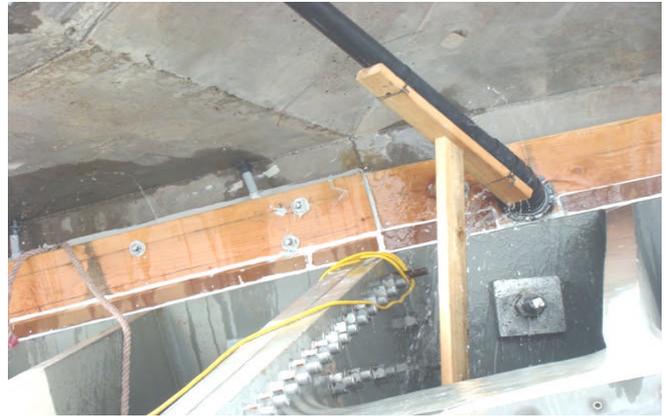
The top of the W2E west deviation saddle formwork where water leaks were observed.

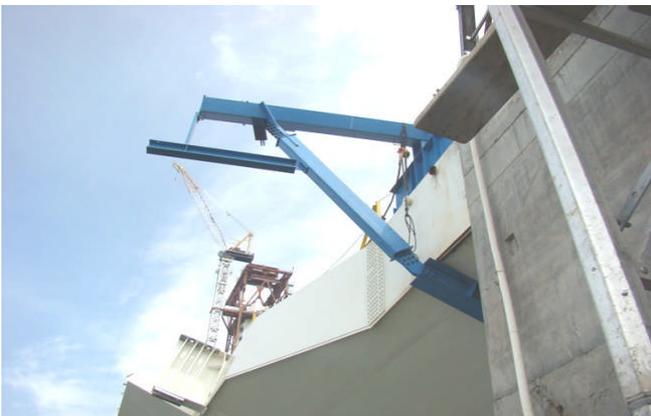
Cable tramway supports installed into the north end of OBG lift 1W.

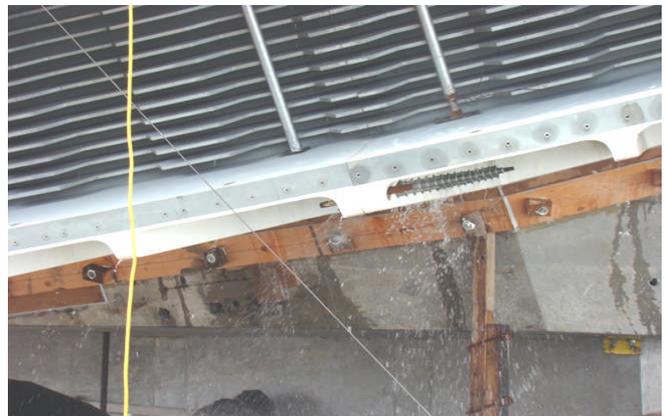
The bottom of the W2E west deviation saddle formwork where water leaks were observed.
