SAS Superstructure

Daily Diary Report by Bid Item

Diary #: 298 Const Calendar Day: 604 Date: 05-May-2011 Thursday

04-0120F4
04-SF-80-13.2/13.9
Self-Anchored
Suspension Bridge

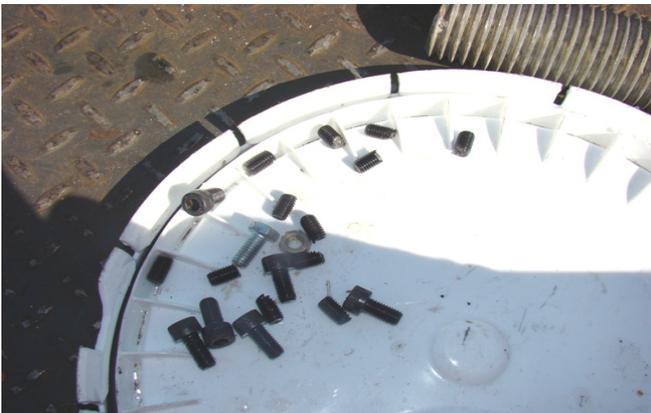
Sheared screws of the Macalloy jack's ram back plate which failed in shear.

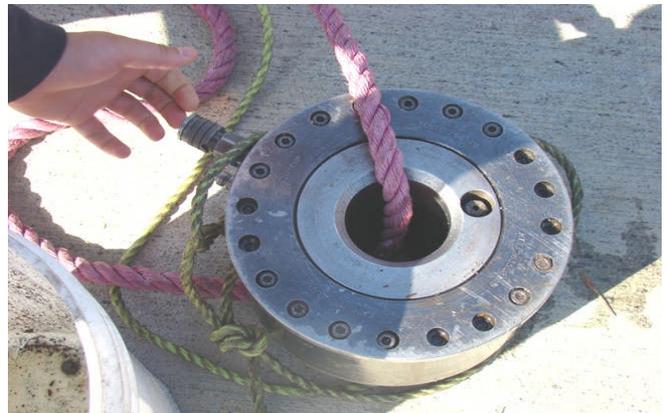
About 7 of 20 screws on the back plate of the Macalloy jack's ram which failed in shear due to high hydraulic pressures in the hoses and jack.

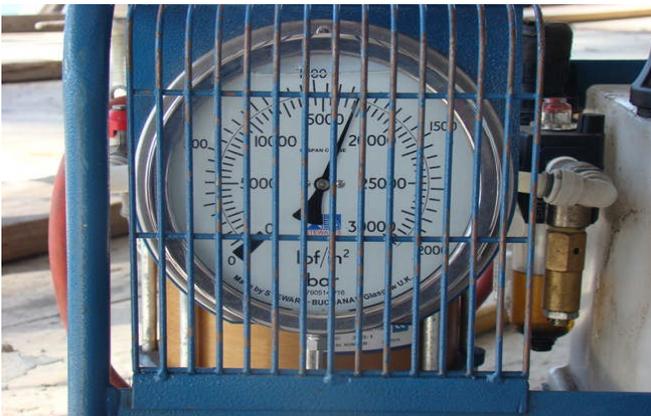
The 100% Pjack pressure of 17,250psi for the west deviation saddle anchor rods as seen on the Boltight pump's pressure gauge.

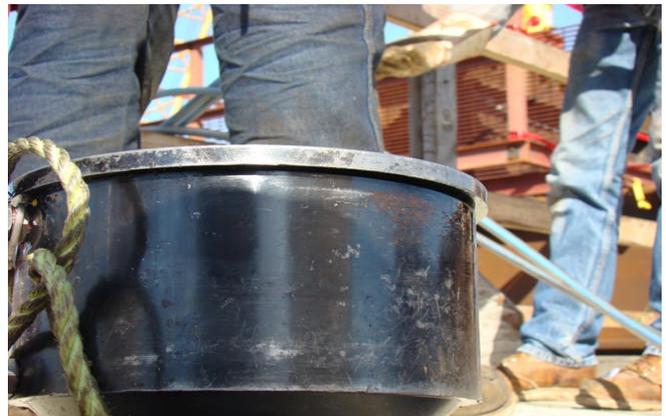
Ram plate displaced from the ram body of the Macalloy jack where 7 screws failed in shear and the "O" ring failed as well.

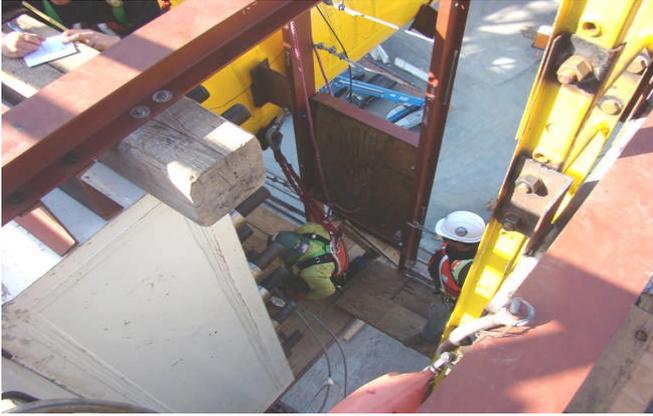
Moment when the Macalloy jack failed due to high hydraulic pressure.

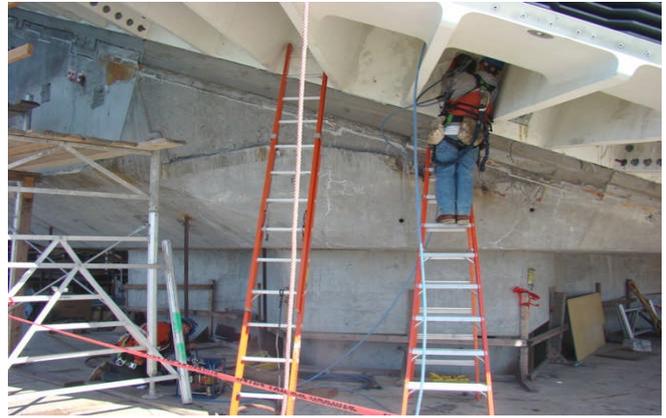
ABF ironworkers in the process of stressing an anchor rod for the W2W west deviation saddle.

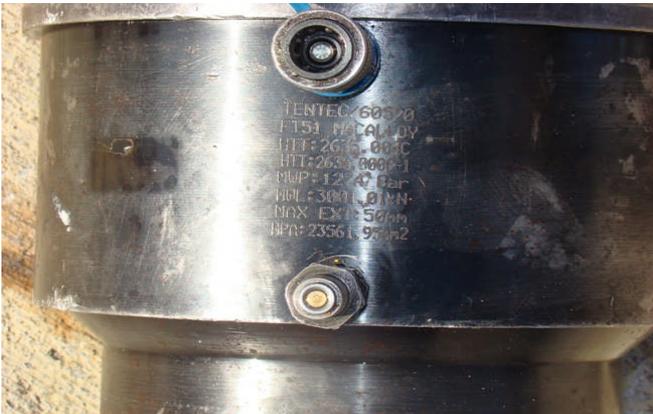
Macalloy jack rated for 3,001.01kN where Pjack is 3,000kN and the corresponding pressure on the pump gauge should be 18,800psi (act. press. 19,000psi)

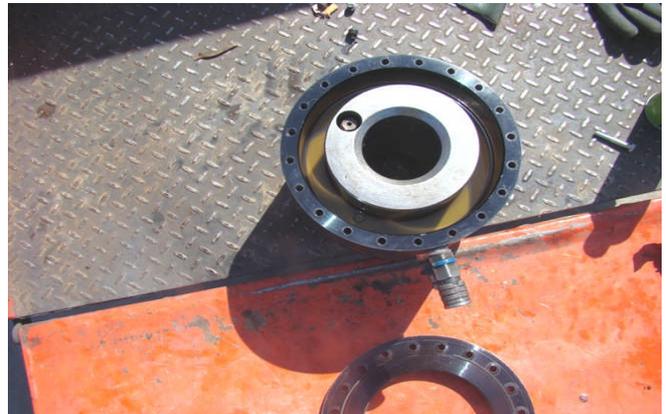
Dissassembled Macalloy jack's ram where it was discovered the ram back base plates "O" ring had failed.

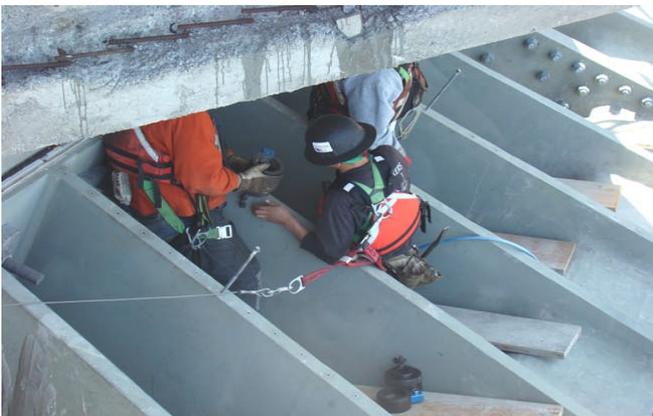
ABF ironworkers beginning to stress the W2W west deviation saddle anchor rods in the middle portion of the saddle.

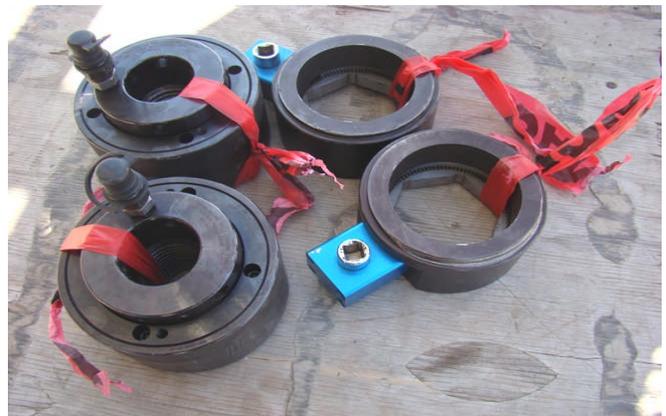
Broken jacks used on the first few rods, see photos below

Bad Boltight jacks where the lip of the jack and bolt tightening component were damaged by improper stressing procedures.
