Daily Diary Report by Bid Item

Contract No.: 04-0120F4

Diary #: 128 Const Calendar Day: 674 Date: 14-Jul-2011 Thursday

04-0120F4
 04-SF-80-13.2/13.9
 Self-Anchored
 Suspension Bridge

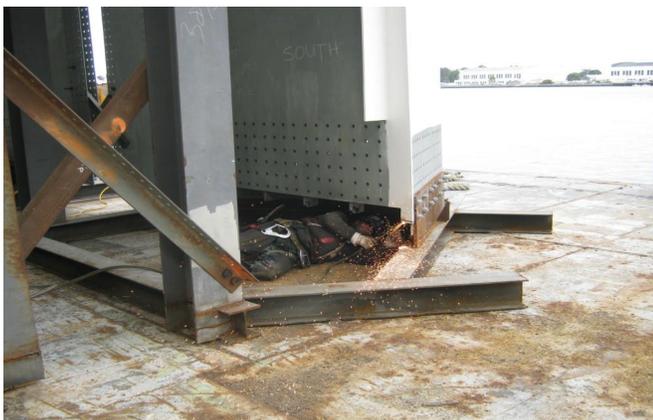
- On the C-D corner at the grillage top plate, the square edge of the corner was ground to make it a smooth curved corner. This should avoid the conflict with the interior C-D corner weld of the Tower head.
- At the bottom of the 'F' plate, near the D-F corner, the bottom 20mm was removed so as to not interfere with the 'F' splice plate weld reinforcement. The was done only in the area where the 'F' plate extended all

the way to the bottom of the Tower head, which was a length of about 150mm. - See attached photo.
 - At the bottom of each longitudinal stiffener on the 'F' plate, a small snipe (12mm) was cut from the corner of the stiffener so as to not interfere with the 'F' splice plate weld reinforcement.

Trimming the area of the 'F' plate that conflicts with the 'F' splice plate weld reinforcement

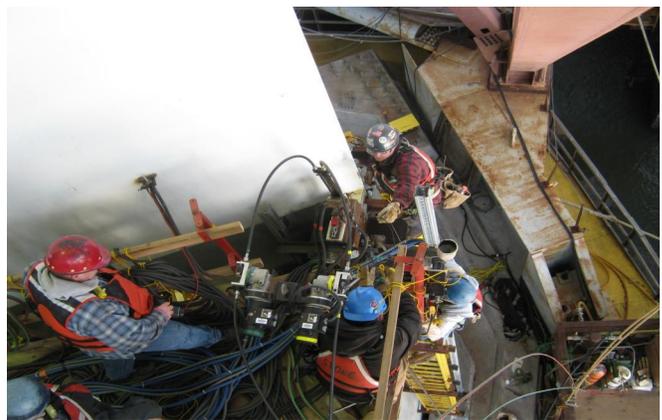
The 15th ESW weld was done today. It was on the butt joint that connects shear plate cW to the South shaft. The following is a list of activities for this operation:

- 2 new barrels of weld wire were brought to the site and connected.
- At 09:15, the consumable guide was installed.
- From 09:15 until 11:30, the insulators, volt pick-ups, and cooling shoes were installed.
- From 11:30 until 12:00, QC & production went through their pre-weld checklists.
- At 13:16, the weld was started.
- It took about 2 minutes, 45 seconds for the weld parameters to stabilize.
- At 17:38, the weld was ended in the run-off tab.

The 15th ESW weld in progress
