Daily Diary Report by Bid Item

Contract No.: 04-0120F4

Diary #: 138 Const Calendar Day: 687 Date: 27-Jul-2011 Wednesday

04-0120F4
 04-SF-80-13.2/13.9
 Self-Anchored
 Suspension Bridge

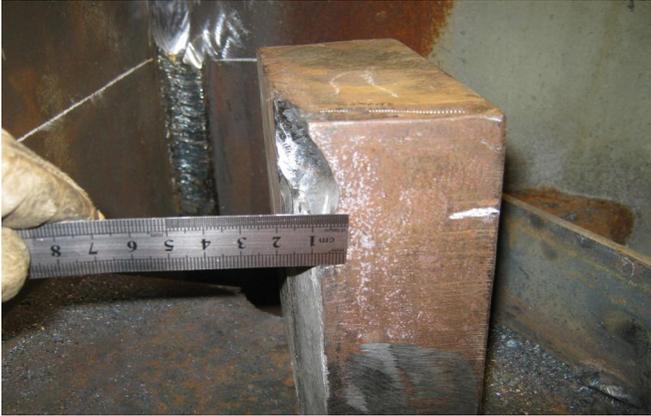
- On the inside of the joint at the bottom of the sloped weld, a steel starting sump block was attached. This sump block had a small area ground into it to act as the sump. The size of this sump was about 10mm deep, 25mm wide, and 30mm long. See attached photo.
- A new consumable guide was brought out, and was trimmed to have a 45 degree angle at the bottom.
- At 12:15, the new consumable guide was installed.
- From 12:15 until 13:30, the insulators, volt pick-ups, and cooling shoes were installed. The shoe on the inside of the joint was tight against the top of the sump block sump block.

Restart sump block

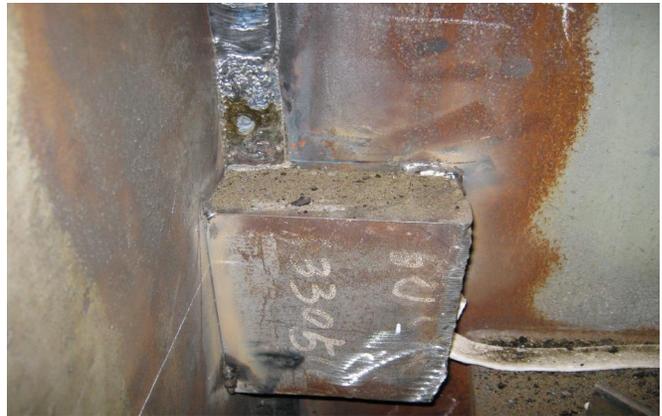
- In the areas of the weld where it was running with 1 wire, there was noticeable underfill, especially on the outside of the weld joint.
- At 18:07, the weld was ended in the run-off tab.

Completed weld just above the restart sump block

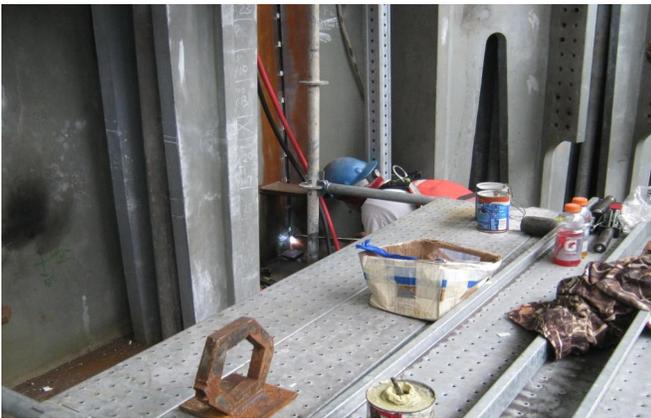
Heating the start area with a torch to remove possible condensation

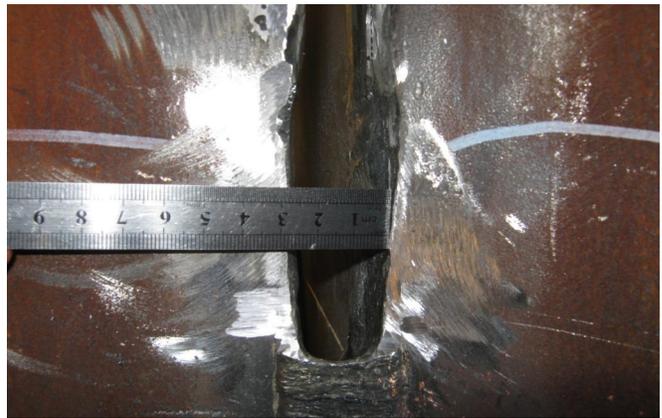
- The cooling shoes and the consumable guide were removed.
- The top of the weld was carbon arc gouged to remove the weld near the abrupt stop. On the outside of the weld joint, 70mm of weld was removed. On the inside of the weld joint, 130mm of weld was removed. The prepped top of the weld was ground clean, and sloped toward the inside of the joint at about an angle of 45 degrees.
- In the area of the weld joint where the weld was removed, the root gap varied from 24mm to 28mm. See attached photo.

Root gap of prepped restart area

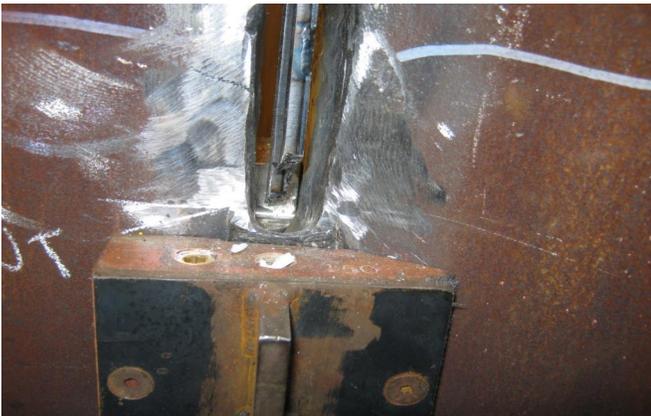
Restart area with guide installed and sump block attached on opposite side of the joint.

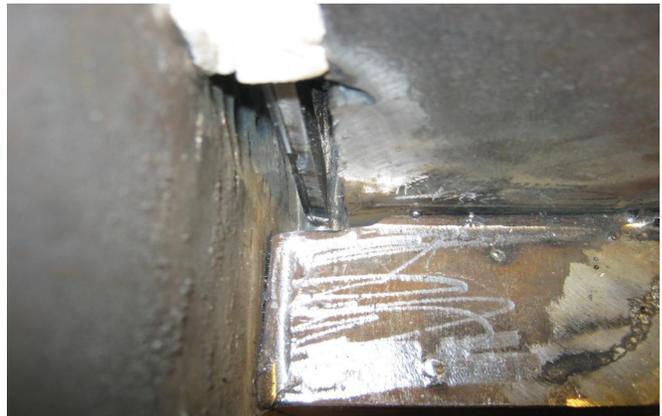
Looking down at the sump block attached to the inside of the joint
