Daily Diary Report by Bid Item

Contract No.: 04-0120F4

04-0120F4
 04-SF-80-13.2/13.9
 Self-Anchored
 Suspension Bridge

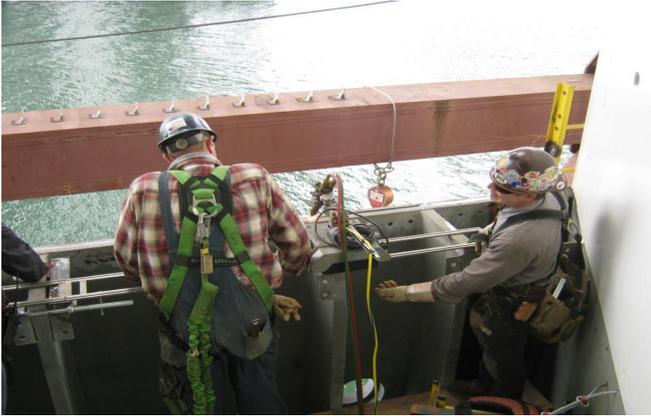
Torch cutting the bevel for the 13m external diaphragm PJP weld on shear plate c(E)

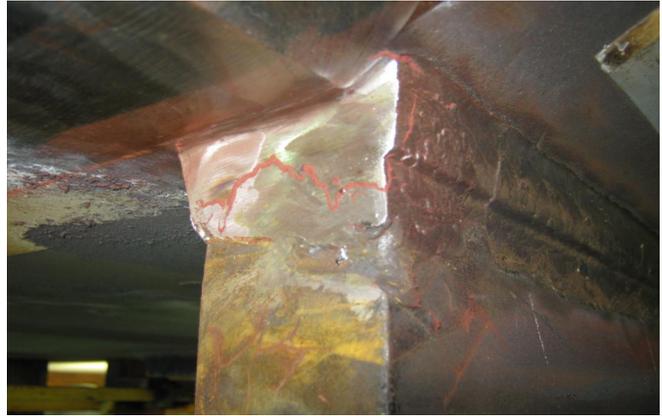
- All of the run-off tabs had previously been cut off the ESW welds, and they were grinding and MT'ing these run-off areas. Most of areas that were MT'd showed cracks similar to one described in yesterday's diary. The cracks varied in length from about 20mm to about 75mm. The X location of the cracks varied on different welds. Some of them were near the edge of the weld close to the skin plates, some were near the edge of the weld away from the skin plate, and some were near the center of the weld. - See attached photos.

- The cracks were on most of the T-joints. No butt joints that were MT'd showed signs of this cracking.
- Of the 12 T-joints, 10 of them had cracks in the top of the ESW welds. The 2 T-joints that did not have cracks were the weld connecting shear plate b1E to the North shaft and the weld connecting shear plate b2W to the West shaft.

Crack in the top of ESW weld location 'L' connecting shear plate b1W to the South shaft

- The cracks were being excavated by carbon arc gouging and grinding. MT was continually performed at various depths of the excavations.
- I gave approval on the request for weld repair of the excavation at the top of ESW weld 'K'. The excavation was MT cleared prior to the start of welding, and it was repair welded using 7018.
