SAS Superstructure

Daily Diary Report by Bid Item

Contract No.: 04-0120F4

04-0120F4
04-SF-80-13.2/13.9
Self-Anchored
Suspension Bridge

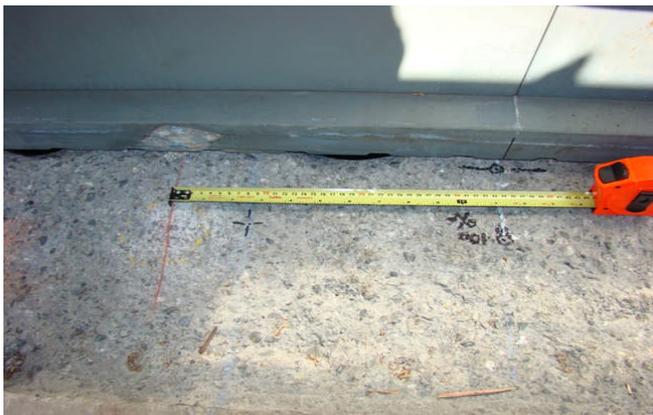
- Continued to process the surveying information from last Saturday August 6th, 2011 for the checks on the marks placed by ABF surveyors on the top of the E2 cap beam concrete surface for the Shear Key and Bearing placement. Went to the E2 cap beam and checked the marks on the concrete surface of the E2 cap beam for the B1, S1, B3, B2, S2, and B4 Shear Keys and Bearings placed this last week. The marks for the correction for the axial camber do not match what is prescribed in Submittal 2419R00: Pier E2 Bearing and Shear Key Erection Plan. In the submittal the distance from the "Established Geometric Line and CL rotation Offset from CL Pier E2" to the "Axial Camber Offset Line" is 295mm. I measured 395mm for the lines placed on the south end for the Shear Keys and Bearings placed this last week. After the analysis the "Established Geometric Line and CL rotation Offset from CL Pier E2" was close to 86mm offset from the centerline of Pier E2. So the "Axial Camber Offset Line" was incorrectly marked. See photos below for additional details and comments.

The measured marks with a tape measure from the south end of the B4 Bearing.

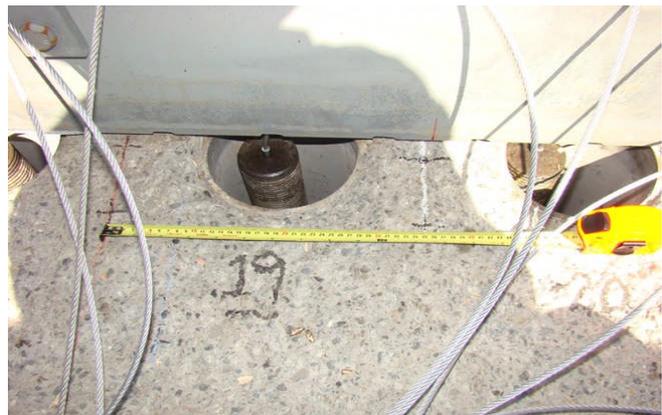
The measured marks with a tape measure from the south end of the S1 Shear Key.
