### SAS Superstructure

Location: 04-SF-80-13.2 / 13.9

## Daily Diary Report by Bid Item

04-0120F4  
 04-SF-80-13.2/13.9  
 Self-Anchored  
 Suspension Bridge

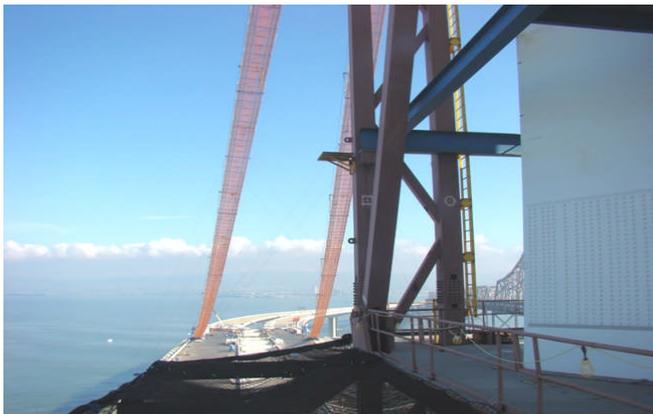
View from the erection tower of the mainspan where the scanner

obtained images.

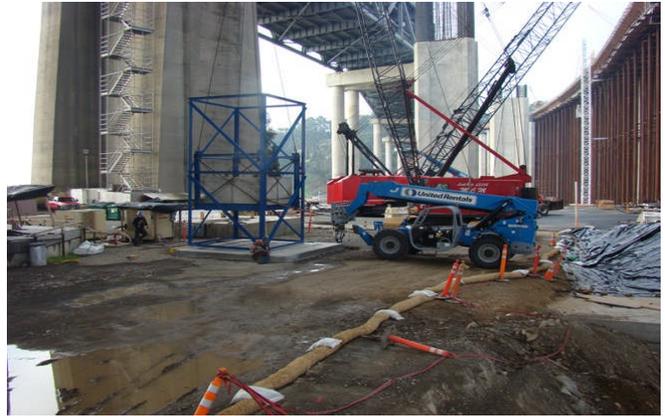
ABF ironworkers relocating/moving the counterweights and corresponding frame underneath the W2 cap beam.

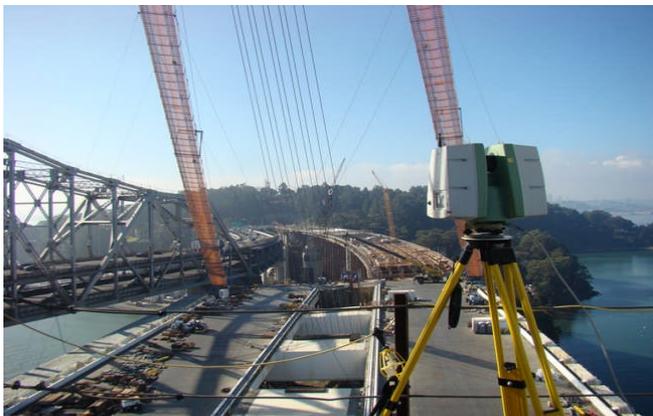
The Leica scanner in the process of obtaining images set on the T1 erection tower.

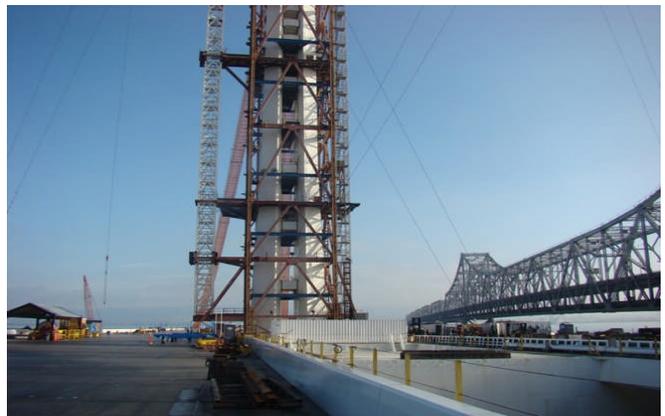
View from control point PP3WS20 used for scanning the backspan of the SAS bridge.
