SAS Superstructure

Daily Diary Report by Bid Item

Date: 23-Dec-2011 Friday

04-0120F4
04-SF-80-13.2/13.9
Self-Anchored
Suspension Bridge

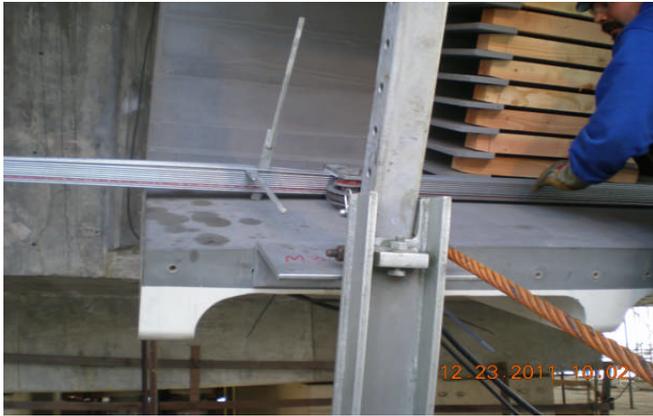
PWS Installation @ SDS

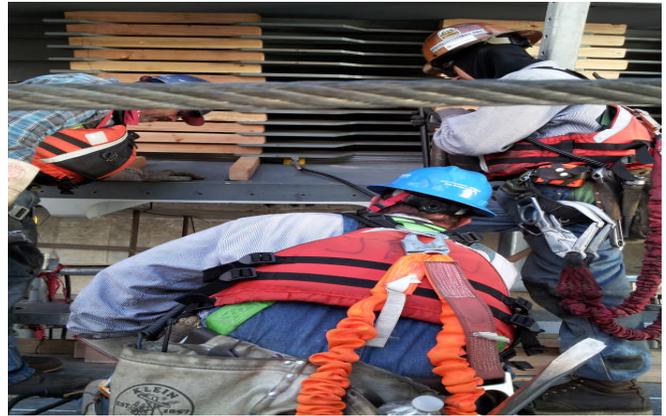
PWS Installation @ SDS - Using Jacking system to jack divider plates

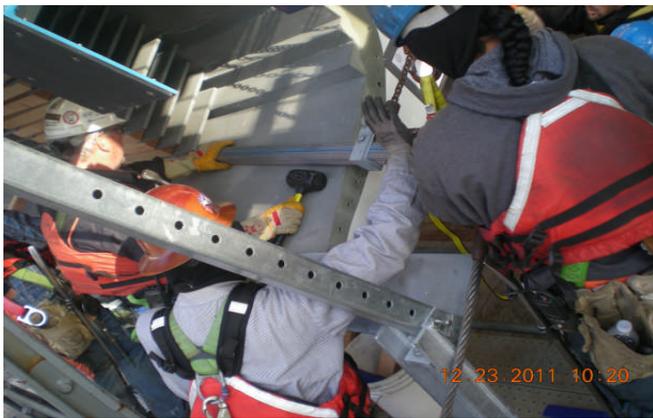
PWS Installation @ SDS

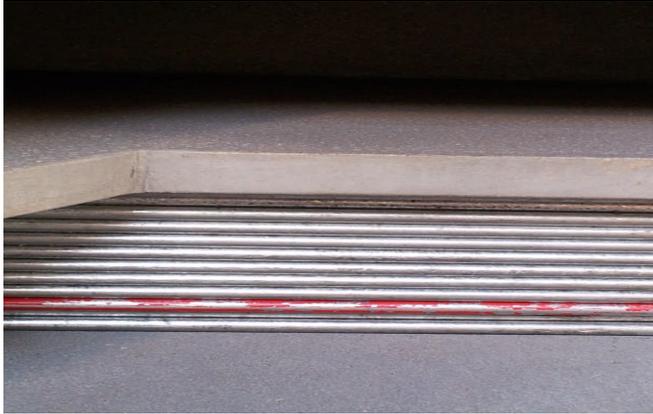
- PWS installation: PWS installation for the Jacking & Deviation Saddles began today. Roman and I was inspecting the installation for the South Deviation Saddle (SDS) operations. During the SDS installation, I observed near the beginning location of the SDS that the red wire was 2nd and not 3rd per approved working drawings. I also noticed in the same location that there were 12 wires and not 11 in the first row. I relayed this information to Brian Boal and showed him the wire layout and he indicated that were not going to have ABF remove the strand from the saddle as a result of this. Issue resolved.

Wire layout near the beginning end of SDS

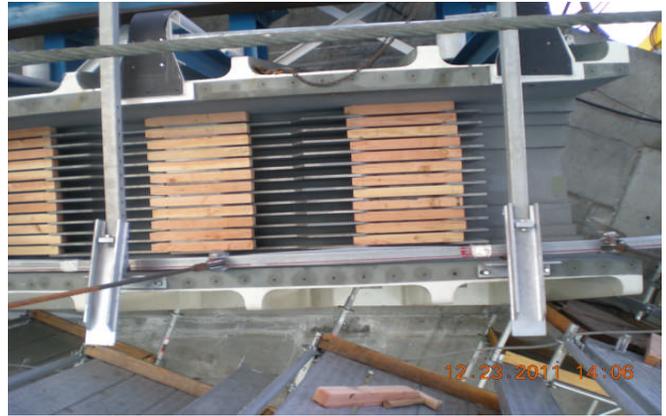
PWS Installation @ SDS

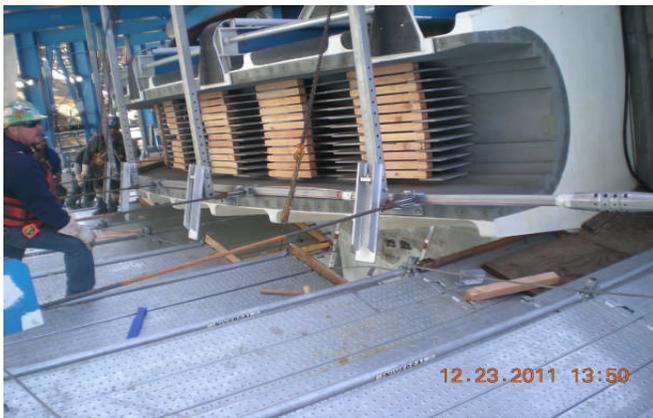
PWS Installation @ SDS

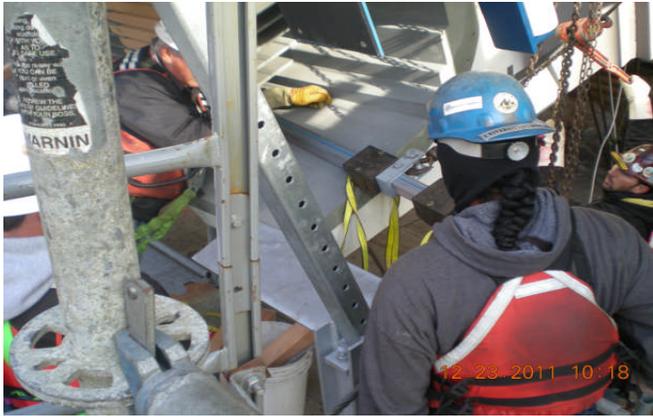
PWS Installation @ SDS

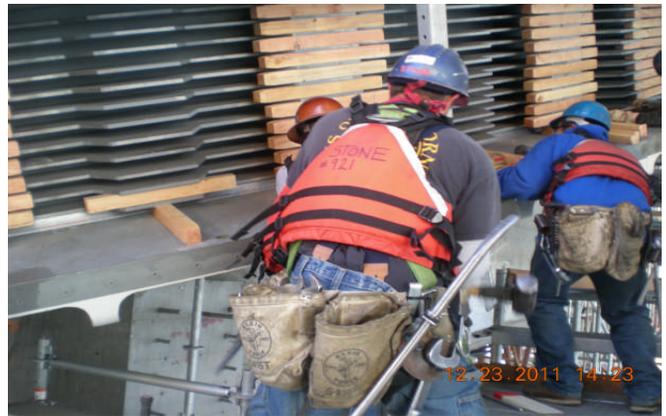
PWS Installation @ SDS

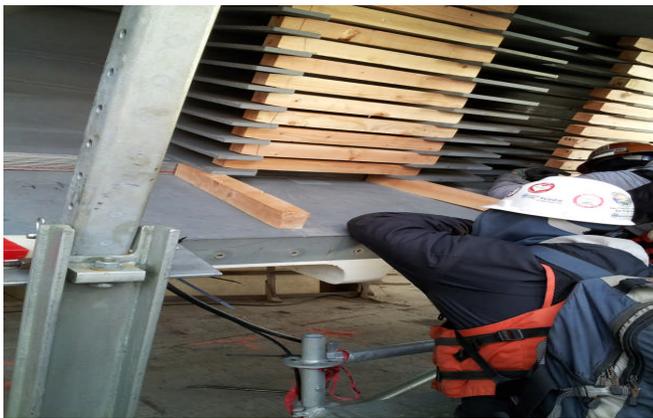
PWS Installation @ SDS
