SAS Superstructure

Daily Diary Report by Bid Item

Diary #: 465 Const Calendar Day: 840 Date: 27-Dec-2011 Tuesday

04-0120F4
04-SF-80-13.2/13.9
Self-Anchored
Suspension Bridge

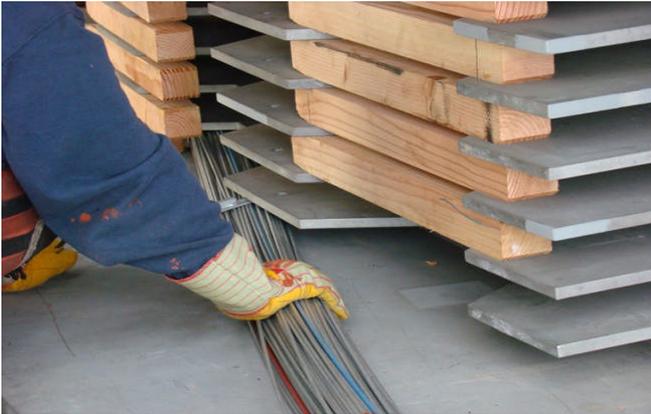
- 2.) It was unclear whether or not the wires were crossing as the ABF ironworkers were placing the cable strand into the E-Line west deviation saddle trough. Better cable forming and placing techniques will need to be utilized to ensure proper cable strand placement into the west deviation saddle troughs.

Close-up of ABF ironworkers placing a section of the first cable strand into the E-Line west deviation saddle trough where wires may have crossed.

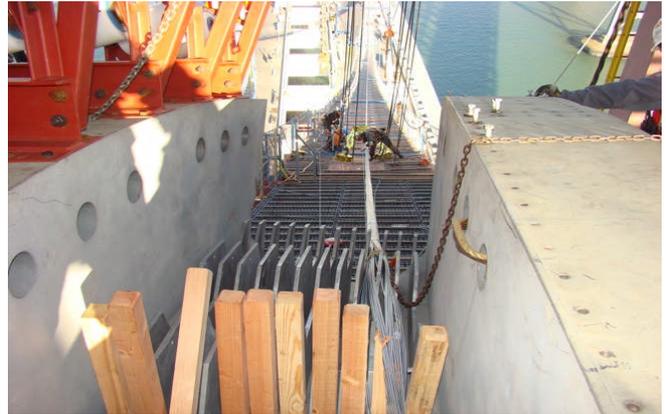
Approximately at 3:00pm an accident occurred while floating the first cable strand. The first cable strand crashed (impact loading) onto the south tower saddle divider plates and the south mainspan catwalks. It is suspected that the Crosby clips used on the cables that support the floating clamps and that are connected to the winches used to float the cable strand failed in tension/friction. It is likely that the improper torque was applied to the nuts of the Crosby clips at the time of installation. After the accident ABF ironworkers were seen torquing the nuts of Crosby clips used on various cables. See the photos below for more details and additional comments.

ABF ironworkers checking the connections of the south mainspan floating clamps after the accident occurred.

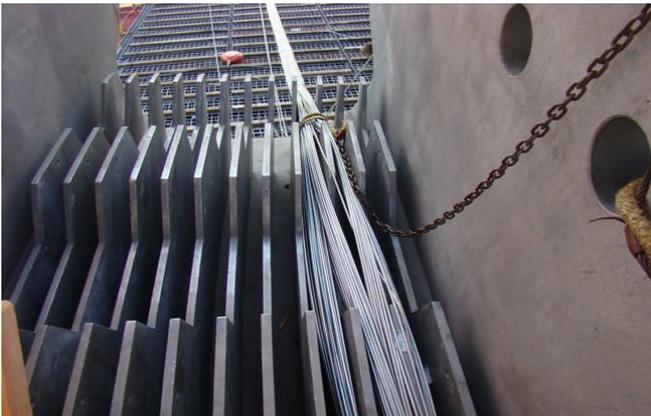
Splayed sections of cable strand #1 wires at east side of the south tower saddle trough.

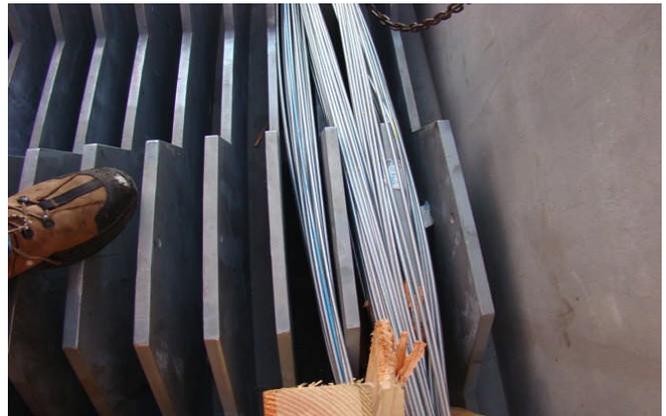
Splayed sections of cable strand #1 wires in the south tower saddle trough.

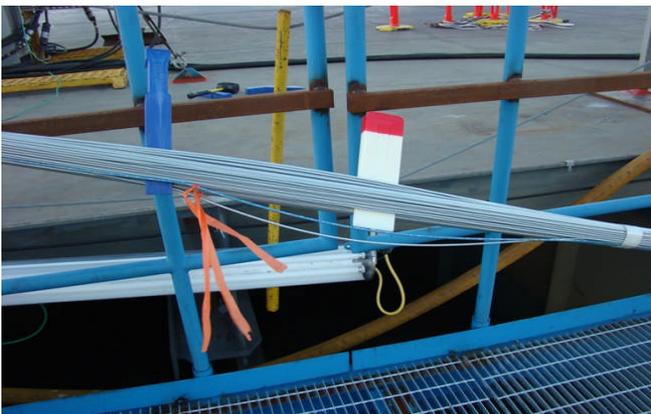
Condition of cable strand #1 at the east end where the cable fell onto the posts of the handrail.

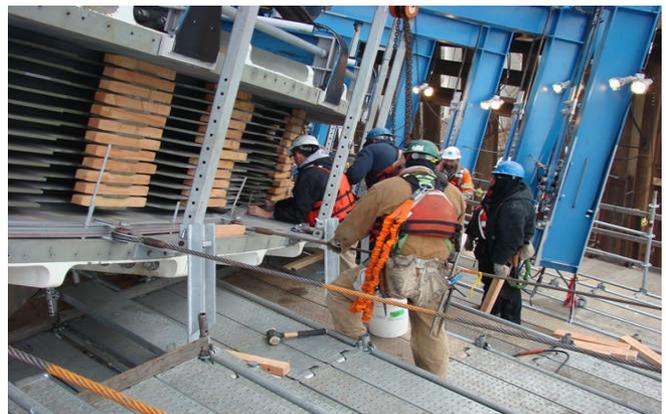
ABF ironworkers and engineers working on placing the rectangular preformed section at the W-Line deviation saddle into the saddle trough.

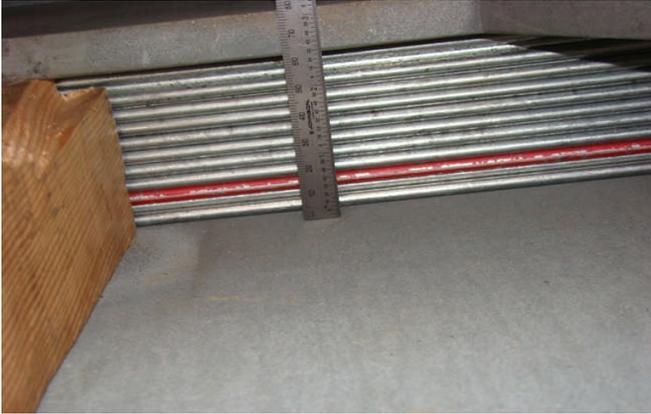
Ruler placed near a section of the first cable strand placed into the E-Line west deviation saddle trough.

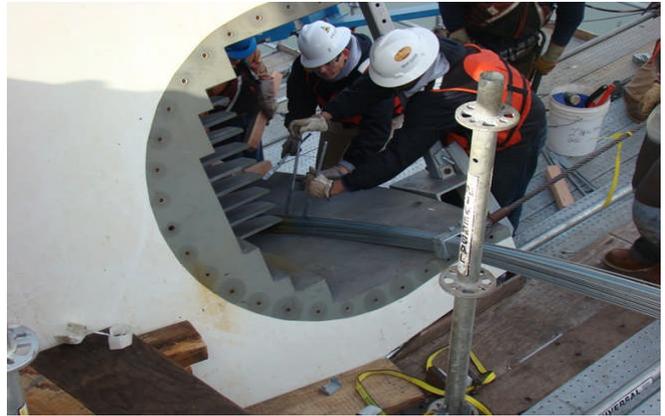
Placement of the last section of cable strand #1 into the W-Line west deviation saddle trough.

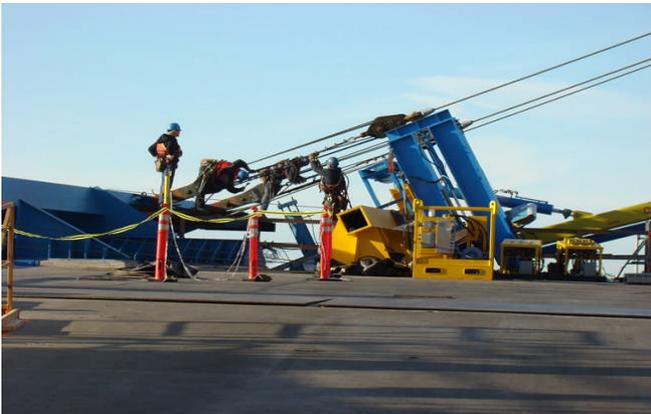
ABF ironworkers seen tightening/torquing the nuts of crosby clips on the north backspan tramway cables after dropping the cable strand accident.

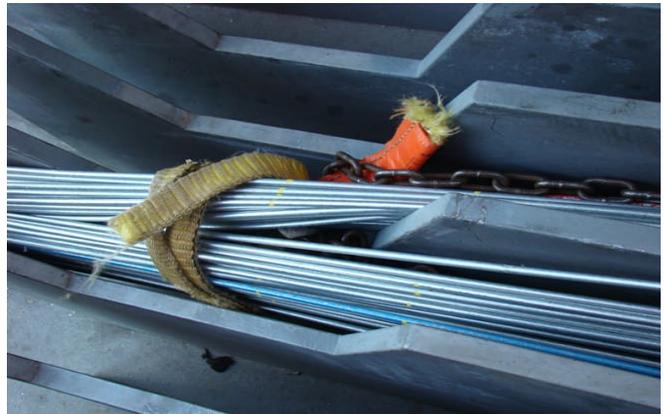
Sheared strap used to temporarily suspend/position the cable strand during floating operations.

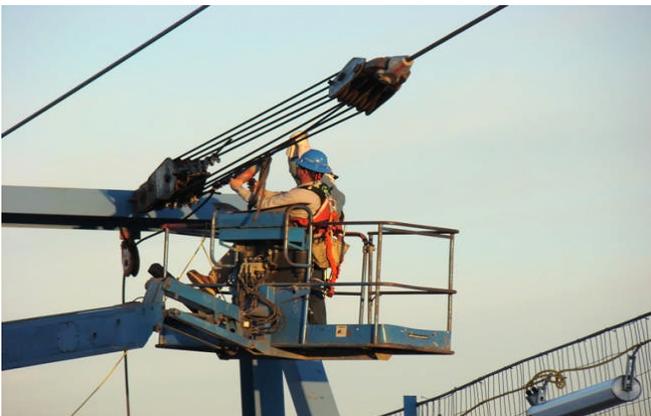
ABF ironworkers seen tightening/torquing the nuts of crosby clips on the south mainspan tramway cables after dropping the cable strand accident.

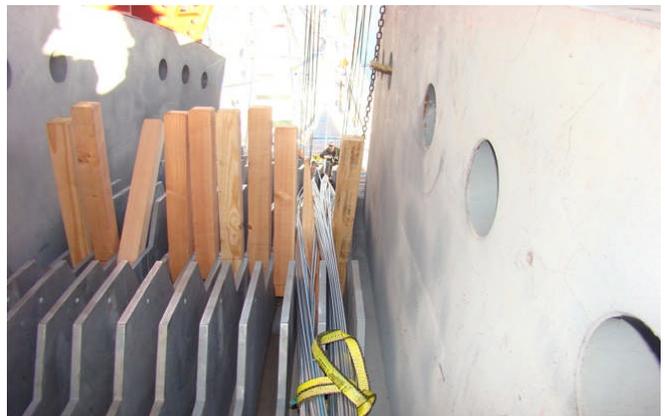
Cable strand #1 after it had been accidentally dropped into the south tower saddle trough onto the divider plates.

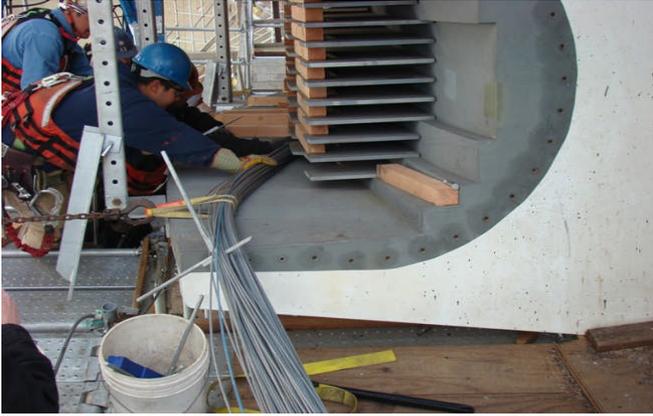
- 1.) The crew placing the cable strand into the W-Line west deviation saddle trough appeared to have better workmanship and supervision than on the E-Line west deviation saddle. Karsten Baltzer, Ankur Singh, and Jerry Kubala supervised and helped place the cable strand on the W-Line saddle while there was nobody supervising the crew at the E-Line saddle.

ABF ironworkers placing a section of the first cable strand into the E-Line west dev. saddle trough where the workmanship was considered marginal.
