SAS Superstructure

Location: 04-SF-80-13.2 / 13.9

Daily Diary Report by Bid Item

04-0120F4  
04-SF-80-13.2/13.9  
Self-Anchored  
Suspension Bridge

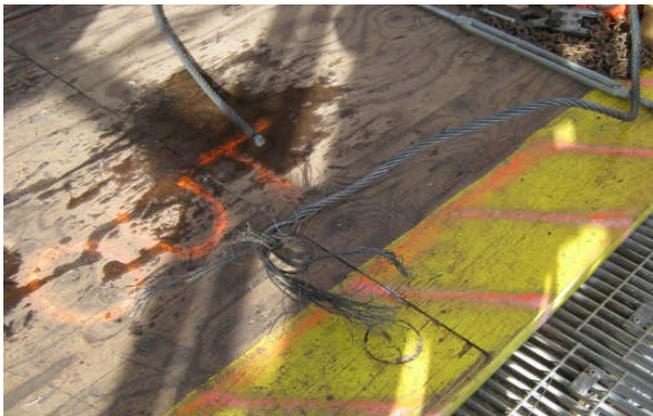
- ABF engineers and safety personnel came up to the site to try to determine the cause. They determined that it appeared as if the cause was that the Crosby clips at the end of the winch line may not have been tight enough. This caused the winch line to slip through the clamps (causing the fraying at the end of the line), which then caused the winch line to fail.

Frayed winch line from South main-span floating winch

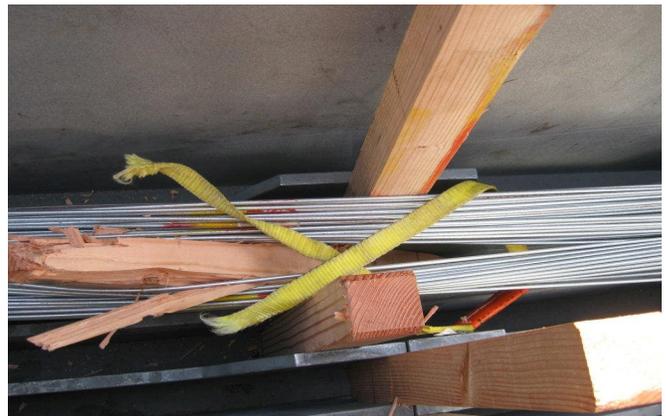
- At 13:05, the floating winch for the South main-span gave out, and the South strand crashed down onto the Tower divider plates, as well as along the entire length of the South main-span catwalk. Nobody was injured. For the next 15 minutes, everyone was trying to determine the cause of the failure. It was determined that the floating winch line had failed (see attached photo of frayed winch line, which was in the area where it failed). When the winch line failed, the nylon slings supported the strand above the Tower saddle could not support the additional weight, and they also failed (see attached photo). I called Warren Collins and Roman Granados to give them an update on these events.

Broken nylon sling

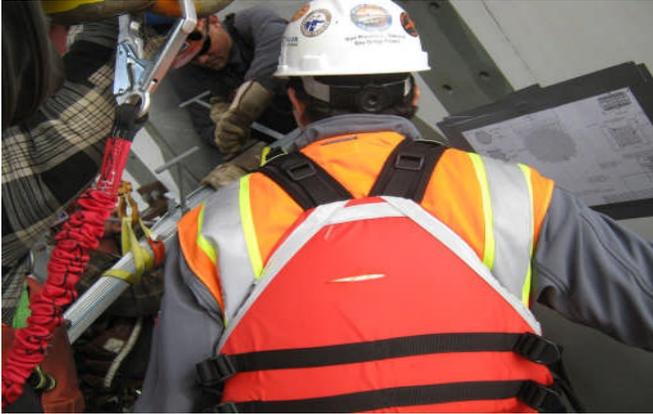
Installing knife plates to start strand forming

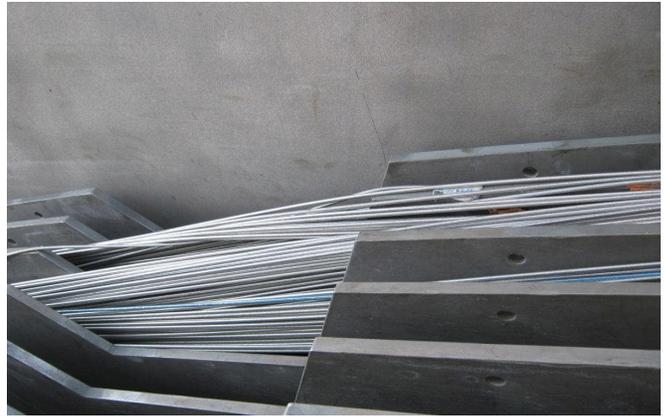
- Possible damage to strand: When the strand fell onto the saddle divider plates, several areas sustained

possible damage or kinks (see attached photos). The full extent of possible damage cannot be determined until the strand is re-floated above the Tower saddle to check the underside where is hit against the edges of the divider plates.

Close-up of strand with possible kinked wire

The Caltrans Cable group met in Brian Boal's office after the end of the shift to go over the details of the incident with the winch line breaking. We discussed the safety issues, as well as possible directions forward with this particular strand (replace strand, splice wires, etc).

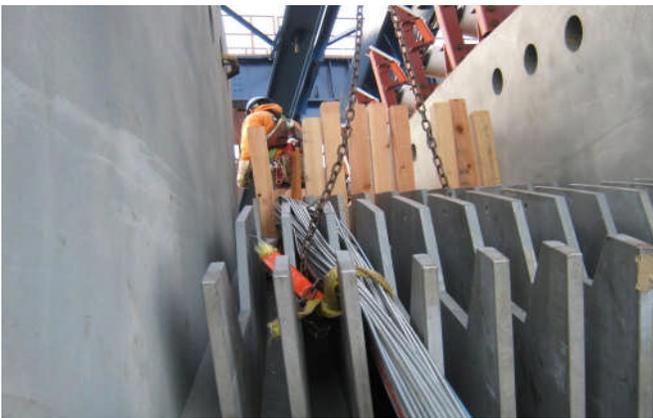
Strand in South trough after winch line failed and dropped the strand

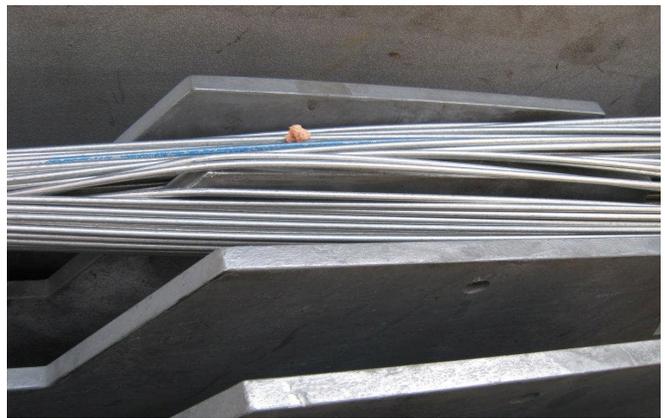
Close-up of strand with possible kinked wire
