SAS Superstructure

Daily Diary Report by Bid Item

Contract No.: 04-0120F4

04-0120F4
04-SF-80-13.2/13.9
Self-Anchored
Suspension Bridge

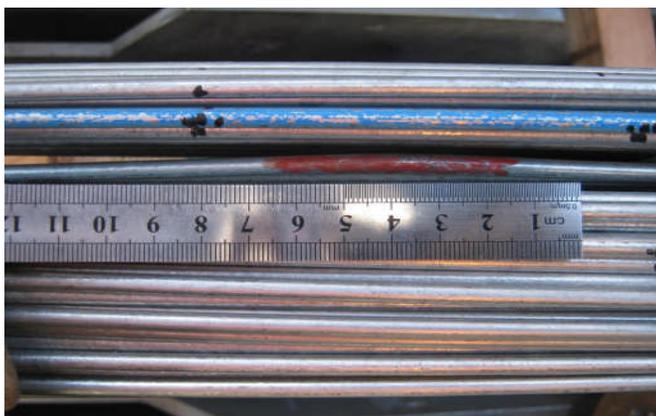
- At 08:50, the winch was engaged, and the strand in the South main-span was re-floated.
- From 09:00 until 10:45, I was checking the strand at the Tower saddle for damaged wires along with Roman Granados, Saman Soheili, and Matt Bruce.. A total of 9 wires were found to have some kinks (see attached photos). ABF plans to perform some testing of spare strand to try to recreate the worst case, and have these samples sent to the lab for testing.

Knink in wire at South Tower trough (length typical of all of the kninks)

that were found)

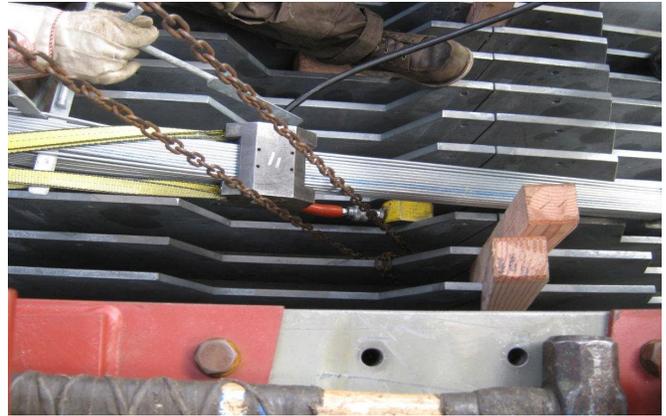
Use of porta-power to separate divider plates during strand installation

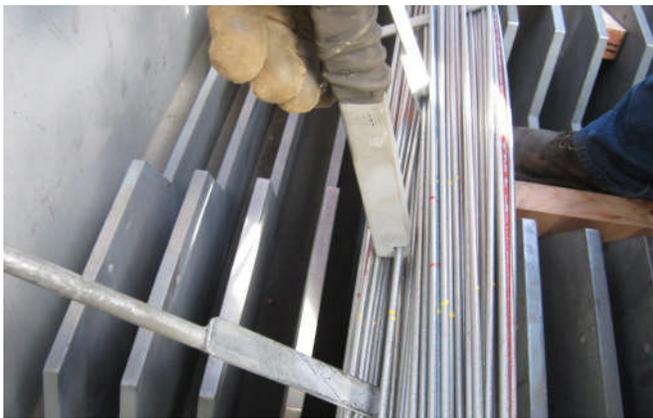
Wire straightening tool in use

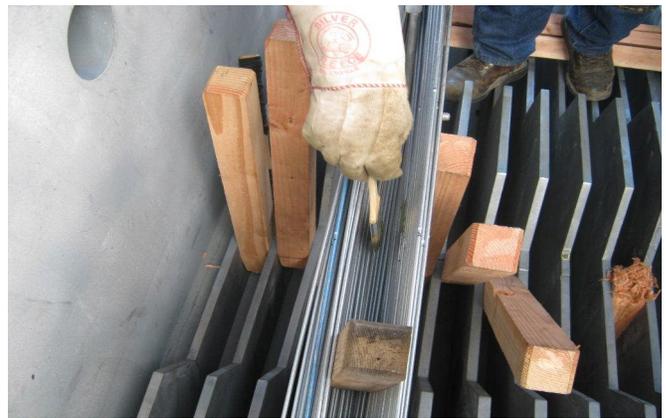
Paint repair to damaged galvanizing

- At 11:50, strand forming and installation was re-started on the South side of the Tower saddle.
- From 13:00 until 13:45, the kinks in the wires in the South trough were straightened. I closely inspected each wire while it was being straightened. See attached photos of the straightening tool that was used. Each kink in the wires that was identified earlier was straightened. Each kink was removed with minimal effort and working of the wire. After the wire was straightened, the area was touched-up with MC-Zinc-100 paint to repair the galvanizing damage (see attached photo).

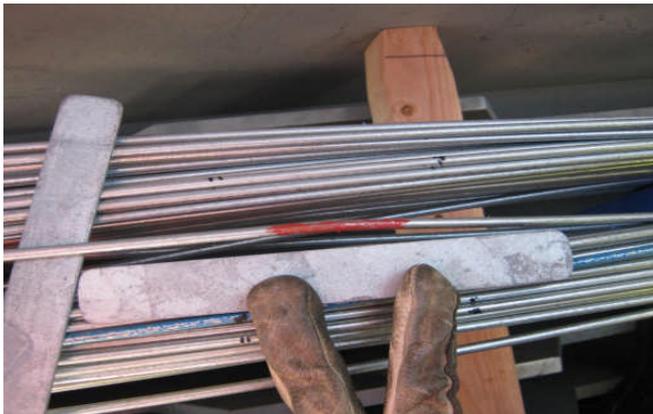
Kink in wire at South Tower trough

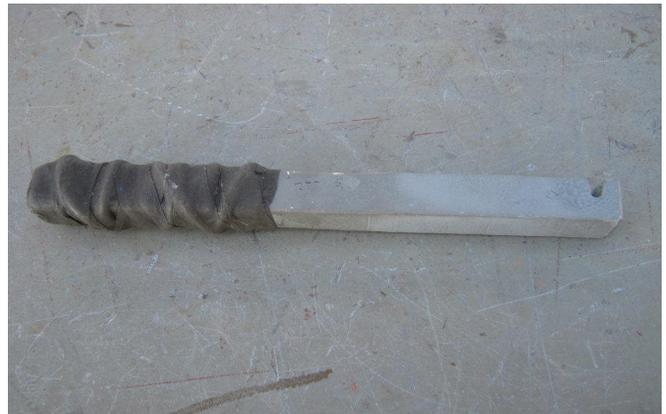
Tool used to straighten kniked wires
