SAS Superstructure

Daily Diary Report by Bid Item

Contract No.: 04-0120F4

04-0120F4
04-SF-80-13.2/13.9
Self-Anchored
Suspension Bridge

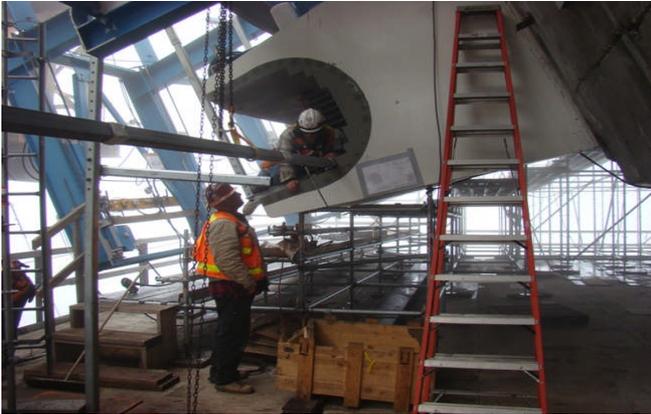
Connection conditions of cable strand #1 at the W-Line west deviation saddle and ABF surveyors measuring sag.

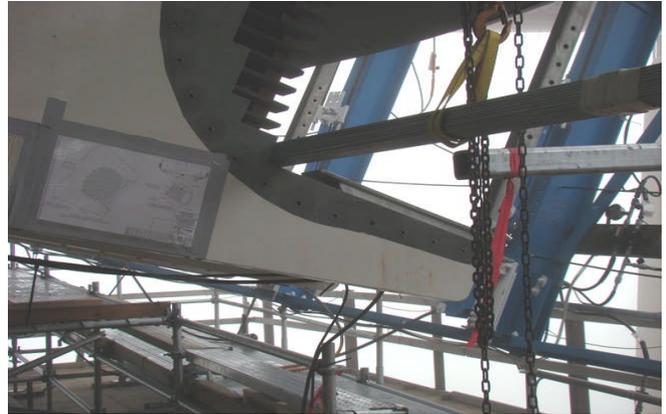
Connection conditions of cable strand #1 at the E-Line west deviation saddle.

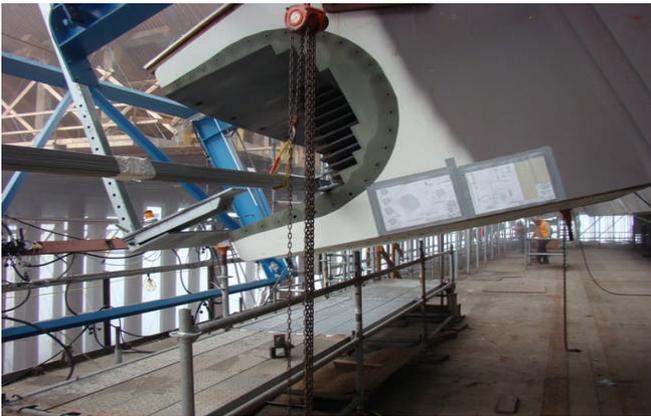
Connection conditions of cable strand #1 at the south side of the jacking saddle.

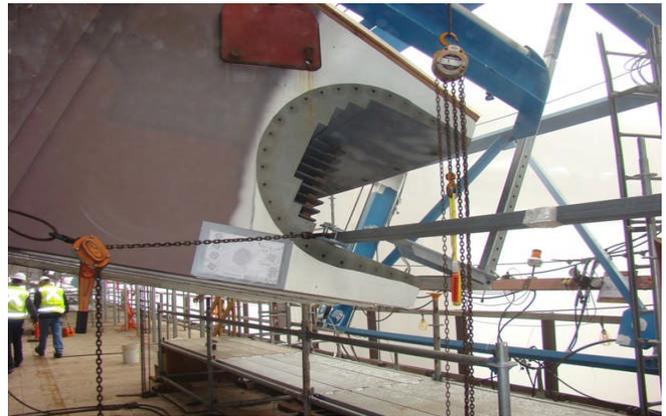
Connection conditions of cable strand #1 at the north side of the jacking saddle.

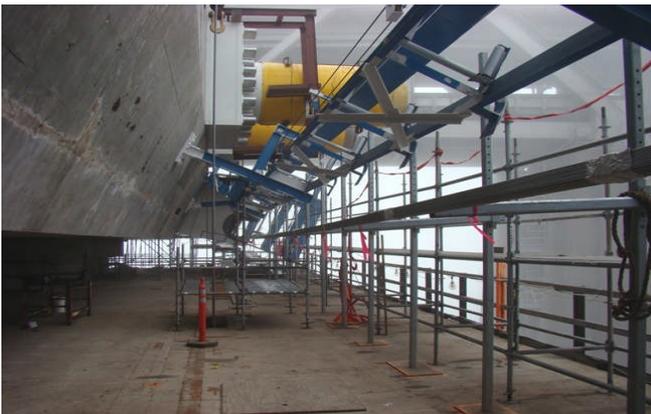
The south section between the jacking saddle and the E-Line west deviation saddle of cable strand #1 looking south.

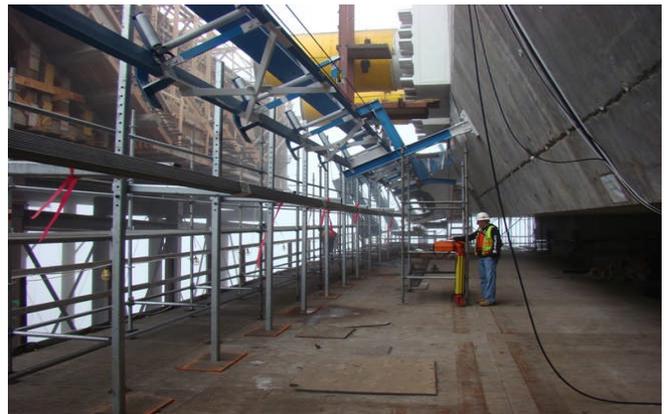
The north section between the jacking saddle and the W-Line west deviation saddle of cable strand #1 looking north.

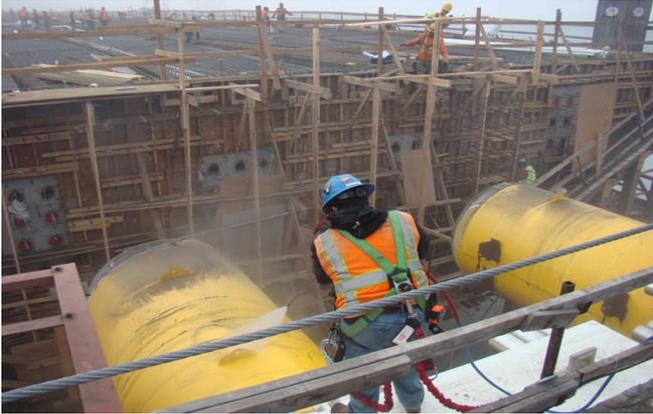
ABF laborer washing the sand blasting residue blown onto the north Hinge K pipe beam protective covers by MCM crews.
