SAS Superstructure

Daily Diary Report by Bid Item

Diary #: 471 Const Calendar Day: 849 Date: 05-Jan-2012 Thursday

04-0120F4
04-SF-80-13.2/13.9
Self-Anchored
Suspension Bridge

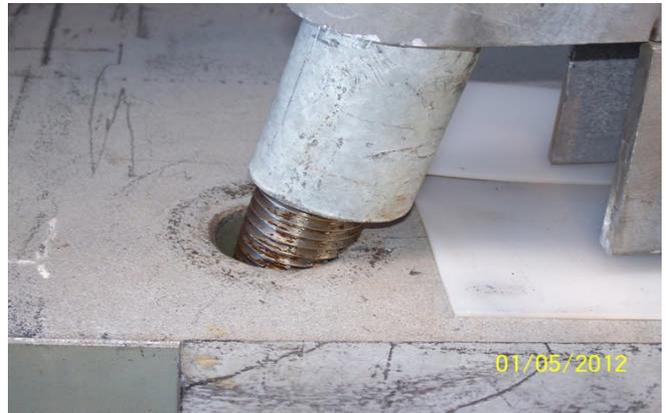
Deformed threaded bar bearing against the bottom trough of the W2W west deviation saddle while adjusting cable strand #1.

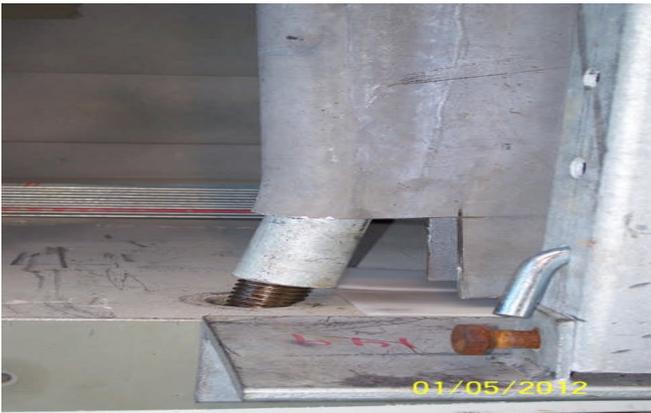
- Inspected the adjustment of cable strand #1 at the west loop for surveying purposes. During the jacking operation I noticed the failure of a threaded rod of the north strand adjuster. After this discovery of the failure in the threaded rod the operation was stopped per the ABF superintendents. See the photos below for more details and my comments related to the failure of the north strand adjuster.

Cut portion of the plate which caused an eccentric load of the strand adjuster where the failure of the threaded rod occurred.

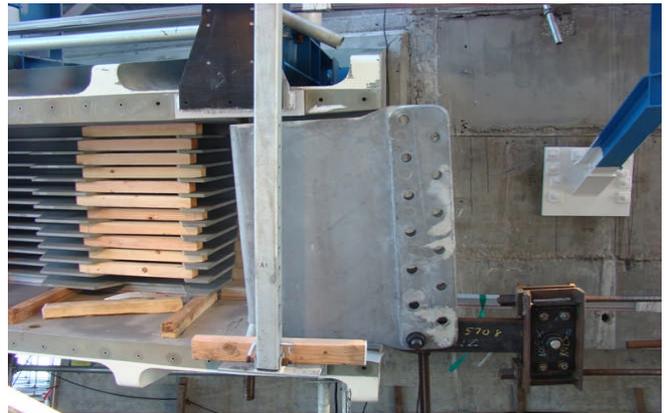
View of the north strand adjuster jacking assembly for the west loop which failed in bending when adjusting the sag of cable strand number 1.

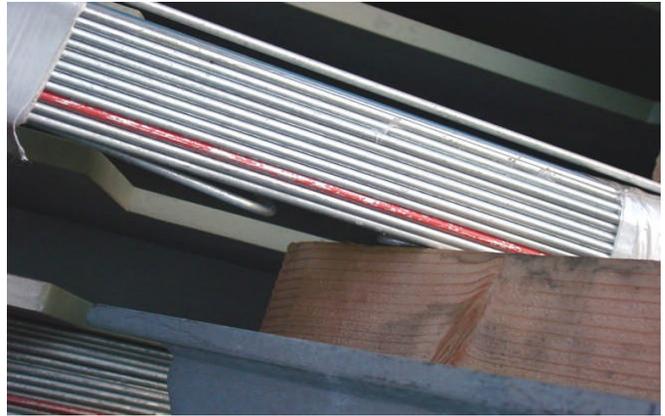
- Measured the additional length of the replacement wire to be cut with ABF engineer Ankur Singh. The replacement wire is for the broken wire in cable strand number 2 that failed in tension during the hauling of that strand last Friday. The replacement wire will be spliced in the cable shroud area and in the west loop. The area in the west loop where the splice will terminate is between the W-Line west deviation and jacking saddles but outside of the cable bands in this area. Ankur used his 300' long nylon tape to measure the wire at increments of 15'-15'-5', he verified these lengths with a pocket tape. After the wire was cut the length of the wire was 124.94'. At the time of measurement the ambient temperature was 59F and the steel temperature of the wire was 78F.

Broken wire on strand #2 seen at the bottom of the preformed west loop rectangular section.

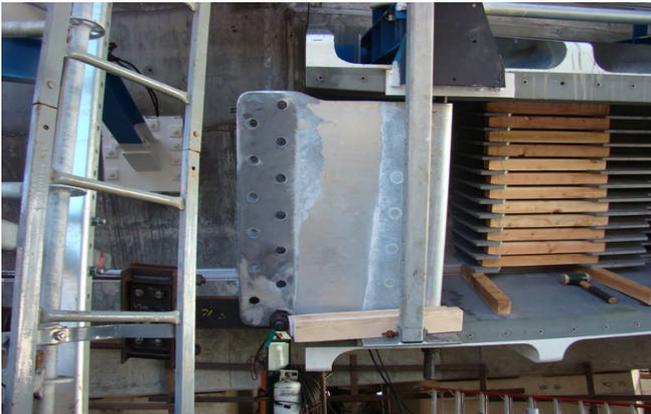
The south strand adjuster jacking assembly for the west loop seen after the incident.

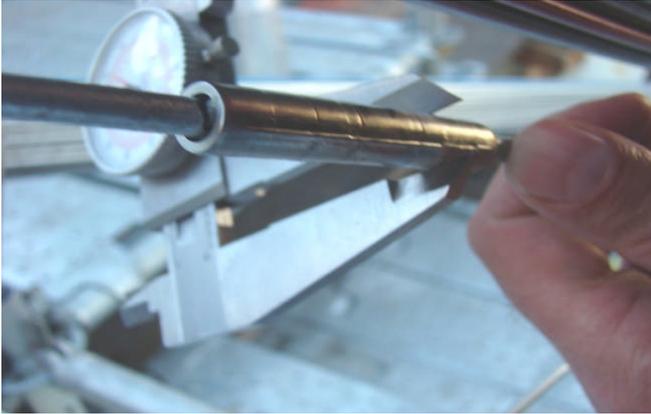
Straight longitudinal groove seen for a properly field fabricated ferrule splice connection.

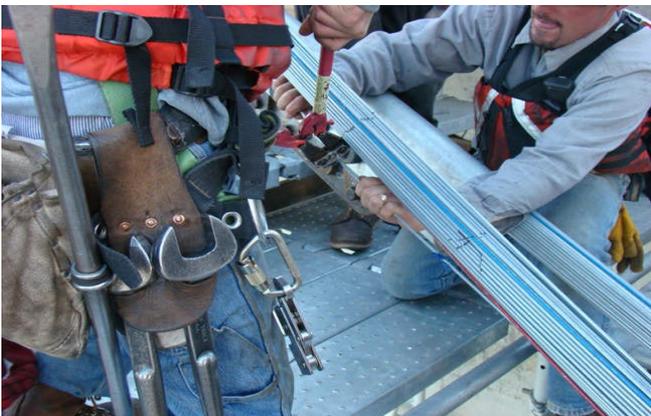
Cutting the broken wire near the W2W west deviation saddle shroud area.

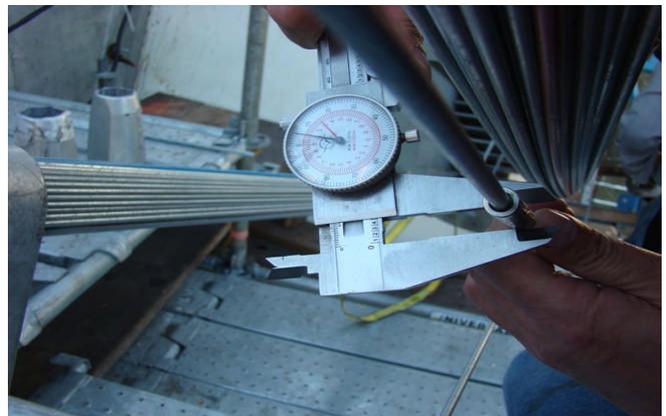
Measuring the bite marks to verify that the proper deformations were applied by the specialty jack to the ferrule.

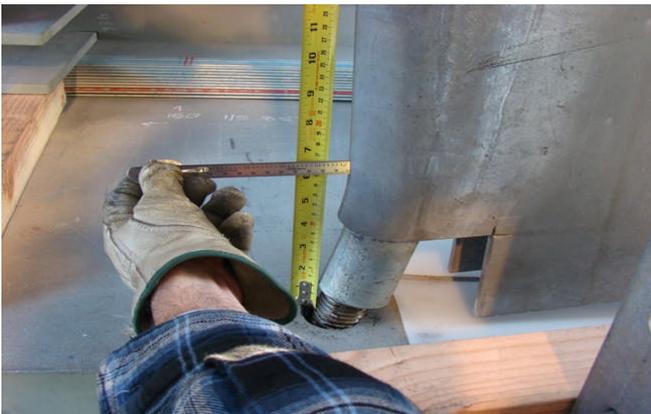
The threaded rod of the north strand adjuster jacking assembly inelastically deformed 17mm before the operation to adjust the sag was stopped.
