SAS Superstructure

Daily Diary Report by Bid Item

Diary #: 477 Const Calendar Day: 856 Date: 12-Jan-2012 Thursday

04-0120F4
04-SF-80-13.2/13.9
Self-Anchored
Suspension Bridge

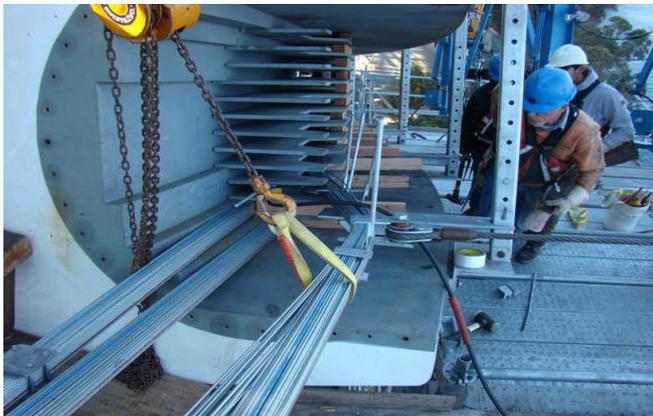
Operation to place cable strand no. 3 at the W2W west deviation saddle which is a dramatically different approach than the W2E west deviation saddle.

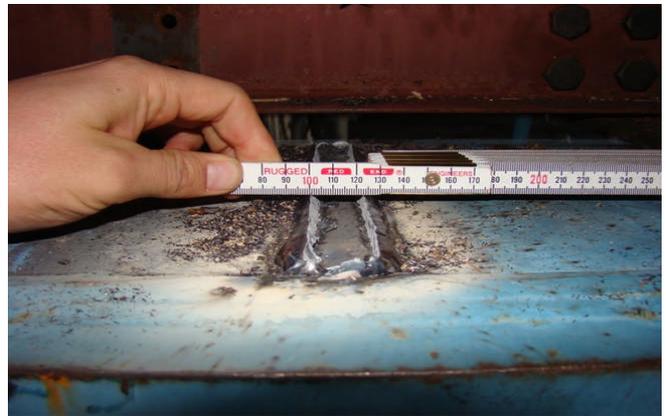
loop adjustment of cable strand no. 3 was being done. Approximately at 5:00pm while ABF was adjusting cable strand no. 3, a gusset plate failed in tension and shear at the north sidespan catwalk anchorage.

Failed weld where the gusset plate was connected to the north catwalk anchorage beam.

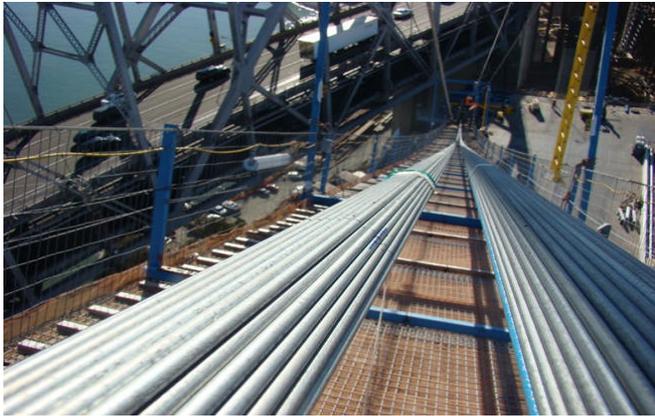
The marked surveyed midpoint on the south sidespan which will be used for measuring the cable adjustment heights.

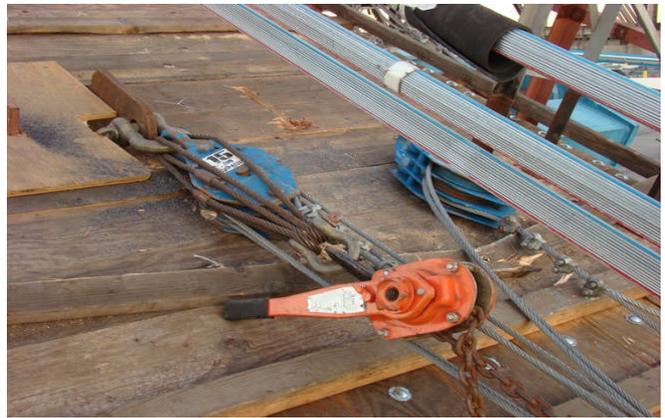
Location where the failure occurred at the north sidespan catwalk anchorage. Notice the hole in the wood and the rig to the left.

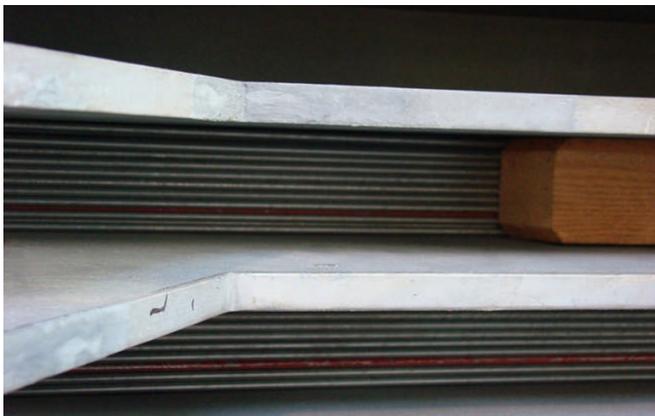
- The decision to pull the cable strand out of the W2E west deviation saddle was made by upper management. The condition of the strand wires in the saddle is unacceptable and needs to improve. The general issue is crossing of strand wires which increases the chance for broken wires when subjected to loading. Corrosion is not as big a concern for the crossing of wires in this area due to the fact it will be adequately enclosed from the weather.

Cable strand no.3 placed in the W2E west deviation saddle trough where the strand wires are still not ideal.

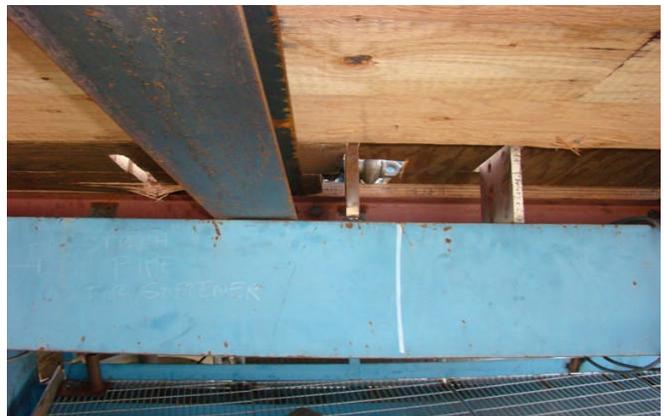
View of where the gusset plate was connected prior to the accident and adjacent gusset plates.

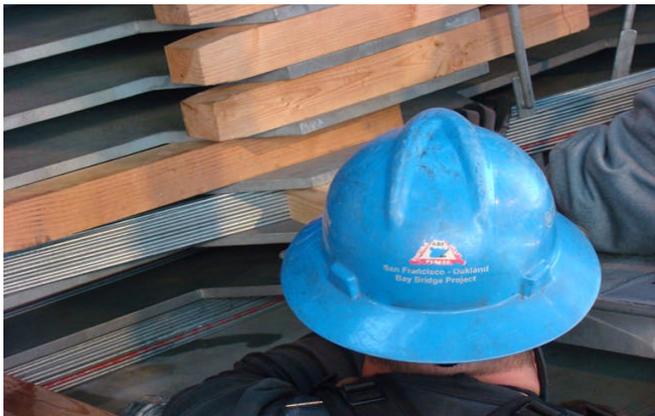
ABF ironworkers placing cable strand no.3 into the W2E west deviation saddle.

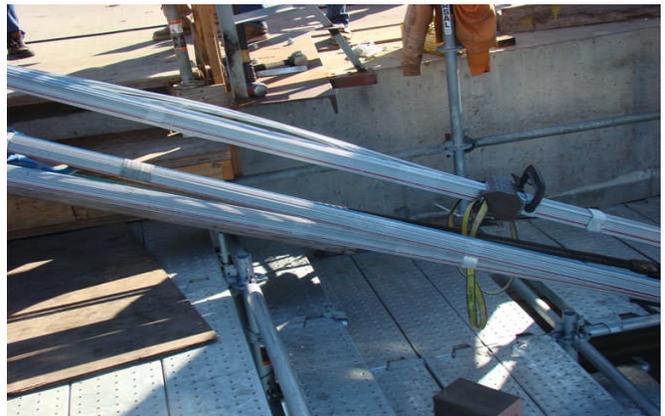
Condition of cable strand no. 3 wires coming out of the W2W west deviation saddle trough after the strand has been placed which is not ideal.

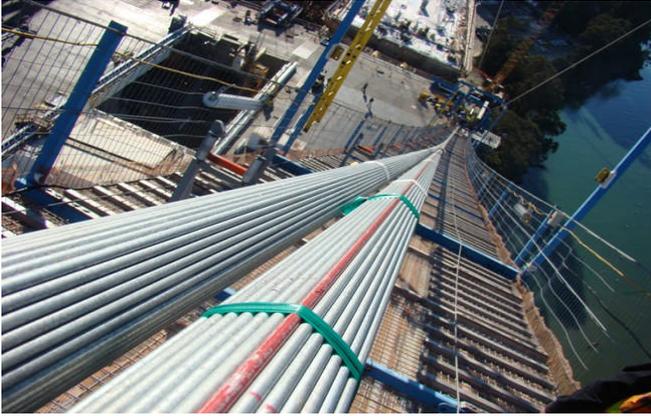
The marked surveyed midpoint on the north sidespan which will be used for measuring the cable adjustment heights.

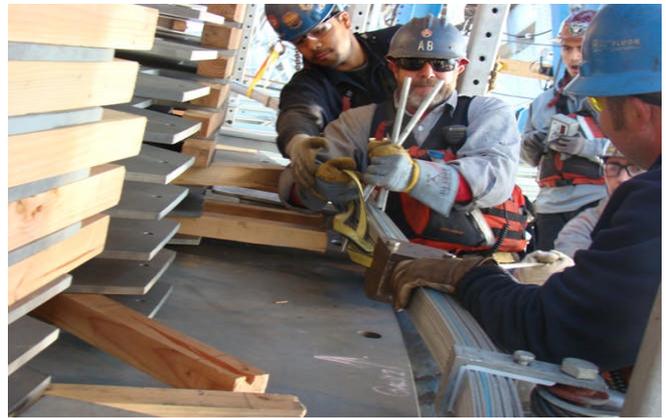
Reforming cable strand no. 3 at the W2E west deviation saddle since the strand was removed from the saddle trough due to the unacceptable placement.

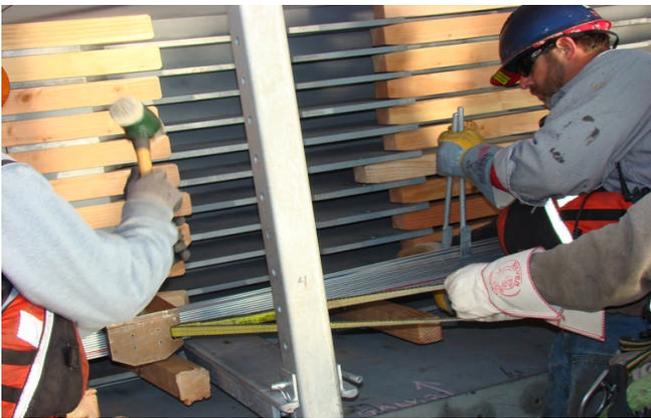
ABF ironworkers reforming the cable strand no. 3 at the W2E west deviation saddle by using the knife plates, cable form and timber mallet.

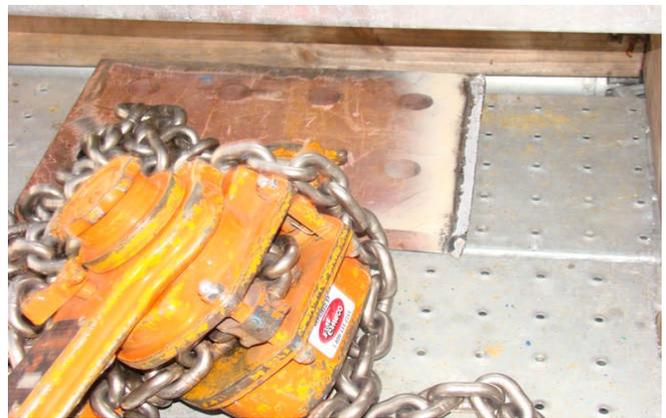
Gusset plate that failed with the welds seen on the right of the plate.

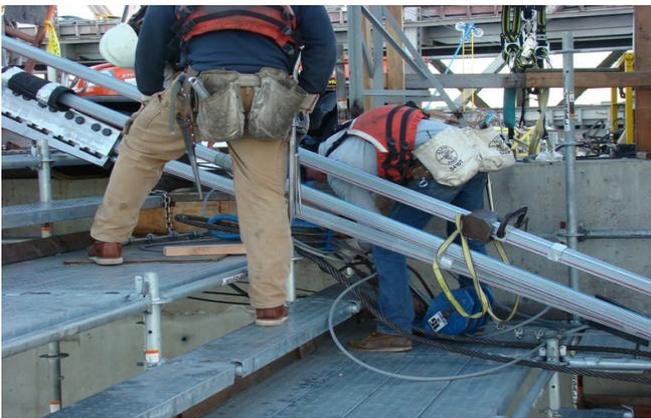
Location where the gusset plate landed after failing and being hurttled in the air.

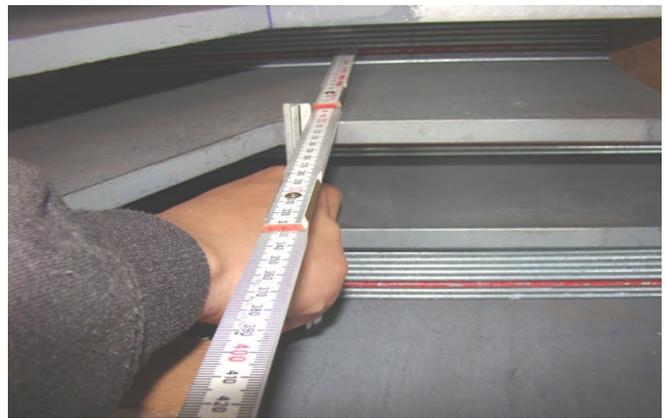
Measuring cable strand no. 3 at the W2E saddle with Victor as a way to try and determine whether or not the strand wires are crossing.

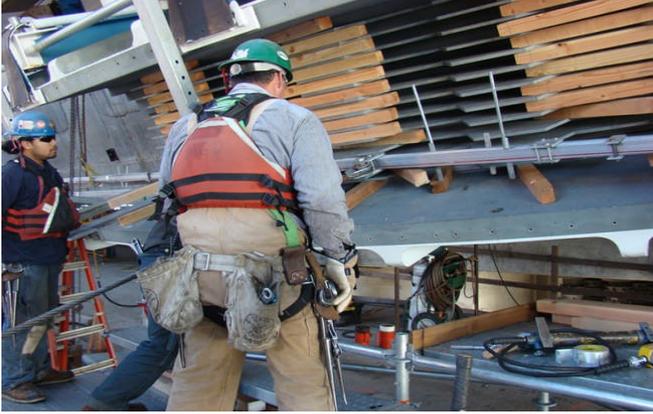
Placing cable strand no. 3 at the W2E west deviation saddle for the second time.
