SAS Superstructure

Daily Diary Report by Bid Item

Diary #: 211 Const Calendar Day: 857 Date: 13-Jan-2012 Friday
Inspector Name: Wright, Doug Title: Transportation Engineer
Inspection Type: Continuous
Shift Hours: 07:00 AM 07:00 PM Break: 00:30 Over Time: 03:00
Federal ID:
Location:
Reviewer: Schmitt, Alex Approved Date: Status: Submit

04-0120F4
04-SF-80-13.2/13.9
Self-Anchored
Suspension Bridge

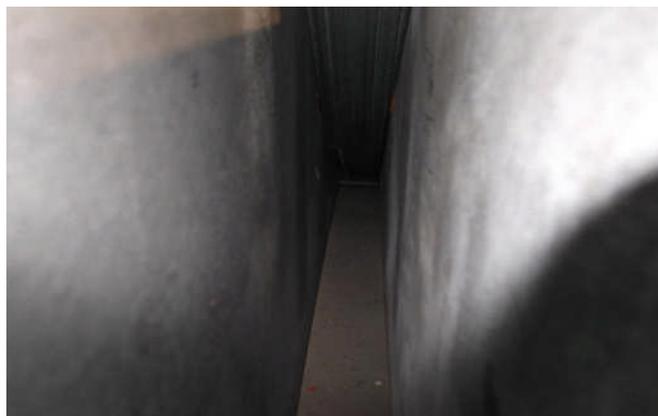
time, I noticed a plate at the bottom of the trough underneath the partially installed strand (see attached photo). I tried to remove it, but it was wedged in tight under the strand. I informed the night shift foreman that it needs to be removed, and I marked the area that needs to be removed to get out the plate. Also, I emailed ABF Engineer Andre Markarian to inform him.

Plate underneath partially installed strand needs to be removed
