Daily Diary Report by Bid Item

Contract No.: 04-0120F4

04-0120F4
 04-SF-80-13.2/13.9
 Self-Anchored
 Suspension Bridge

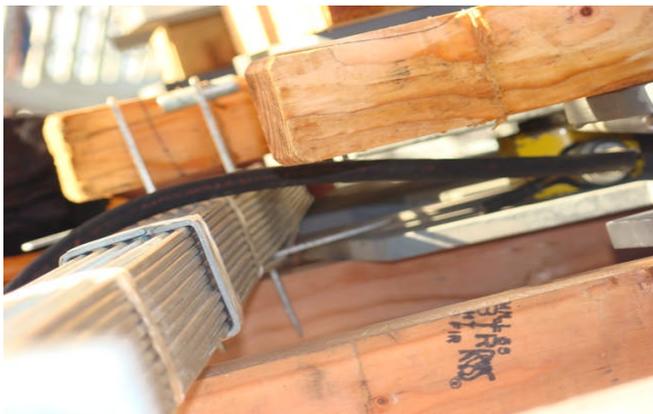
View of the backside of cable strand no.7 just prior to the section being installed into W2E west deviation saddle trough.

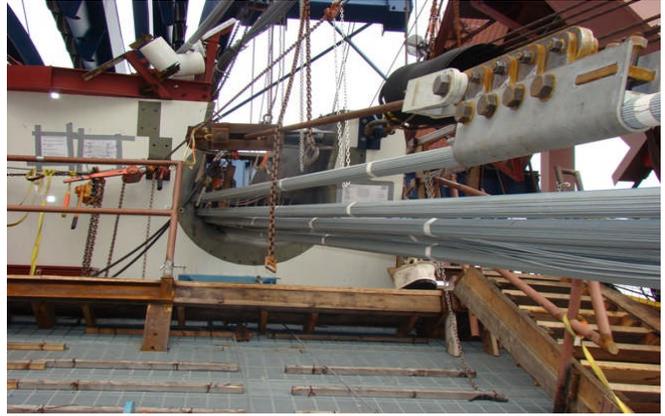
2:45pm = Rough adjusting was completed on cable strand no. 4 at the west end of the tower saddle for the south sidespan. I took a measurement on cable strand no.4 after adjustment and recorded a value of 326mm. The amount of adjustment was East 29mm in the horizontal direction. John Lyons confirmed this measurement as he took his from the east end of the tower saddle.

Cable strand adjuster jacking assembly prepared to rough adjust cable strand no.4 at the tower saddle for the south sidespan.

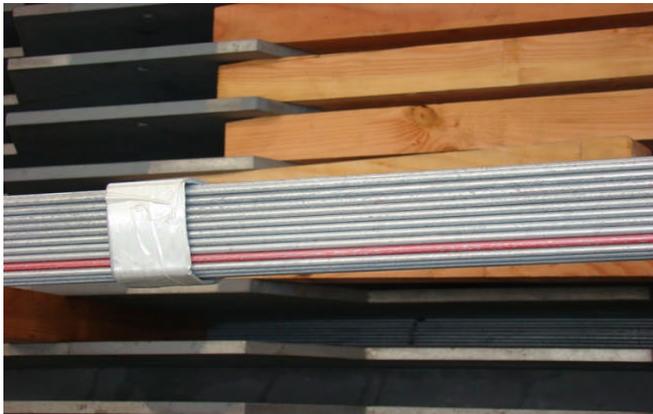
Observed the operation to form/place cable strand No. 7 at the west loop particularly at the W2E west deviation saddle. I took pictures of cable strand no. 7 at the south end prior to placing into the saddle trough. This was done to document the condition of the preformed cable strand prior to placing into the saddle. See photos below for additional details and comments. The preformed section for the upper 1/3 of the saddle was unacceptable prior to placing into the saddle trough. The following are my observations for the remainder of the operation at this location:

Unacceptable preforming of the rectangular shape for cable strand no. 7 prior to placing into the W2E west deviation saddle.

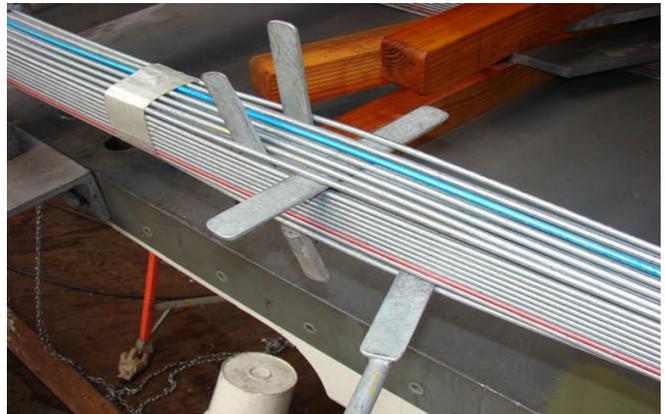
ABF ironworkers are now using 4 knife plates on cable strand no.7 just prior to the section being installed into W2E west deviation saddle trough.

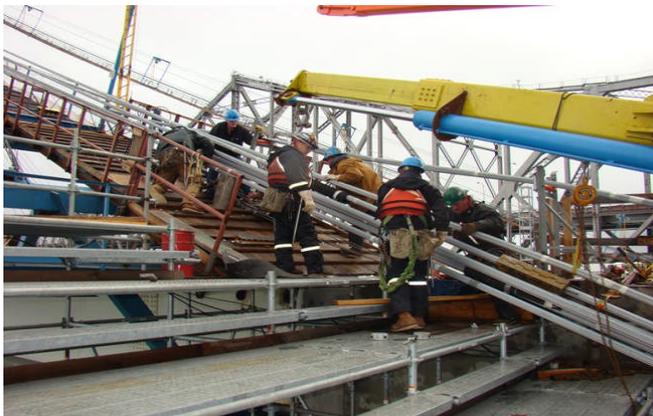
ABF ironworkers connecting the PWS adjuster grip to cable strand no. 6 and the sheave block/comealong at the north end of the W2 cap beam.

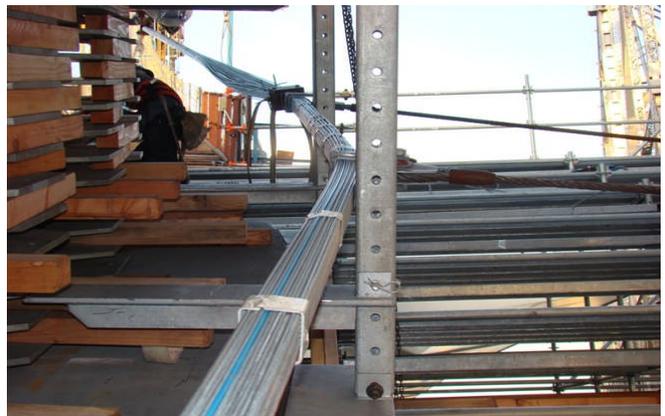
being 4:35pm = ABF ironworkers began to set up the cable strand adjuster for cable strand no. 7 at the west deviation saddle. ABF plans to begin adjusting the cable strand as it is installed into trough due to issues with not being able to adjust the cable strand to the proper sag with the all of the cable strand in the west loop troughs.

The ABF ironworkers installed approximately 10 to 15 feet of cable strand into the trough before the end of shift. At this time Brian Maroney, Marwan Nader, George Baker, James Duxbury, Kevin Smith, et. al. were onsite to observe the issues related to the placement of cable strand in general at the W2E west deviation saddle. See Warren Collins and Roman Granados diaries for additional details regarding the discussions and decisions. I gave my opinions and observations to Warren and Roman to convey the message to the designers regarding cable strand placement at this location. I think the tape is a "band-aid" for poor workmanship by the foreman Jerry Kubala at this location. The cable strand placement has improved at this saddle due to the tape being left on the strand. However the same bad habits while installing strand are still present and the proper techniques of not being meticulous are not being emphasized by ABF management. The preformed shape is still not acceptable even with the tape as the cable strand is rounded in some locations and the 11 outer faced wires are not in tact prior to installing into the saddle trough. This bad practice was executed on cable strands nos. 5 and 6 where the tape was allowed to be left on the strands. For the time I was present listing to the designers they more or less agreed to these observations and conveyed their concerns to Kevin Smith.

Poorly preformed section of cable strand no.7 inside the W2E west deviation saddle restraint system and birdcaging outside the restraint clamps.

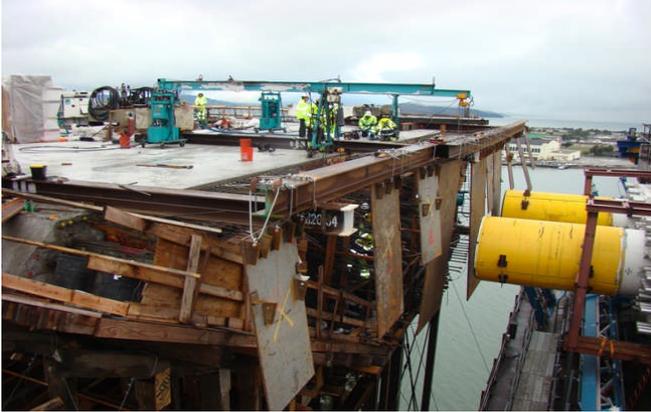
Schwager Davis Inc. post-tensioning the W-Line of the YBITS bridge with the protective shields placed by MCM for wedge/strand failure.

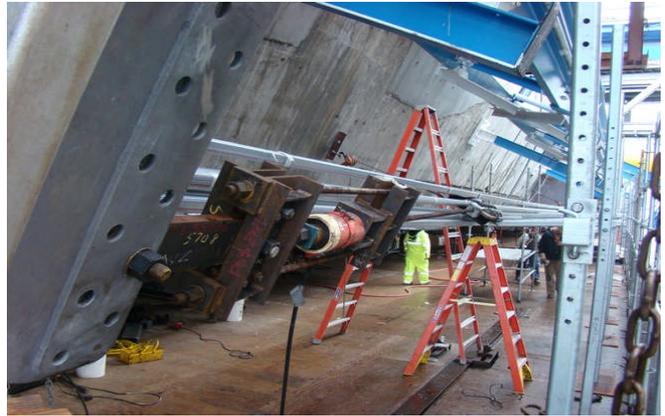
Cable strand adjuster jacking assembly pulling on cable strand no.6 for adjustment at the north section of the west loop.

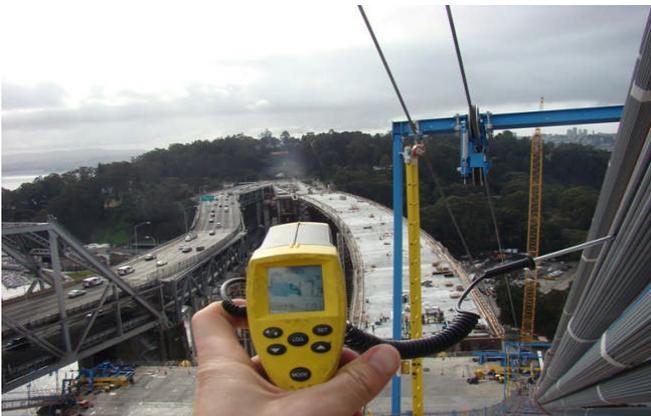
North Sidespan Cable Stand No.			
	1	2	3	4
Temp. Ambient (F)	54	53	52	55
Temp. Steel (F)	54	54	57	61

were Note: Cable strand no. 4 was exposed to the sun while the other strands were partially shaded by the angle of the sun and cable strand no. 4.

Steel temperature of cable strand no. 4 at the north sidespan taken under mostly cloudy skies w/the infrared temperature gun probe.

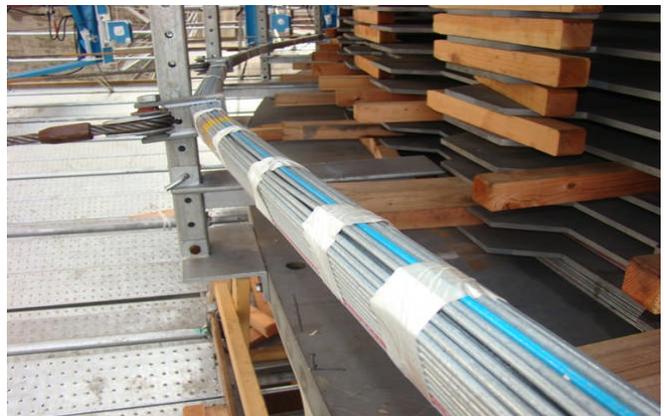
Unacceptable preforming of the rectangular shape for cable strand no. 7 prior to placing into the W2E west deviation saddle.

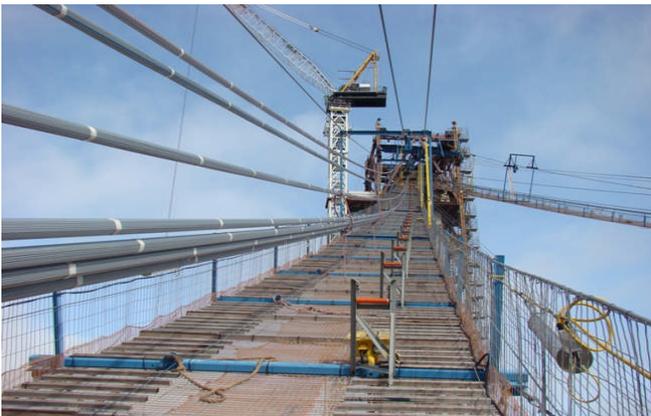
Cable strand configuration on the north sidespan today under mostly overcast skies for the ambient/steel temperature measurements.
