SAS Superstructure

Daily Diary Report by Bid Item

Contract No.: 04-0120F4

04-0120F4
04-SF-80-13.2/13.9
Self-Anchored
Suspension Bridge

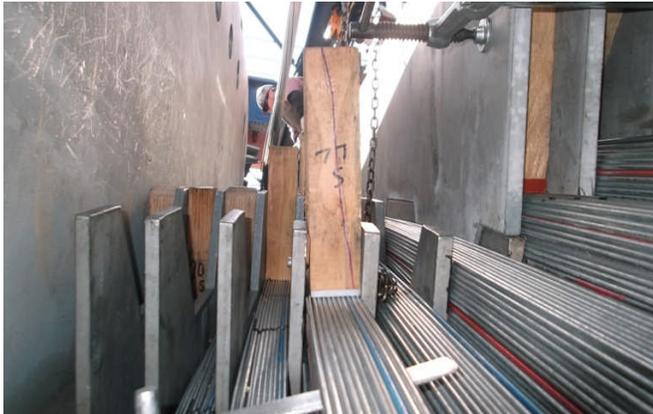
Strand77South(AfterAdjustment)

- Begin RA of Strand #77 South at about 14:00, moving eastward 1200mm;

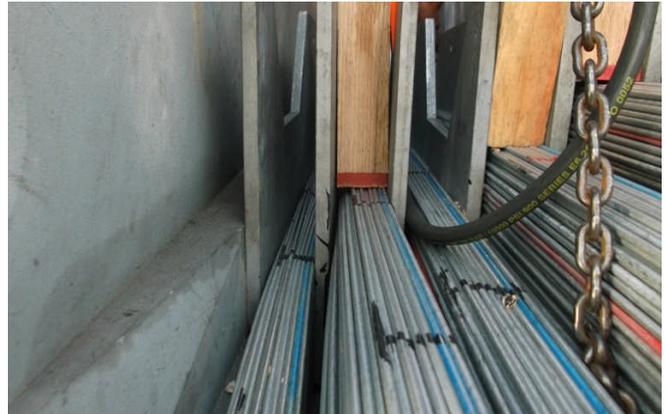
Strand75South2(AfterAdjustment)

- Rough Adjust (RA) Strand # 75 South at 8:15, resulting in a move of 1320 East, which was followed by a the usual 2nd adjustment of 70mm West, with the end result of 1250mm East;
Once again, as it has been repeated happening, no one was on the wood block during the 2nd adjustment during which the Strand was pulled back 75mm resulting in the banking of the strand and the bunching of the wires.

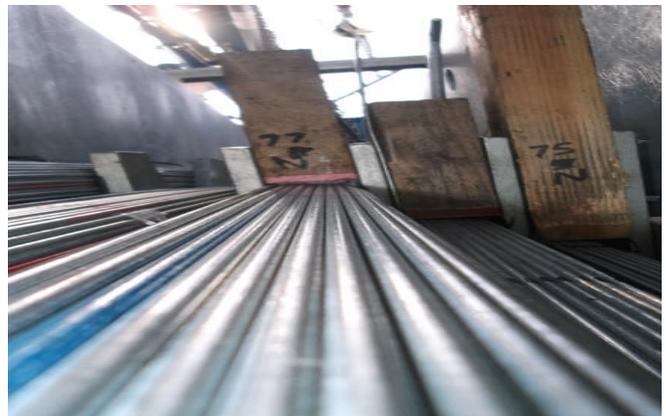
Strand75and77North3(AfterAdjustment)

- Begin RA of Strand No. 77 North at about 13:15, resulting in a eastward move of 1410mm; In a sad scene that has become all too commonplace, the total disregard and disobedience of the crew on the N. Side continues. Once again, Ethan's name was called out by Tony (adjusting foreman,) to bang on the wood blocks and once more, he did absolutely nothing. The strand as of the conclusion of this operation does not look too bad yet, even though it sits about ¼" above the strand at this time;

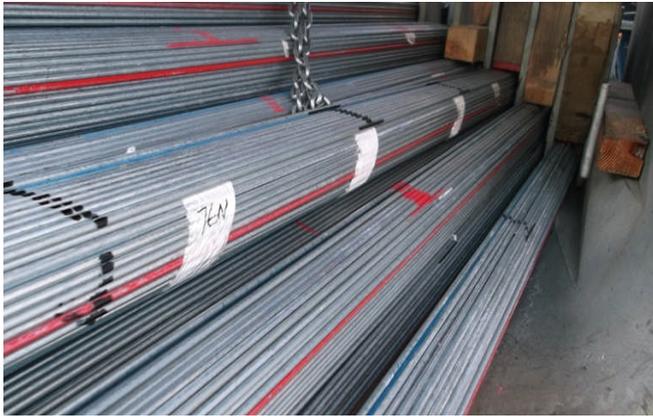
Strand76North4(AfterAdjustment)

As I was about to walk down the N. Side span for twist check I realized that Strand #76 is being moved to the East(I was at the West end at this time,). Walking up the saddle from West end to the East end, I realized it was clear that no one is bothering with the wood blocks. As I got to the East end of the saddle, the operation was almost over and the disregard for the wood blocks was painfully obvious. This is the North side where Ethan and CJ continue to cause problems and disregard orders. Sami said that Jose was initially at the East end, but it is not clear why he had disappeared by the time I got there and before the operation was over! Consequently, the woodblock moved up, with the resulting mild banking of the strand and void.
