SAS Superstructure

Daily Diary Report by Bid Item

Diary #: 036 Const Calendar Day: 941 Date: 06-Apr-2012 Friday
Inspector Name: Soheilifard, Saman Title: Transportation Engineer
Inspection Type: Continuous
Shift Hours: 07:00 am 05:30 PM Break: 00:30 Over Time: 2:00
Federal ID:
Location:
Reviewer: Schmitt, Alex Approved Date: Status: Submit

04-0120F4
04-SF-80-13.2/13.9
Self-Anchored
Suspension Bridge

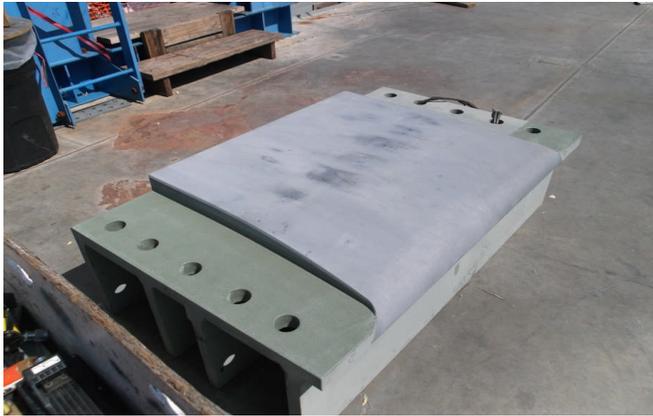
PaintDamage-NorthSplayPlate (1)

On my first day back following a 5-day vacation (March 29 thru April 5th, 2012) I was tasked with the painting assignment of the Splay Plate. The two Splay plates at the East anchorage had been damaged, with the South Splay Plate's damage being of a more serious nature, i.e. gouging of the plate and damage to the chamfer. In addition to that, there are locations on both saddles at the East end (small areas) that are in need of paint repair. These areas had been marked for the painters, already.

In the meantime, Luis Diaz and Jose Avila were removing rust from the Splay Plate. The extent of these blemishes was not extensive and in fact following the removal of rust, Charlie and Mark measured the paint thickness at these locations. The measurement came in mostly upwards of 377 mils. The damaged surface is of the Metallized variety and the paint thickness at such locations shall have a thickness measuring from 3715 to 425 mils.

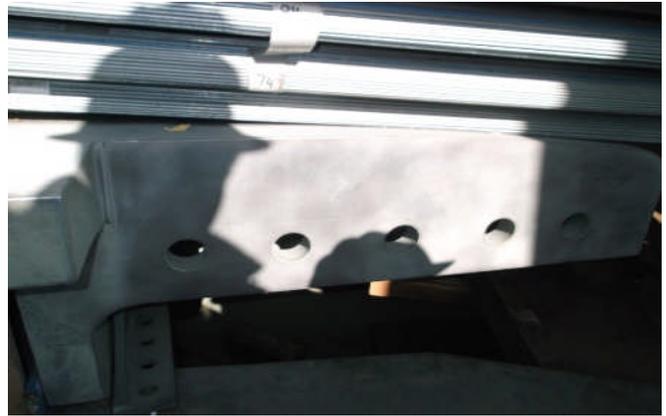
SaddlePaintRepair-SouthAnchorage

The paint measurement prior to power tooling on the faying surface of the top section of the saddle, at the South-East corner of the South saddle (where the Splay plate connects to the Splay Saddle) is as follows (in microns):

Using TESTEX tapes, the profile measurement following the use of the power tooling came in at 2.5mils, 1.8 mils, and 2.5 mils, which is greater than the minimum requirement by the manufacturer and SSPC-SP11.

The paint thickness at the Bottom Section of the South Saddle prior to the power tooling was as follows:

The profile roughness following the power tooling using Testex tapes came in at: 2.4 and 2.0 mils, which are higher than the required minimum of 1.0 or 1.6 mil.

With Mark Miller and Charlie Stewart of the METS, we started on the South saddle. At about 10:00 AM, Mike Gaya, began prepping the surface by solvent cleaning it (using MEK) first as outlined in SSPC-SP1. This was followed by the use of power tools per SSPC-SP11, to create an acceptable profile onto the steel surface prior to painting. The SSPC-SP11 recommends a minimum profile roughness of 1 mil, whereas the manufacturer's recommendation for Interzinc 52 (organic paint) is to achieve a surface profile of 1.6 to 3.0 mils (40 - 75 microns).

Following the acceptance of the preparation work, the painting was to begin with the Interzinc 52, with the environmental conditions as follows (@ 10:35):

Painting began shortly thereafter and was complete in about 10 minutes. The Batch numbers for parts "A" and "B" were MC5777UH and NA4637UH, respectively.

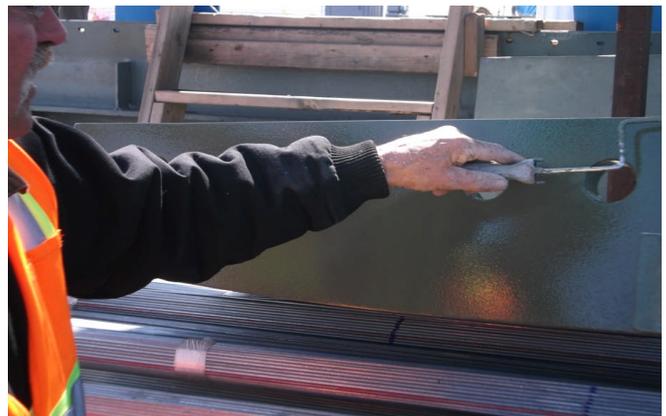
SaddlePaintRepair- NorthSaddle

At the TOP surface on the North saddle, the paint measurement following the power tooling came in at: 76, 76, 52, 41, 56, and 58 mils.

At the Bottom surface, the readings were as follows: 42, 18, 43, 29, 32, and 48 mils. Given the fact that the mil thickness of the Inorganic Zinc should be in the 25 to 125 range, it seemed that the surface at this location needed a heavier application of paint.

The TESTEX tapes revealed a profile roughness of 1.6, 2.8 at the Top and 2.3mil at the Bottom.

At about 10:50, Mike Gaya and son Brandon were at the North side doing the solvent cleaning and preparing the surface of the saddle where repair was needed.

The painting at the North side was completed by 11:20.
