SAS Superstructure

Daily Diary Report by Bid Item

Contract No.: 04-0120F4

04-0120F4
04-SF-80-13.2/13.9
Self-Anchored
Suspension Bridge

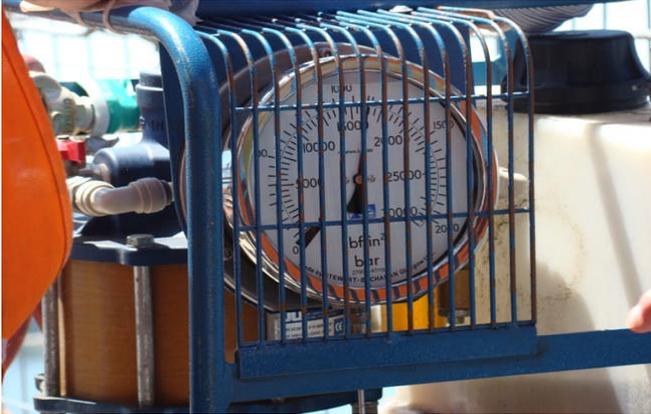
Pjack at 105% of the required load where the pressure on the gauge was approximately 17,400psi.

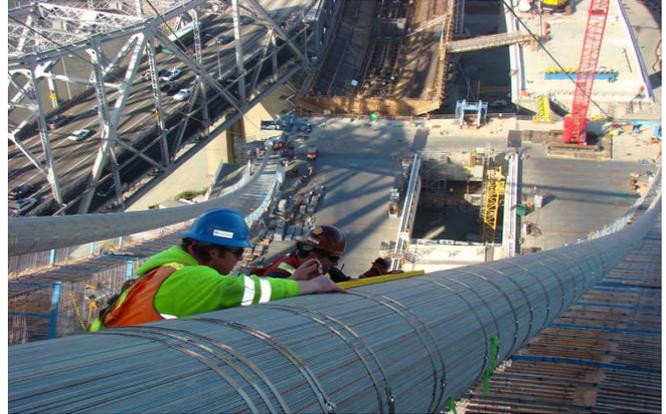
ABF surveyors using a straight edge to lay-out the rotational camber centerline for cable band 40 on the north sidespan.

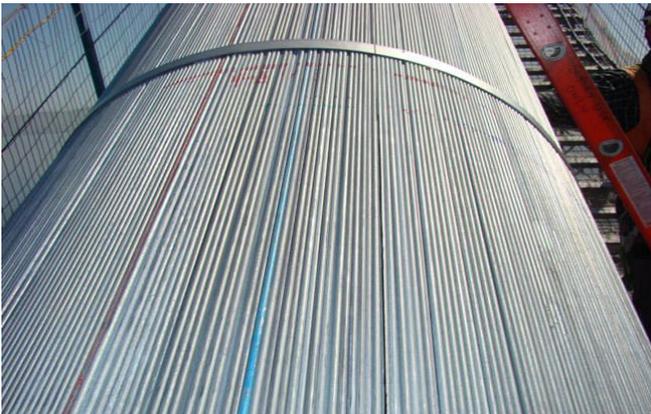
Black line drawn on the compacted cable to indicate rotational camber centerline of a North sidespan cable band.

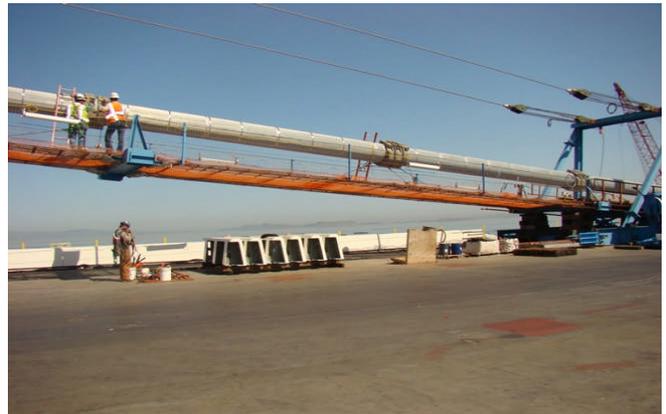
Cable bands 102, 104, and 106 were installed on the North Mainspan cable on Saturday during the day after the marks were approved early in the morning

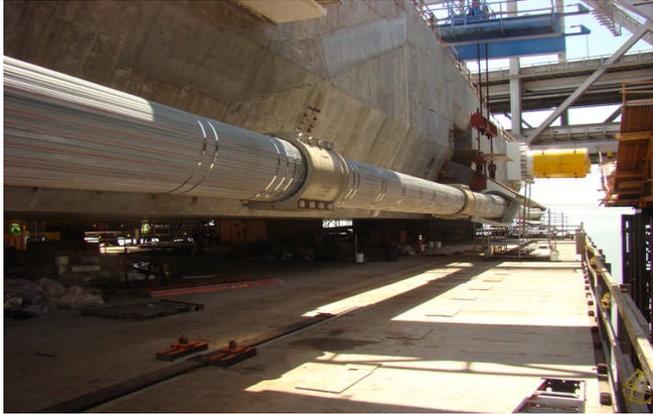
Cable bands placed at the North west-loop, also the south west-loop cable has been compacted and is ready for cable band placement.

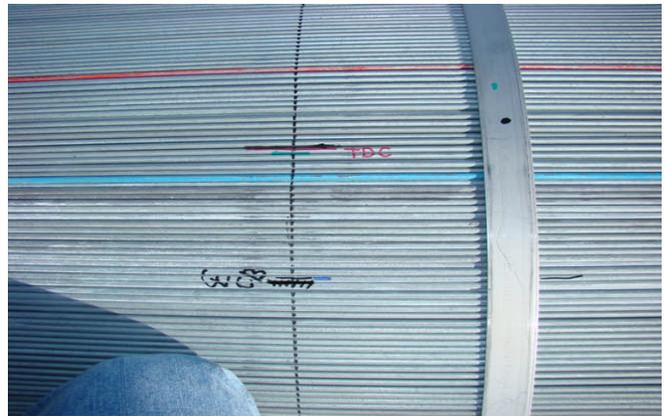
Typical marks seen at the 1.5m offsets for the top dead center and the rotational camber of the cable band.

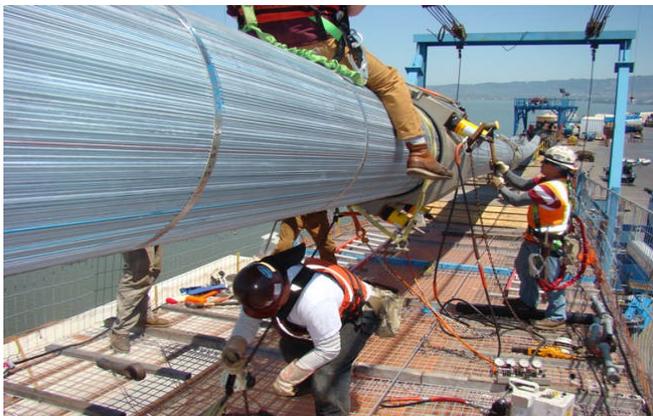
ABF ironworkers in the process of closing the female and male halves for cable band 104N and aligning to the control marks on the cable.

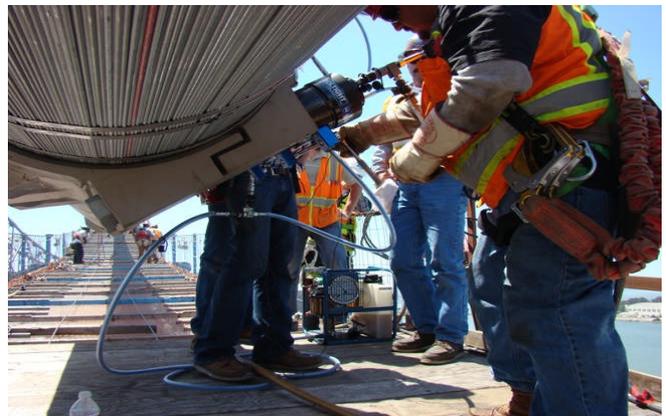
Turning the gear box with a socket wrench which tightens the cable band bolt nut down after stressing is done and before releasing the load.

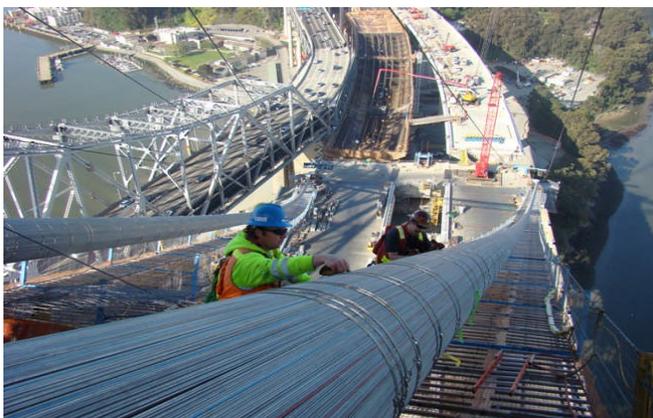
ABF surveyors in the process of laying out the rotational camber centerline for cable band 40 on the north sidespan.

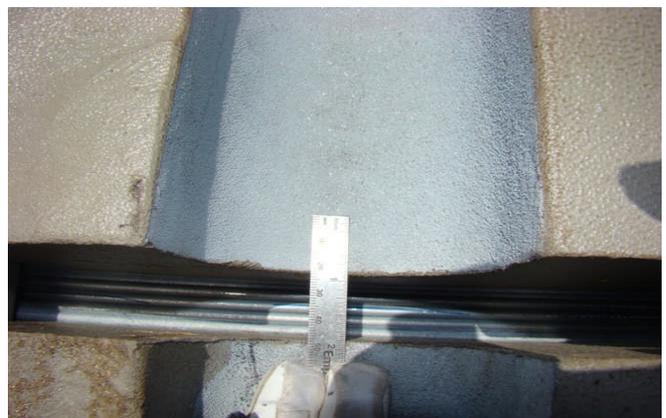
Cable band 102N was placed to the rotational camber centerline where the gap of the two halves on top was 26mm prior to stressing operations.

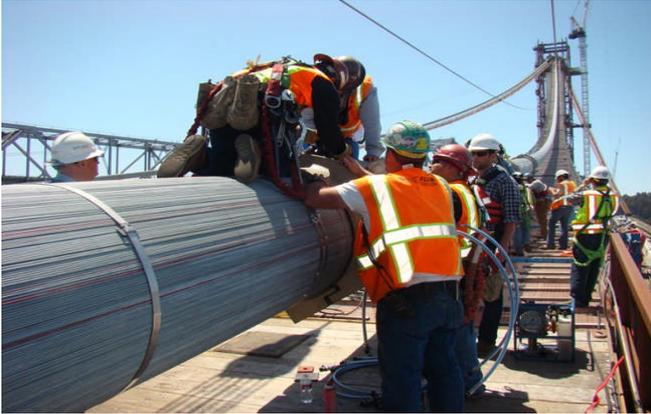
Preparing to stress the cable band bolts for cable band 102N.

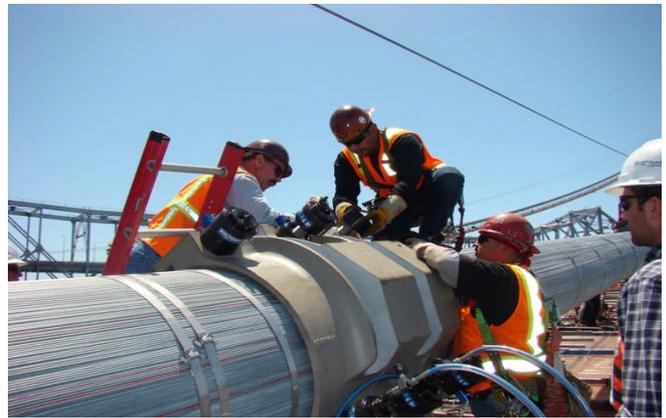
Installing the Boltight jacks and bridges on the outboard side of cable band 102N.

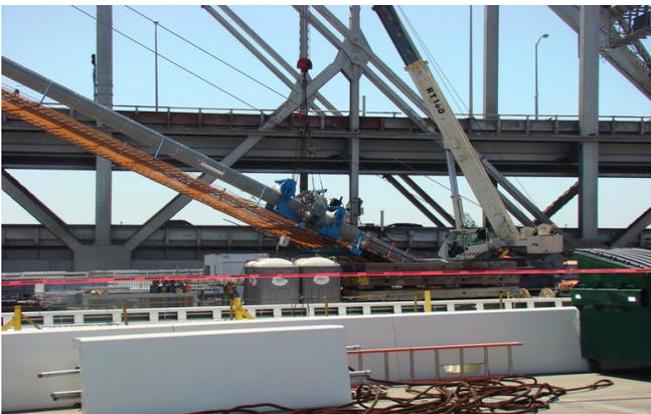
Compaction of the south sidespan cable was completed approximately at 10:00am this morning and the equipment was ready to be demobilized.

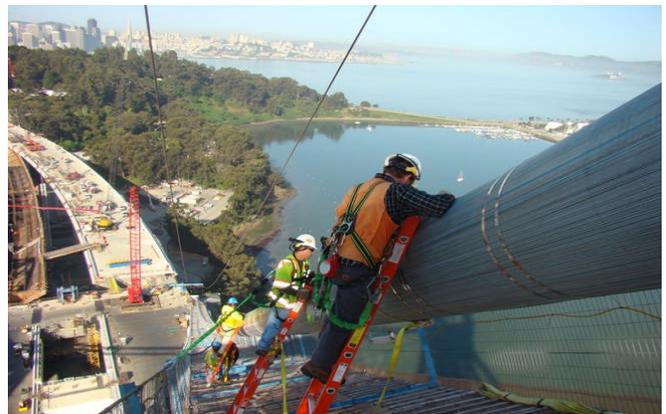
Caltrans engineers checking the cable band rotational camber on the compacted cable layed-out by ABF surveyors. Also note the access for the work.
