SAS Superstructure

Location: 04-SF-80-13.2 / 13.9

Daily Diary Report by Bid Item

04-0120F4
04-SF-80-13.2/13.9
Self-Anchored
Suspension Bridge

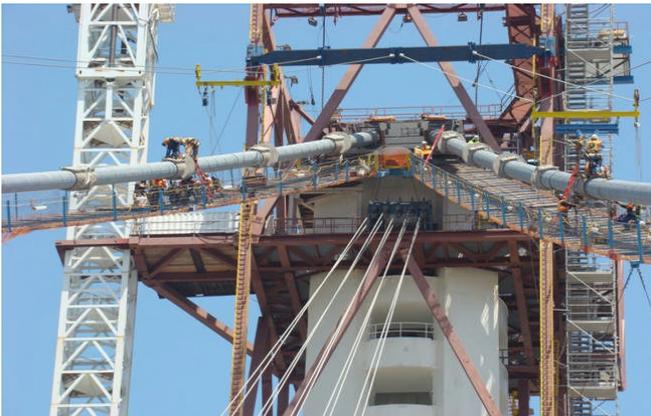
Cable band installation progress and operations along the Sidespan near the tower.

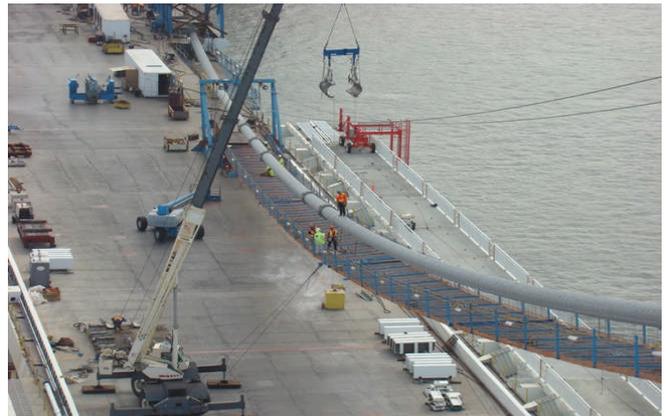
Terex crane lifting a cable band to be placed on the South Mainspan.

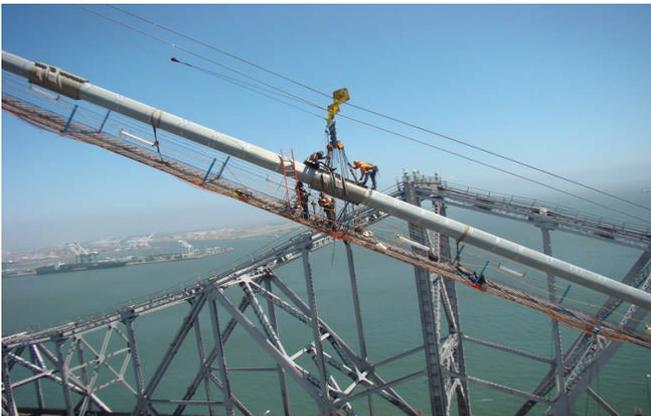
ABF ironworkers in the process of installing a cable band on the South Sidespan.

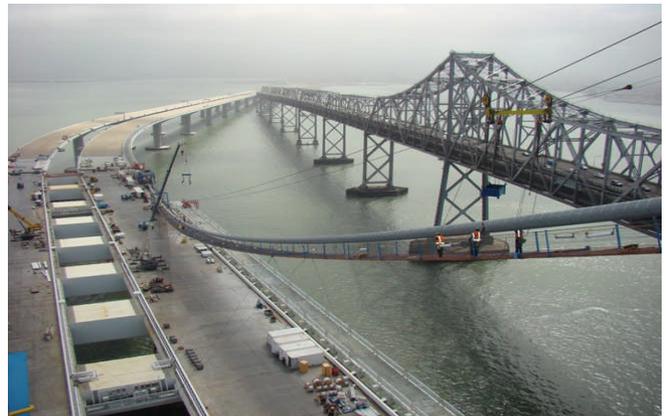
Cable band installation progress along the South Mainspan.

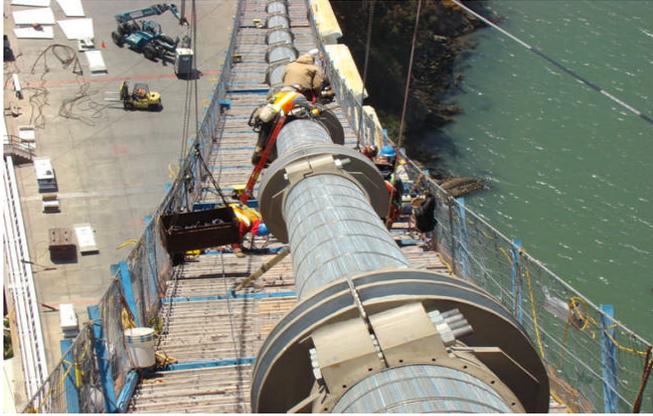
ABF ironworkers detensioning a North Sidespan cable band to improve the condition of the gap spacing.

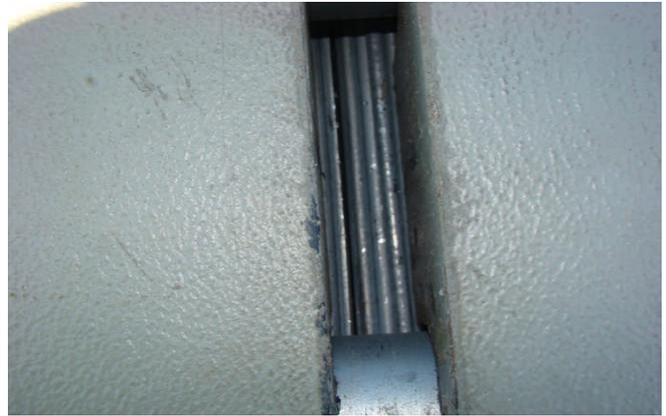
Top gap on the Uphill side of cable band 24N where there is evidence of pinched wires after stressing the cable band.

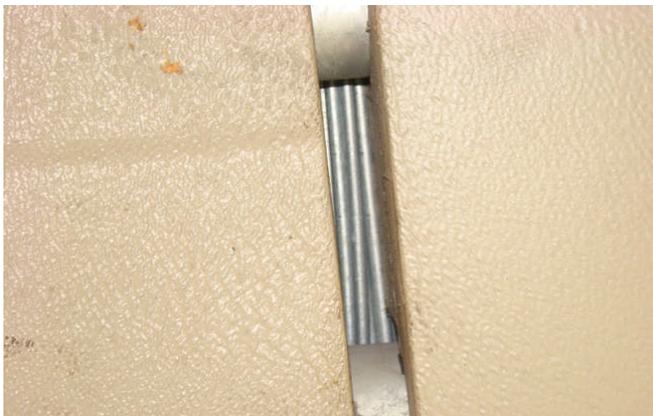
Bottom gap on the Uphill side of cable band 22N where there is evidence of pinched wires after stressing the cable band.

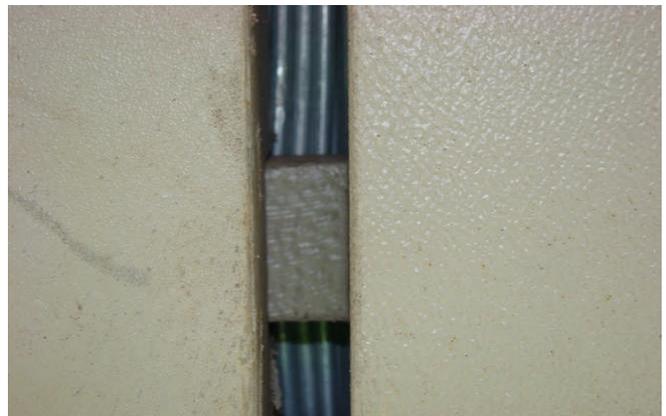
Bottom gap on the Downhill side of cable band 16N where there is evidence of pinched wires after stressing the cable band.
