SAS Superstructure

Daily Diary Report by Bid Item

Contract No.: 04-0120F4

Diary #: 303 Const Calendar Day: 982 Date: 17-May-2012 Thursday

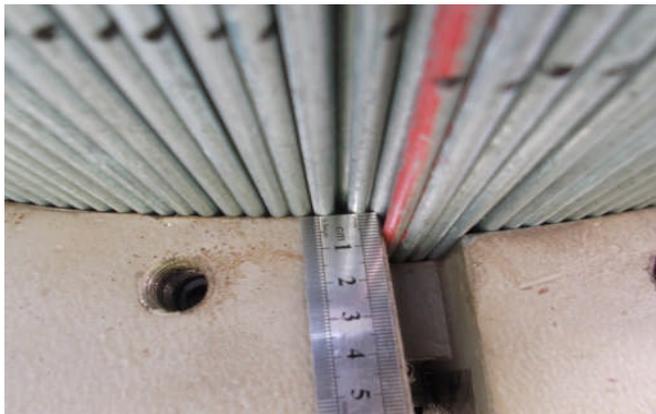
- From 08:30 until 09:30, I was inspecting the CB bolt tensioning at PP40N. All of the bolts were simultaneously brought up to 17,400 psi with bolt tight jacking equipment. They were then re-cycled up to 17,400 psi 3 additional times to try to make sure all of the bolts had equalized tension. After tensioning, there were some bunching wires in the bottom gap between CB halves. Also, there was one pinched wire noticed in the bottom gap between CB halves (see attached photo). Also, there was a slight vertical misalignment between the CB halves (see attached photo). I mentioned these things to Roman Granados & Warren Collins.

Vertical offset between CB halves of about 4-5mm at PP-40N

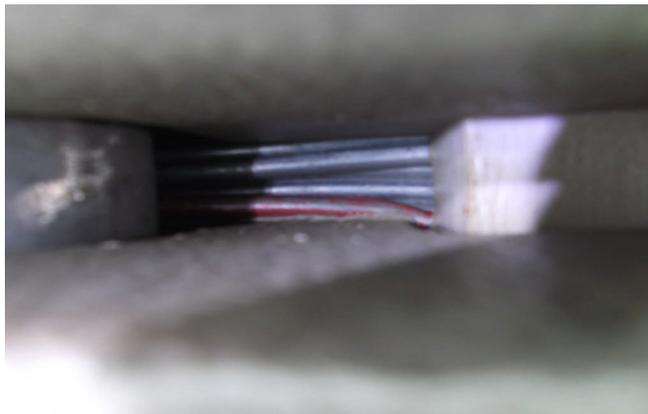
Pinched wire in bottom gap between CB halves at PP-40N
