SAS Superstructure

Daily Diary Report by Bid Item

04-0120F4
04-SF-80-13.2/13.9
Self-Anchored
Suspension Bridge

Day #1 for the Repair of Galvanizing Damage to the Sockets and the Repairing/Painting of the Tie-Rod Holes

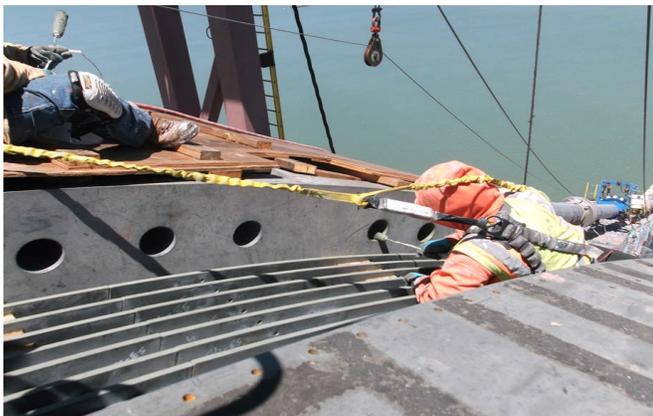
At this time we were in a holding pattern for paint application. At about 7:45, with Andy not on-site yet, I headed up to the Tower Saddle to assess the status of work up at this location. Javier and Victor were tasked with the cleaning of the bolt holes and the application of the Interzinc 52 (I/Z 52) following the cleaning of the tie-rod holes. There are a total of 96 holes that need to be fixed at this location for paint damage and rust.

RepairingTie- RodHoles

I stayed with the painters at the saddle until the close of the day. I had to mark a few more holes for further prep work that John Falkner had not. They used wire brush/100 grit sand papers and MEK (solvent wipe) in order to prep these holes. These holes are painted with Organic Zinc and are repaired using the same paint. Power tooling is not feasible in these holes. All the exterior and interior holes in the South saddle, in addition to all the exterior holes and ½ the interior holes in the North saddle were repaired and painted today. CCC will repair and paint the remaining 12 holes on the interior of the North saddle and will paint the 2nd coat of I/Z 52 on the divider plates of the North Saddle on Monday. The metalized surface of the trough of the Tower saddle will be addressed next week as well.

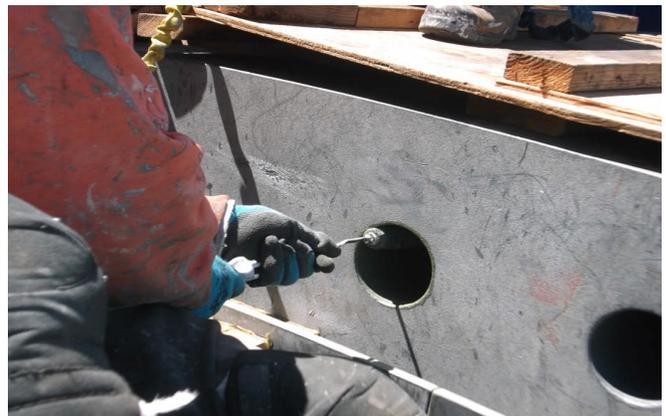
RepairingTie- RodHoles (1)

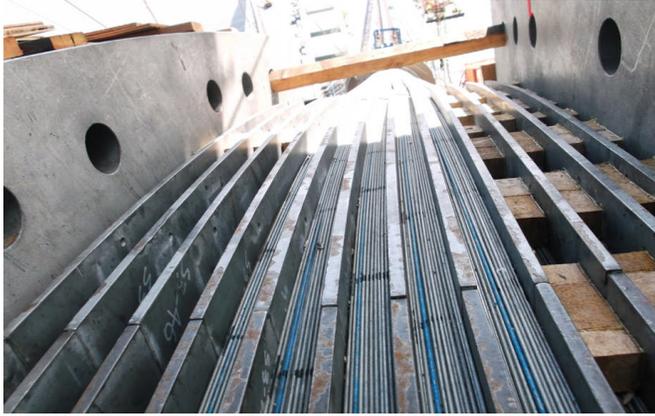
Rust-Tower Saddle-Divider Plates (4)

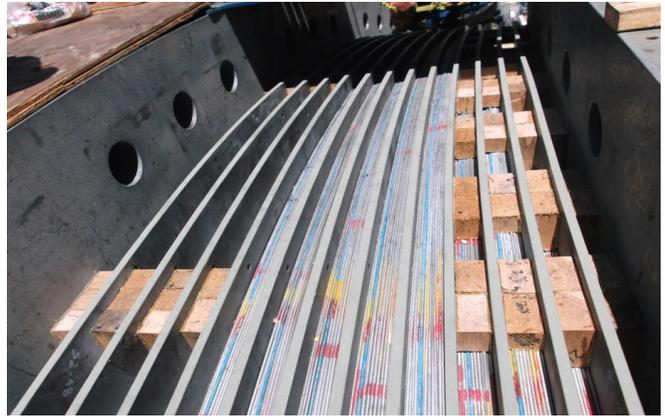
Repaire&PaintedDividerPlates

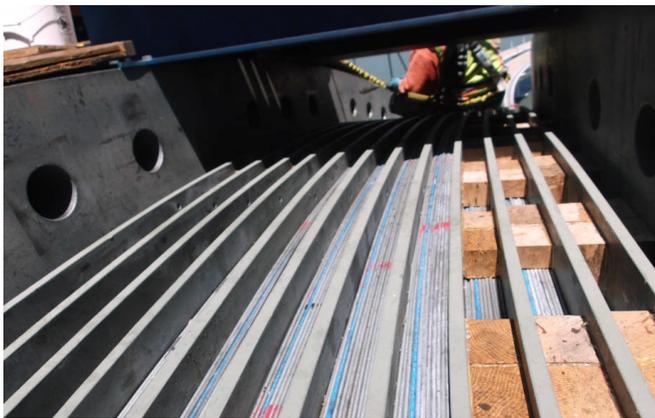
Repaire&PaintedDividerPlates (1)
