Daily Diary Report by Bid Item

Contract No.: 04-0120F4

04-0120F4
 04-SF-80-13.2/13.9
 Self-Anchored
 Suspension Bridge

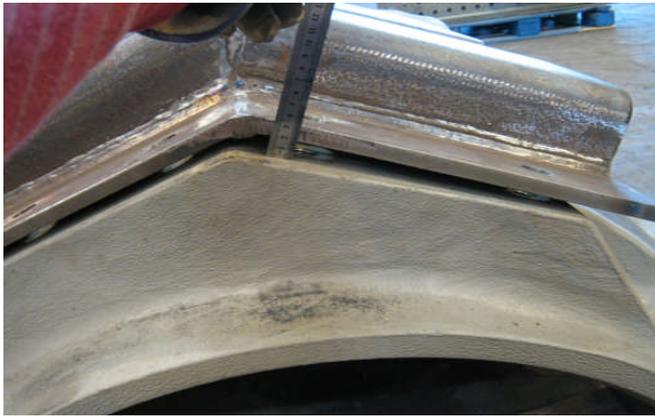
- The pitch of the bracket appeared to match the pitch of the CB, but the bracket appeared to have a flatness issue along its length. This made the center section tight fit, but both ends sit above the CB.

CCO-200 bracket fit-up at WB PP98

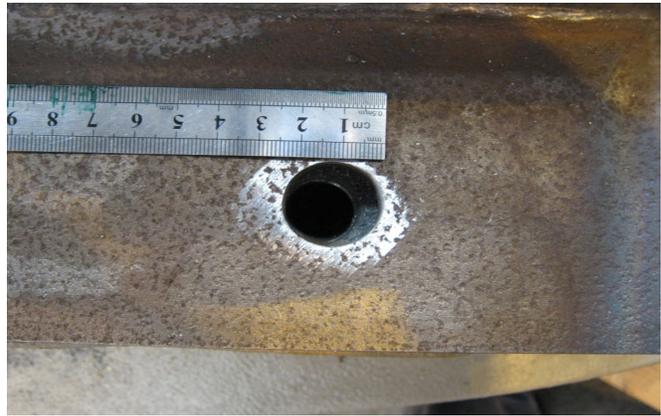
- 2 of the stanchion post bolt holes had a minor misalignment.
- From 13:15 until 14:00, I went to the weekly field issues meeting with Roman Granados & ABF Engineers Adam Roebuck & Scott Yeager. We discussed options on fitting up the CCO-200 bracket onto CB98, SWPPP issues at the suspender jacking platforms, & several other minor field issues.

CCO-200 bracket misaligned stanchion post hole
