SAS Superstructure

Daily Diary Report by Bid Item

Contract No.: 04-0120F4

04-0120F4
04-SF-80-13.2/13.9
Self-Anchored
Suspension Bridge

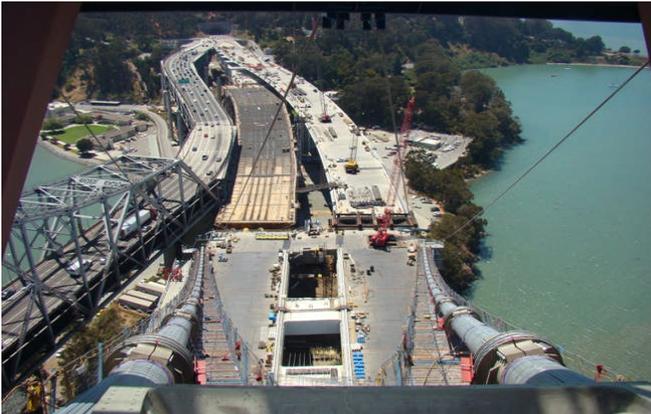
View from the tower saddle of the west end of the SAS and the YBITS bridges where a point will be placed for shooting the tower during load transfer.

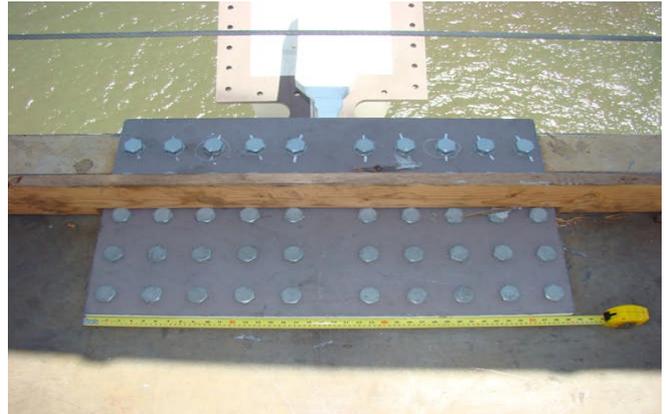
The measured distance of suspender bracket E108 top OBG gusset plate is 1.000m.

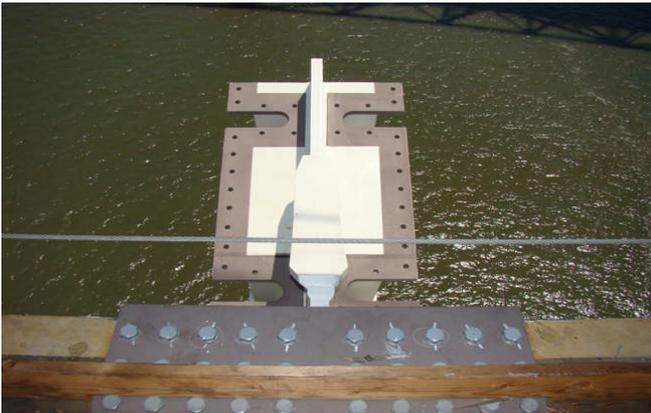
View of suspender bracket E108 top OBG gusset plate from the edge of the OBG.

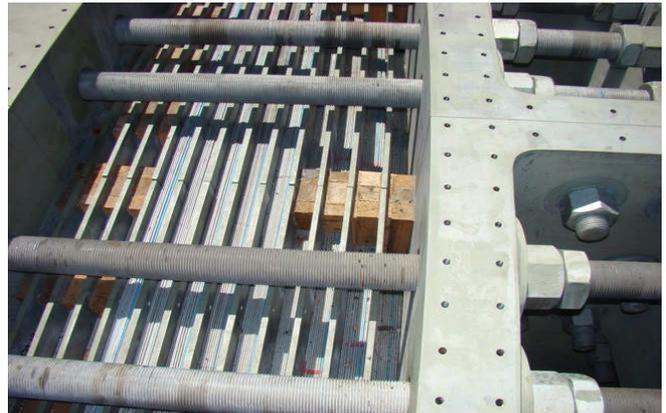
Tower saddle troughs still need to be cleaned prior to the saddle cover plate installation.
