**SAS Superstructure**

**Daily Diary Report by Bid Item**

Contract No.: 04-0120F4

04-0120F4  
04-SF-80-13.2/13.9  
Self-Anchored  
Suspension Bridge

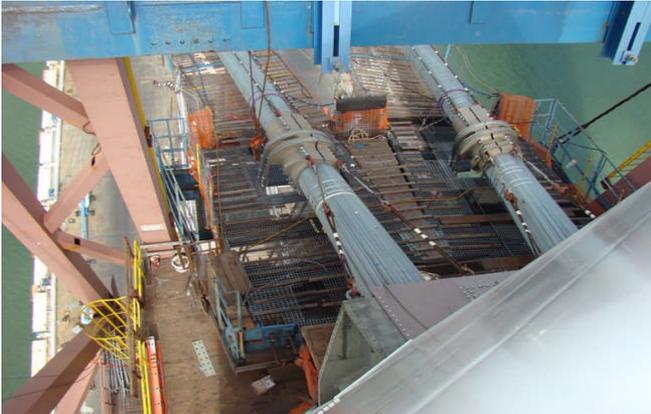
Standing at the top of the north tower head looking down and to the east at the main span cables coming out of the tower saddle.

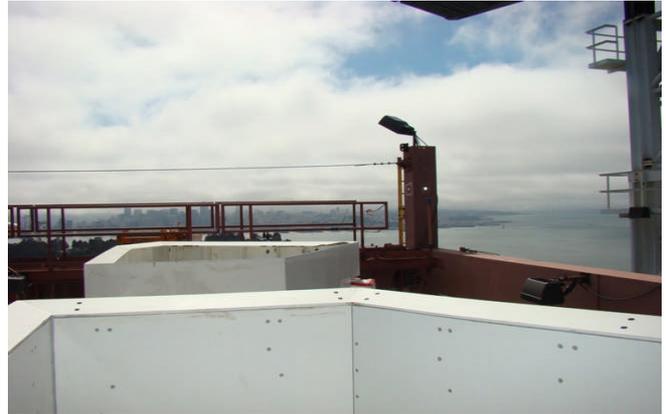
Standing at the top of the north tower head looking west.

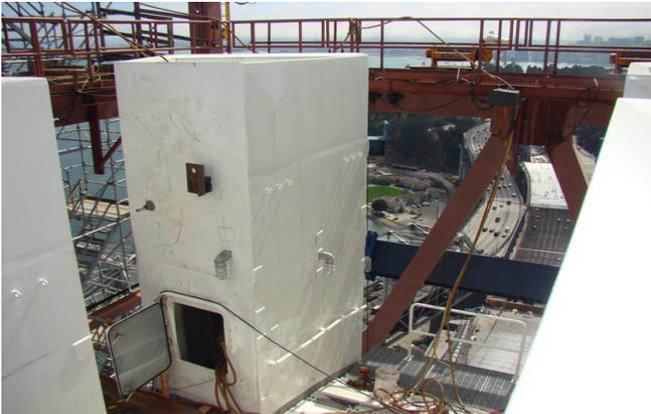
Standing at the top of the north tower head looking southwest.

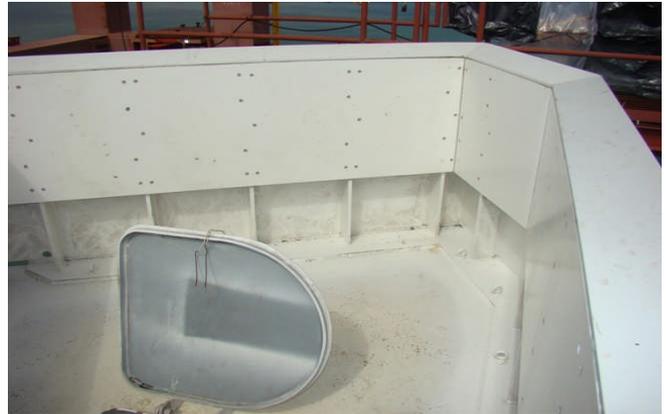
Standing at the top of the north tower head looking down at the possible location to place a survey point.
