SAS Superstructure

Daily Diary Report by Bid Item

Contract No.: 04-0120F4

04-0120F4
04-SF-80-13.2/13.9
Self-Anchored
Suspension Bridge

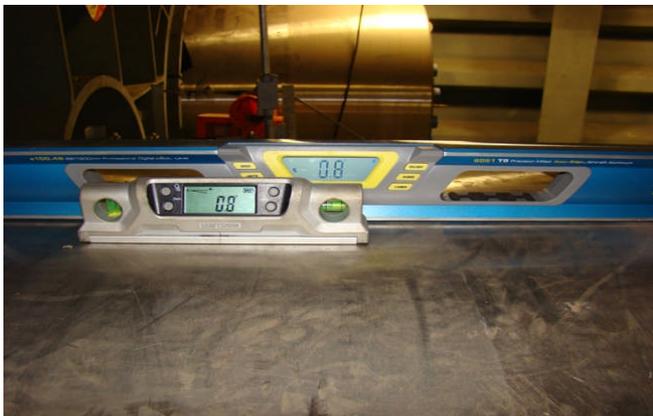
-----  
South Pipe Beam - on top dead center of the stainless steel section east of diaphragm D = 0.8 degrees tilted up on the west end

Vertical angle of 0.8 degrees tilted on the west end of the South E-Line Hinge A pipe beam while the North pipe was being jacked into position.

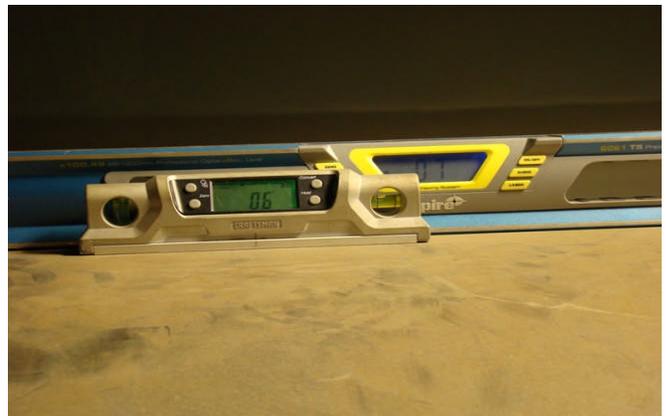
The first task of the shift was to adjust the North E-Line Hinge A pipe beam which began at 8:00pm. While ABF ironworkers were adjusting the pipe beam, the Caltrans SMART level was left on top of the stainless steel section east of Diaphragm D and observed. The pipe beam vertical angle went from 0.7 degrees to 0.6 degrees and finally to 0.8 degrees during the jacking operation. When the jacking was completed the last vertical angle measured was at 0.8 degrees. The South E-Line Hinge A pipe beam vertical angle was checked at 0.8 degrees prior to jacking the North pipe beam. This was the same vertical angle measured last night. Caltrans measurements were taken from 8:15pm to 10:45pm where the steel temperature inside of the Skyway Diaphragm D was 54F. The concrete temperature inside of the Skyway taken on the north stem wall at E3E-5W measured 56F.

Intermediate angle of 0.7 and 0.6 degrees tilted on the west end of the North E-Line Hinge A pipe beam observed during jacking operations.

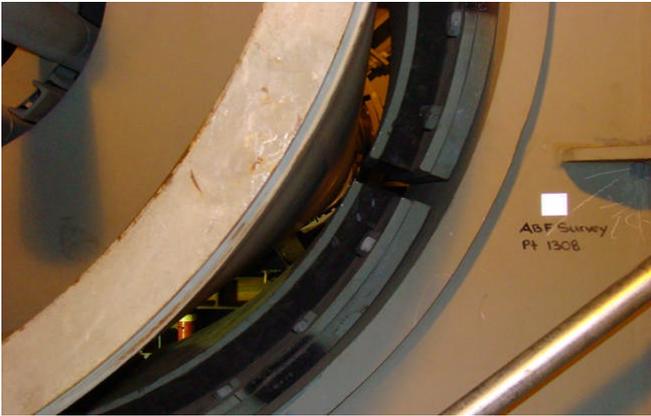
The gap between the Hinge A pipe beam and the bearings looking east from Diaphragm A after jacking operations of the North pipe beam.

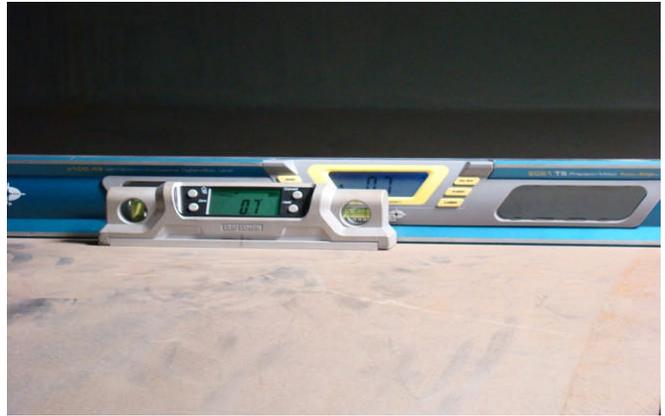
Intermediate angle of 0.7 degrees tilted on the west end of the North E-Line Hinge A pipe beam observed during jacking operations.
