SAS Superstructure

Daily Diary Report by Bid Item

Diary #: 725 Const Calendar Day: 176 Date: 27-Nov-2012 Tuesday

04-0120F4
04-SF-80-13.2/13.9
Self-Anchored
Suspension Bridge

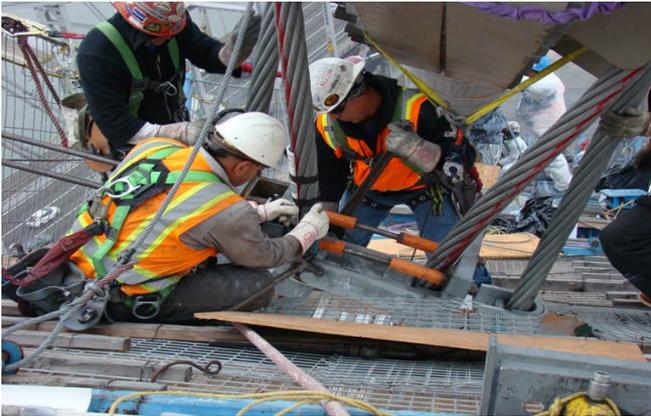
Tightening the suspender rope clamp bolt on 36S-Uphill to a "snug tight" torque or until the ironworkers can't physically push the wrench.

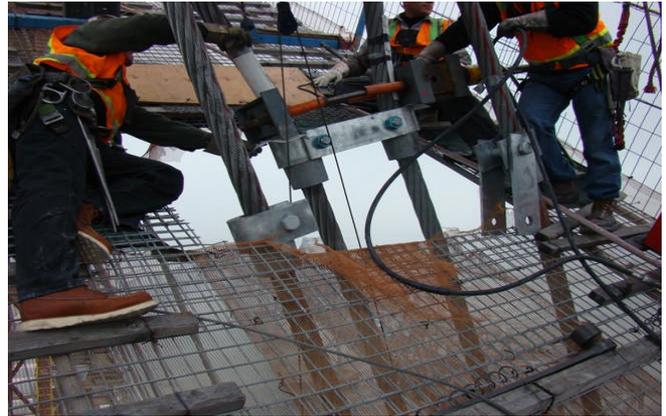
Completed suspender rope clamp with the bolts "snug tight" however the stressing equipment is still holding the horizontal load on the suspender ropes

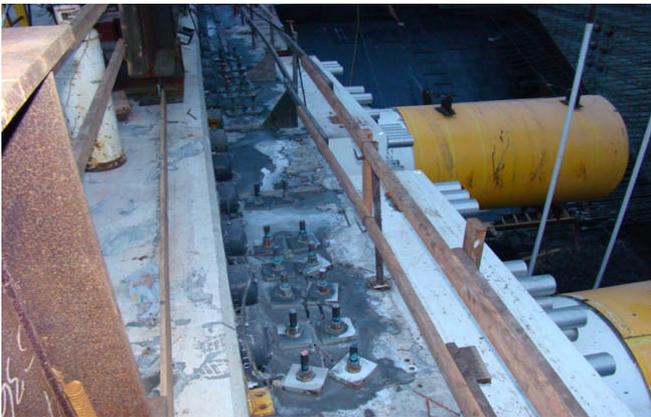
- Used Sika 300PT grout in an attempt to "top-off" the remaining portion of the short vertical PT bars embedded in the W2 cap beam. One bag was mixed in a bucket with 13 pints per the manufacturers recommendation then placed with a cup in the slotted vents of the top hex nut. As the grout placement progressed it appeared that the bars were being "topped-off". To reiterate the reason grout wouldn't hold in the blockout area between the nut and bottom of the plate was due to the rough concrete surface not in full contact with the vertical bar bearing plate. Thus not making the blockout mortar tight allowing grout to seep out near the nut and bearing plate connection.

Short vertical PT bars seen along the E-Line where grouting has been done, however even with the grouting "top-off" today another round is needed.

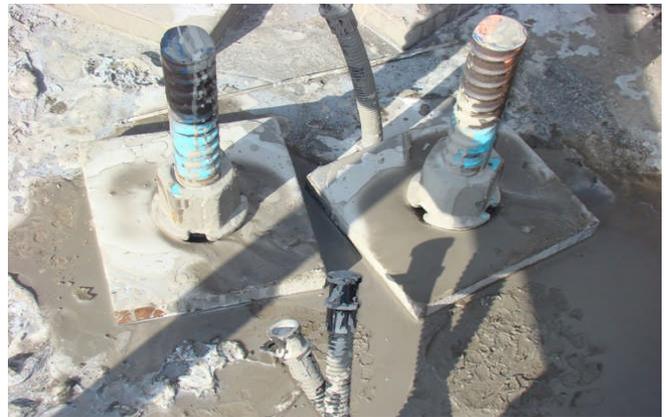
Example of two vertical PT bars that were grouted but still need additional grout to "top off" the effective area within the breakout to be grouted.

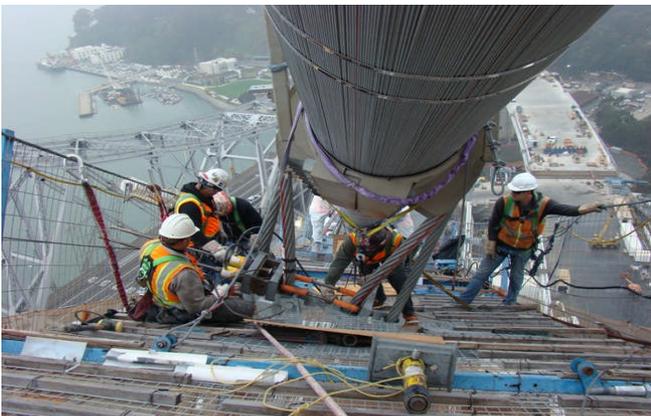
ABF ironworkers in the process of installing a suspender rope clamp on the uphill side of cable band 36 South.

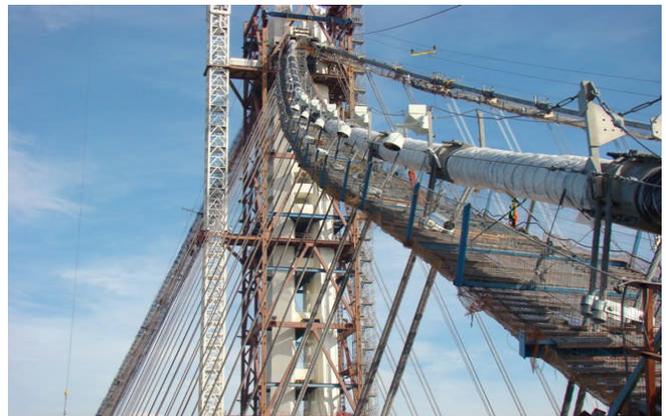
Installation of lights on the North Sidespan done by Subcontractor Bleyco, which began today.

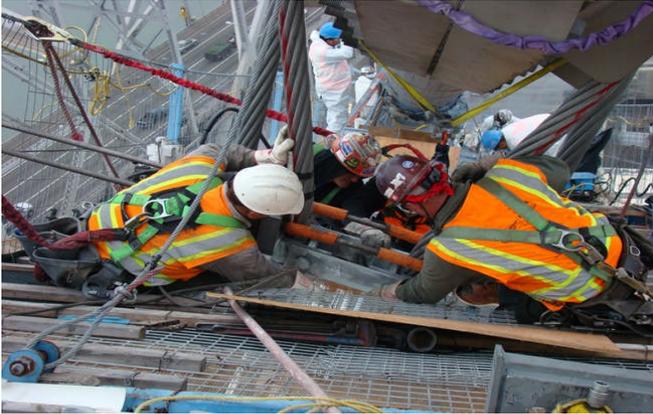
Closing the gap between the clamp plates to align the bolt holes of suspender rope clamp 36S-Uphill.
