SAS Superstructure

Daily Diary Report by Bid Item

Diary #: 737 Const Calendar Day: 191 Date: 12-Dec-2012 Wednesday

04-0120F4
04-SF-80-13.2/13.9
Self-Anchored
Suspension Bridge

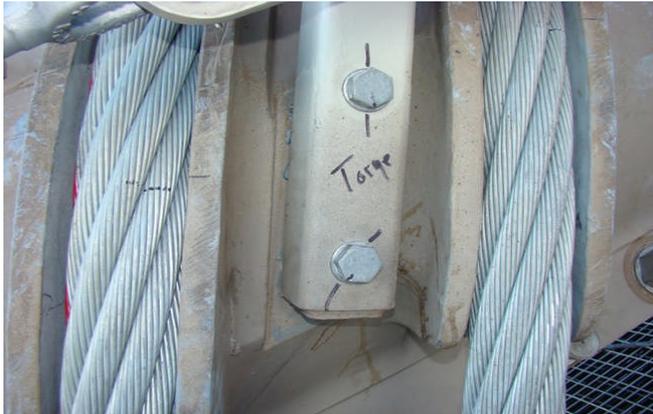
North Mainspan: a.) 2 Stanchion post bolts (1/2 turn) are complete except for the following:
- 44N Outboard bolts
- 46N Inboard top bolt only

Bolts seen on the outboard side of cable band 44N requiring 1/2 turn torque, note the stanchion post paint surface near the washer.

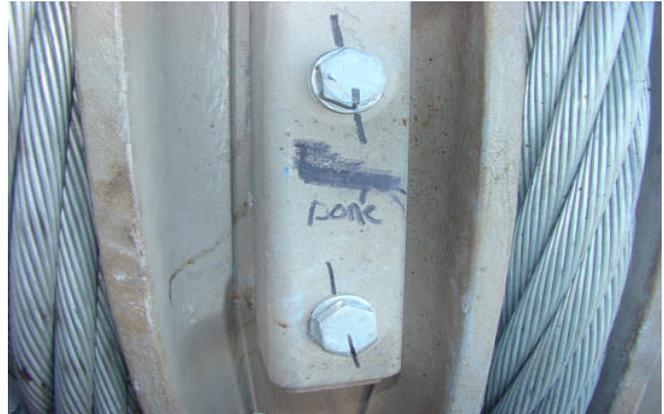
Bolts seen on the inboard side of cable band 44N w/1/2 turn torque, note the compressed stanchion post paint surface near the washer.
