SAS Superstructure

Daily Diary Report by Bid Item

Diary #: 739 Const Calendar Day: 193 Date: 14-Dec-2012 Friday
Inspector Name: Bruce, Matt Title: Transportation Engineer
Inspection Type: Continuous
Shift Hours: 07:00 am 05:30 pm Break: 00:30 Over Time: 02:00
Federal ID:
Location:
Reviewer: Schmitt, Alex Approved Date: Status: Submit

04-0120F4
04-SF-80-13.2/13.9
Self-Anchored
Suspension Bridge

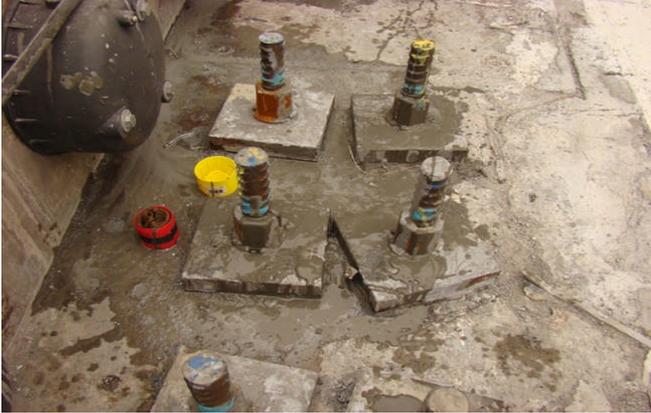
At 11:00am I had a chance to inspect the grouting top-off of the short vertical PT bars and initially the grout appeared to be placed properly with some residual water. I called ABF engineer Levi Gatsos to informed him that I inspected the grout placement and that I would check before the end of the day to see if the grout line dropped in the blockout. It was explained on many occasions to ABF, SDI, and other Caltrans inspectors that the grout had to be placed and then checked again to see it the grout line dropped past the hex nut slotted vents.

Initial grout placement of the short vertical PT bars along the E-line where the grout was at the top of the blockout or hex nut slotted vents.

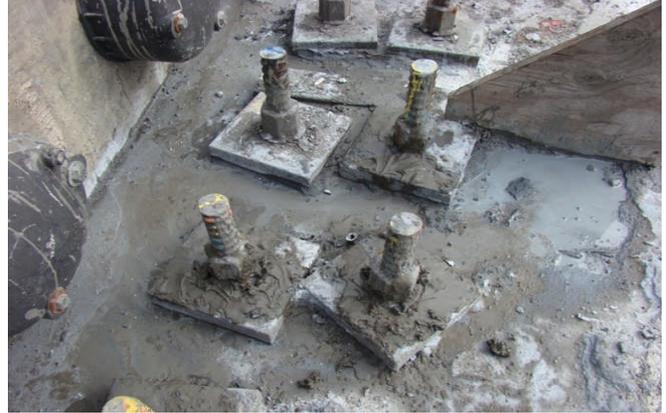
When I check the grout lines in the afternoon at 2:30pm it was discovered that on a few of the bar top plates there was a thick layer of grout smeared over the hex nut slotted holes. This grout wasn't set yet and I removed some of the thick grout to check if there was any water at the hex nut slotted vents. There may have been some water still in the blockouts which was difficult to truly see. Therefore it is not known if there is any residual water in the blockout. I called and left messages for Levi and Jason Wilcox to inform them of this discovery. See photos below for additional details and comments.

Second placement of a thicker layer grout at the same location over the top vents where it was unclear whether or not the fluid grout held.
