SAS Superstructure

Daily Diary Report by Bid Item

Diary #: 756 Const Calendar Day: 219 Date: 09-Jan-2013 Wednesday

04-0120F4
04-SF-80-13.2/13.9
Self-Anchored
Suspension Bridge

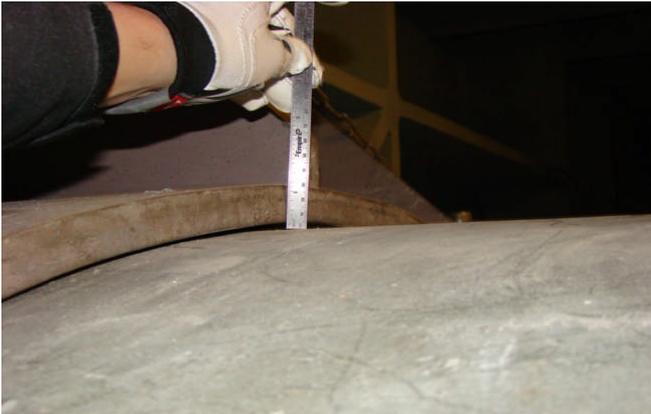
brackets is to try and eliminate gaps between bracket and the pipe beam. The worst case gap that was found on the approved location of the restraint brackets was 5mm.

A 5mm gap was measured between the top of the South E-Line pipe beam, east of diaphragm B.

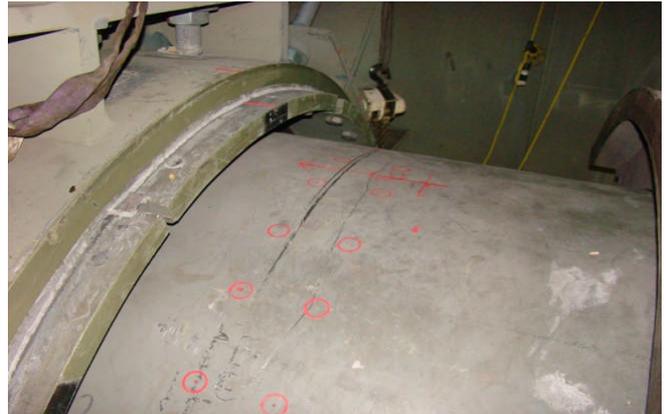
Punched and marked holes for the restraint bracket for the E-Line North pipe beam east of diaphragm B before drilling operations begin.

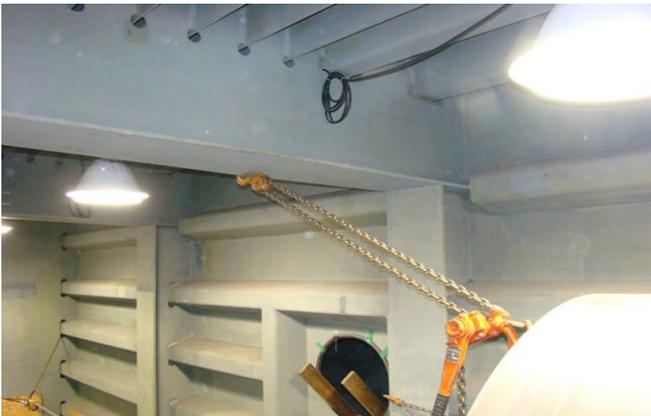
Comealongs anchored to the adjacent W-Line Skyway diaphragm on the South side where the top flange may be bent as a result of moving the pipe beam.

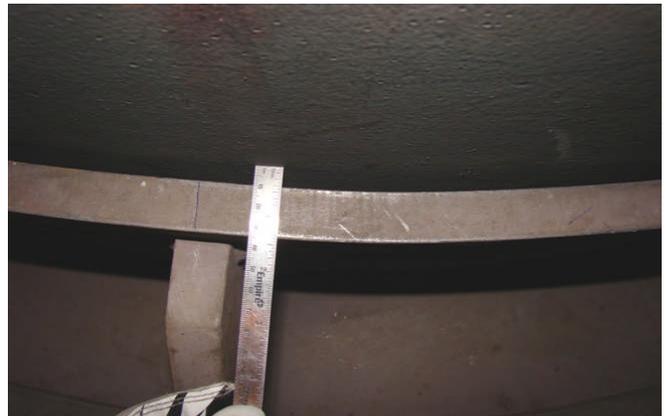
The restraint bracket denoted with an \* was placed but had an excessive gap between the pipe and the bracket of 10mm. I had the ironworkers remove the bracket so that I could inspect the pipe beam. There was a slight depression on the pipe surface near the west side of the bracket which was caused the 10mm gap. I spoke with ABF engineer Andre Makaranian and Paul Jefferson about the issue and decided that the DJV needed to get involved before center punching and drilling commence at this location.

A 10mm gap (worst case) was measured between the bottom of the North W-Line pipe beam, east of diaphragm A.

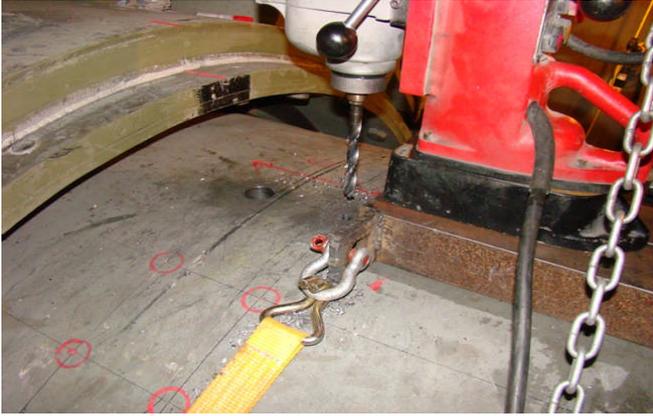
The first holes drilled in the top of the North E-Line pipe beam, east of diaphragm B.

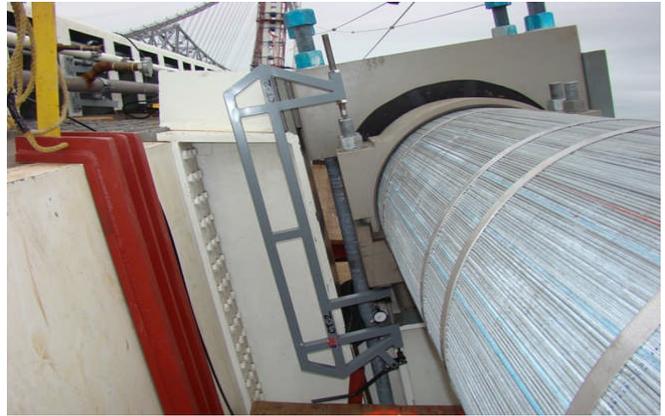
Orientation of the Extensometer number 2 placed on the easternmost inboard bolt at panel point 116 along the W-Line.
