SAS Superstructure

Daily Diary Report by Bid Item

Diary #: 176 Const Calendar Day: 219 Date: 09-Jan-2013 Wednesday

04-0120F4
04-SF-80-13.2/13.9
Self-Anchored
Suspension Bridge

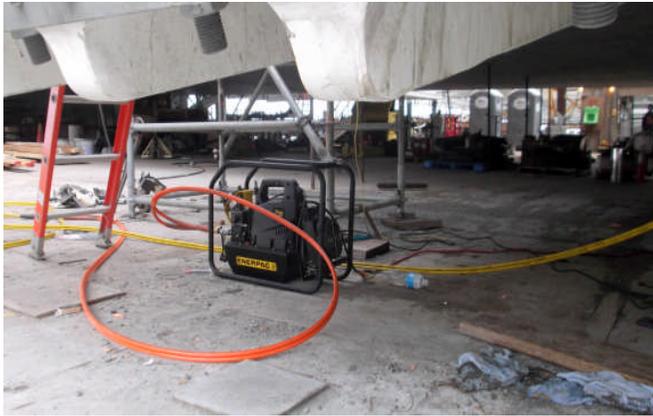
- Crew added longer line (yellow color) to top of the shorter line (Red color) for reaching top of the bolt set
- Crew did bottom two corner bolt set @ 0840 & 0850 AM respectively.

Bolt Tightening Machin with longer longer line (yellow line)

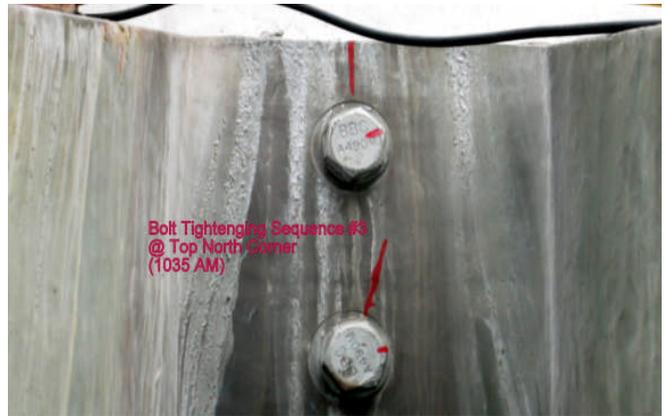
Bolt Tightening Cofiguration (#3)

Bolt Tightening on the saddle bottom

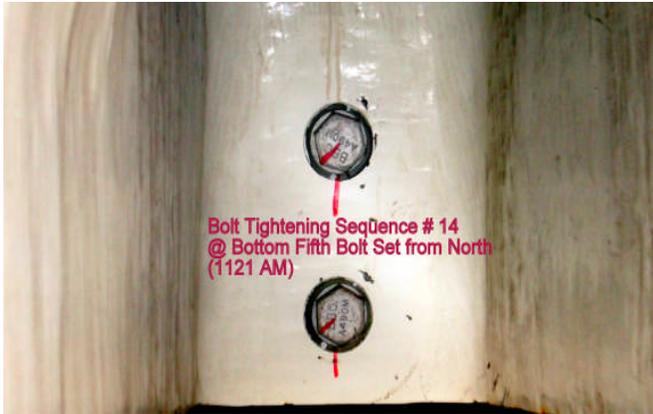
BTC #14

- Among tightening bolts (total 31), the tightening sequence # 14 bolt set were not reaching 1/4 turn (see picture), I questioned to forman Jimmy, he told me that the bolt already in the max turn limit, it will damage the bolt if continue to touge. I took pictures, other set of the bolt were OK for turning.

- Back to office, I talked to Warren and phoned Bob.
- I talked to Bob, he said that the bolts tightening is for preventing bolt from falling down not for the tensioning it should be OK. I also talked to Brian let him to know the situation.

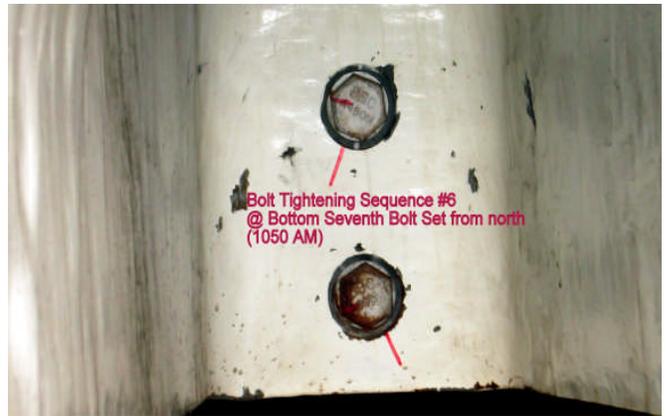
Forman Jimmy & Standley performed bolt tightening between jacking Saddle & Form Box

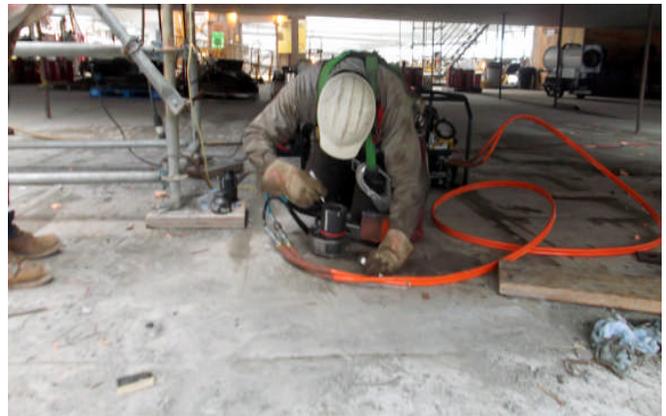
IRW Standley Marking line on driving head
