SAS Superstructure

Daily Diary Report by Bid Item

Diary #: 758 Const Calendar Day: 221 Date: 11-Jan-2013 Friday
Inspector Name: Bruce, Matt Title: Transportation Engineer
Inspection Type: Intermittent
Shift Hours: 07:00 am 05:30 pm Break: 00:30 Over Time: 02:00
Federal ID:
Location:
Reviewer: Schmitt, Alex Approved Date: Status: Submit

04-0120F4
04-SF-80-13.2/13.9
Self-Anchored
Suspension Bridge

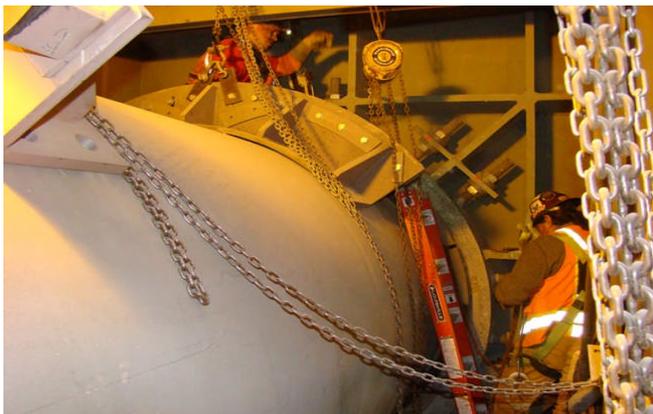
ABF ironworkers installing a restraint bracket on the top of Hinge A pipe beam AE-North west of diaphragm B.

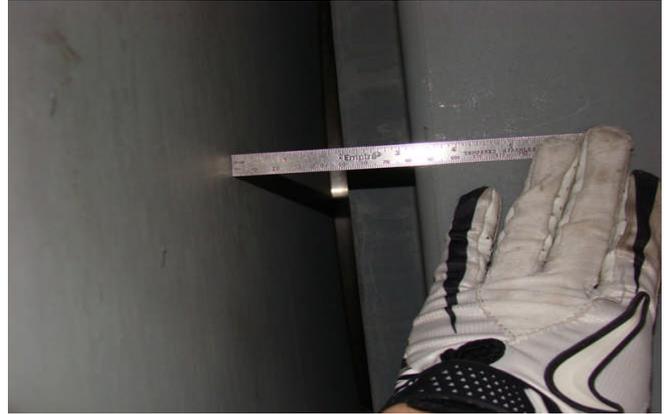
yesterday the upper and lower housing gaps of bearing castings at E2 were not acceptable. Today to reinforce this issue that needs to be fixed prior to grout placement, measurements were taken of the west/east face gaps, and the bearing pin stickout. The following are measurements taken on all four of the bearings:

Bearing	// West Gap //		// East Gap //		// Pin Stickout //	
	North	South	North	South	North	South
1	60	63	67	57	42	42
2	76	45	79	44	22	60
3	53	68	53	67	52	34
4	57	65	40	82	54	31

All measurements presented above are in millimeters. For the gap measurements the upper casting was measured to the lower casting. The lower housing retaining ring plate has a nominal thickness of 40mm which can be subtracted from the gap measurement above to find the actual (theoretical = 20mm +/-2mm) gap distance. This gap can't be directly measured due to access with a straight edge, see photos below for more details. Informed ABF engineer Zach Lauria of this issue and the results of the measurements. Also Bob Brignano compiled photos of the B2 Bearing showing unequal gaps. After presented with additional evidence and discussing, Zach agreed to resolve the issue with the bearing housing gaps.

B4 bearing east face gap of 42mm between the upper and lower housing castings on the south end, note the exposed area of the pin.

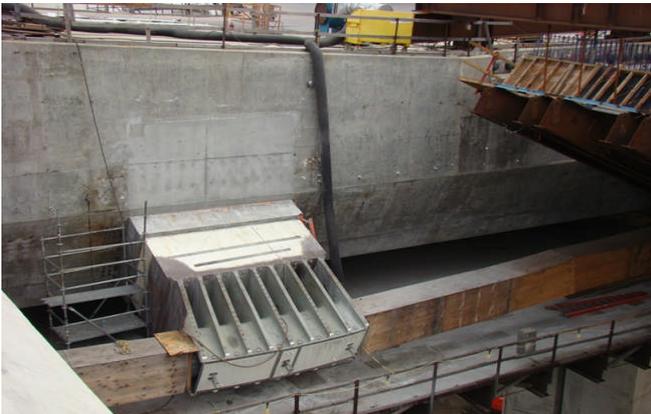
Looking east at the jacking saddle stage 2 concrete recently placed.

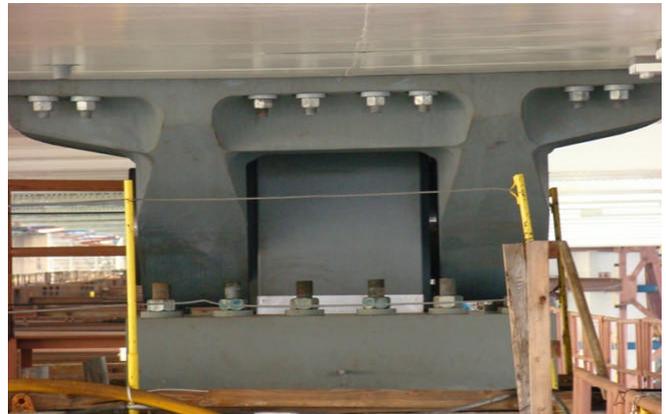
East face of the B2 bearing looking west with the unequal gaps seen and measured which need to be corrected prior to grouting.

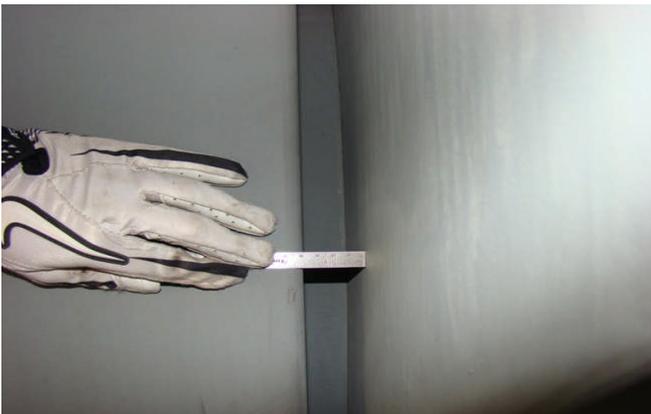
B4 bearing east face gap of 0mm between the upper and lower housing castings on the north end, note that the pin is not seen.

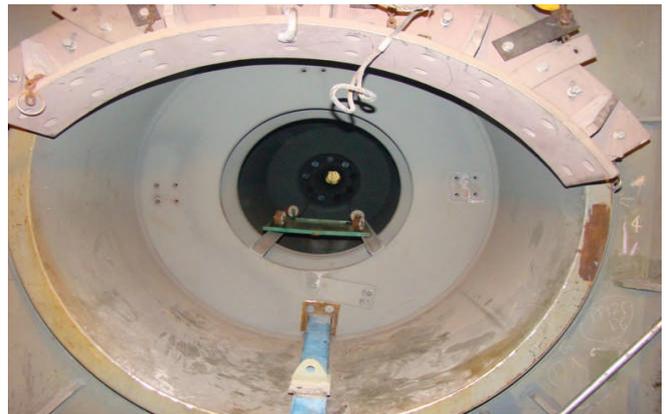
View of Hinge A pipe beam AW-North from the SAS looking east as the MEP conduit pipes have been moved back to enable restraint bracket bolt install.
