SAS Superstructure

Daily Diary Report by Bid Item

Contract No.: 04-0120F4

Diary #: 767 Const Calendar Day: 232 Date: 22-Jan-2013 Tuesday

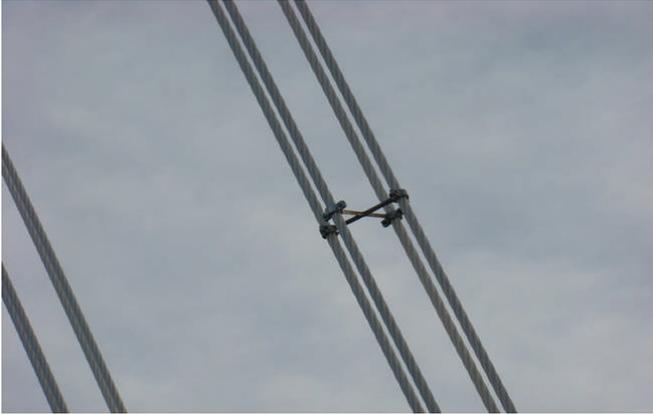
One suspender rope separator installed at panel point 20 South.

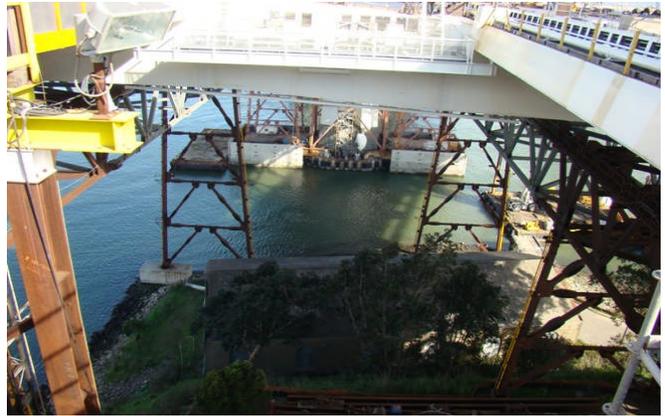
View from the W2 cap beam looking east towards the tower of the removed trestle in preparations for the temporary truss removal.
