SAS Superstructure

Daily Diary Report by Bid Item

Contract No.: 04-0120F4

Diary #: 476 Const Calendar Day: 240 Date: 30-Jan-2013 Wednesday

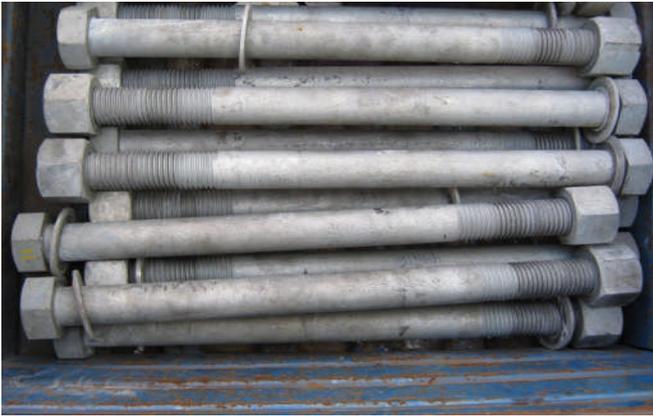
- These bolts were being replaced 3 at a time. 3 bolts were de-tensioned & removed, & then new bolts were installed & tensioned to 24,000 psi (about 1.1 MN).
- Note: There was no difficulty in removing or re-installing any of the bolts.
- Note: There was no rust on the bolts removed at PP 44N, which is different from the bolts recently removed at PP 40S & 40N.
- All of the new bolts were tensioned simultaneously to 29,000 psi (about 1.4 MN). The pressure was cycled up 5 times to try to minimize seating losses.
- Extensometer measurements were taken by A. Schmitt, M. Bruce, & J. Lyons. I calculated the new elongations & load on each of the new bolts. The minimum load on the new bolts was about 0.98 MN, the maximum load was about 1.35 MN, & the average was about 1.15 MN. This information was given to Roman Granados & Warren Collins.

The old bolts from PP 44N were not rusty, & generally in good condition.

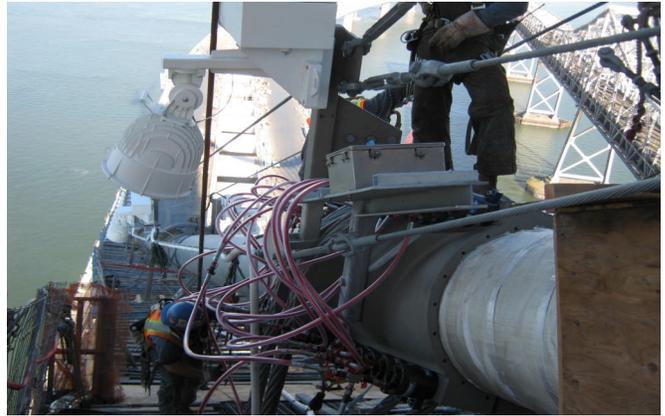
Tensioning of new CB bolts at PP 44N

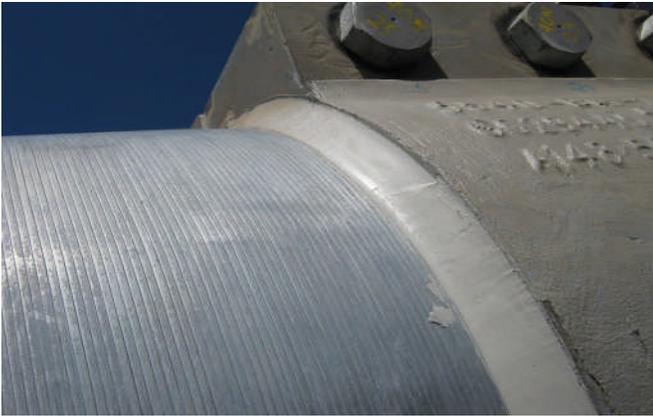
- Note: I did a final inspection after the tensioning was completed. There appeared to be no damage to

the CB caulking (see attached photo). Also, the wrapping wire appeared to maintain good tension at the terminations at the CB.

Caulking at the CB at PP 40S appears in good condition after the re-tensioning
