SAS Superstructure

Daily Diary Report by Bid Item

Contract No.: 04-0120F4

04-0120F4
04-SF-80-13.2/13.9
Self-Anchored
Suspension Bridge

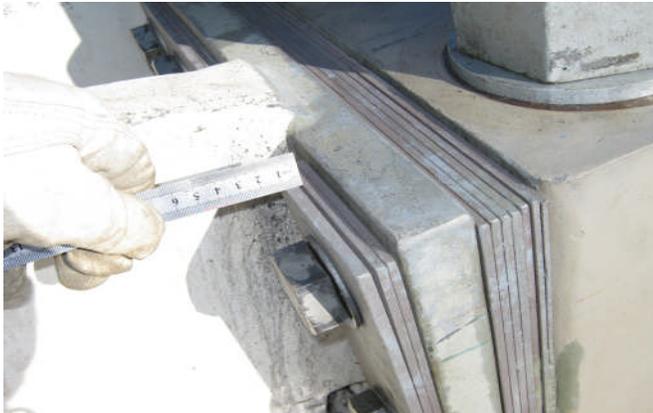
- The bolts between the suspender bracket & the upper strong-back of the cable bracket (inboard side) were tightened. However, the plies within the connection could not be brought into firm contact. Also, one of the bolts seized, & could not be tightened or loosened. See attached photo.
- The bolts between the suspender bracket & the lower strong-back of the cable bracket (outboard side) were tightened (snug plus one half).
- The bolts between the suspender bracket & the upper strong-back of the cable bracket (outboard side) were tightened (snug plus one quarter since they were in tapped holes).
- The vertical bolts underneath the lower strong-back were tightened (snug plus one quarter since they are

Note: I mentioned the issue with the plies of the bolted connections at PPs 116N & 116S to Brian Boal, Warren Collins, & Roman Granados.

Plies within bolted connection at PP 116S not in firm contact
