SAS Superstructure

Daily Diary Report by Bid Item

Contract No.: 04-0120F4

Diary #: 813 Const Calendar Day: 299 Date: 30-Mar-2013 Saturday

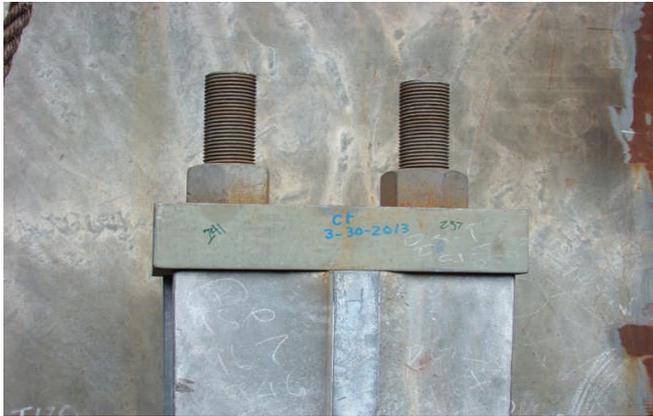
Marking made near the anchor rods confirming that there was minimal loss of the tensile load.

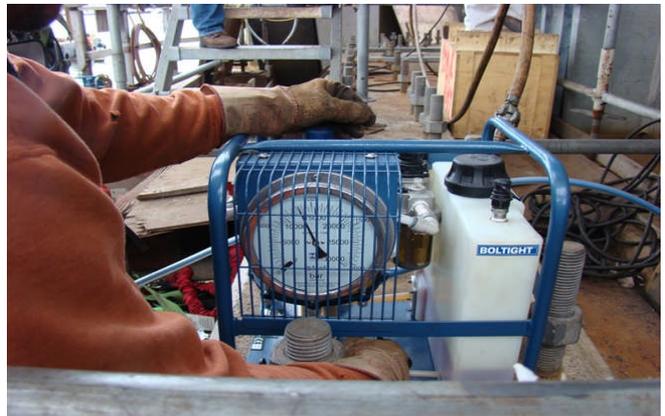
Pjack pressure of 12,600psi at 100% on the 3" diameter anchor rods seen on the Boltight pump gauge.

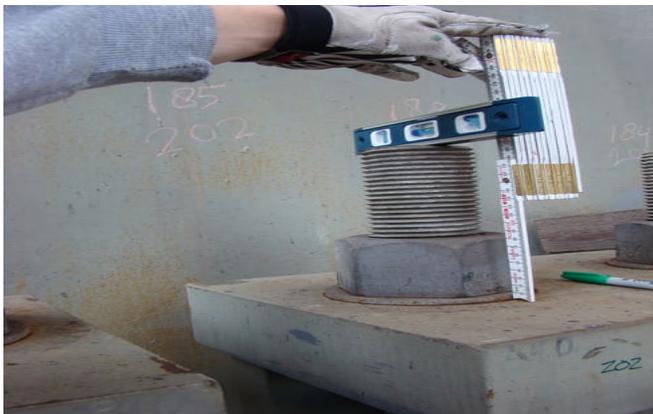
Initial measurement taken before performing load verification on the outer perimeter tower anchor rods.

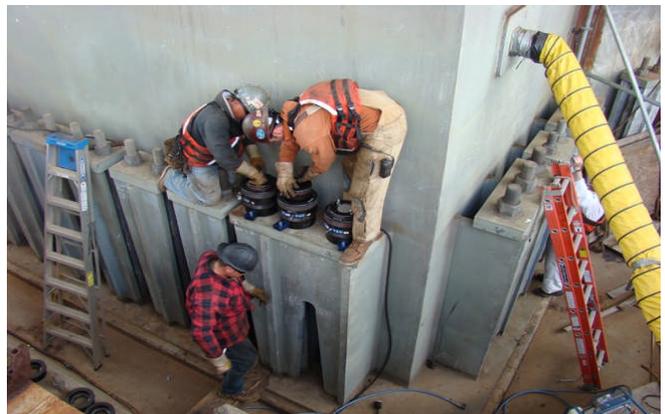
ABF ironworkers placing Boltight jacks over the 4" diameter rods on the corner of the North tower shaft.
