**SAS Superstructure**

**Daily Diary Report by Bid Item**

Contract No.: 04-0120F4

Diary #: 817 Const Calendar Day: 304 Date: 04-Apr-2013 Thursday

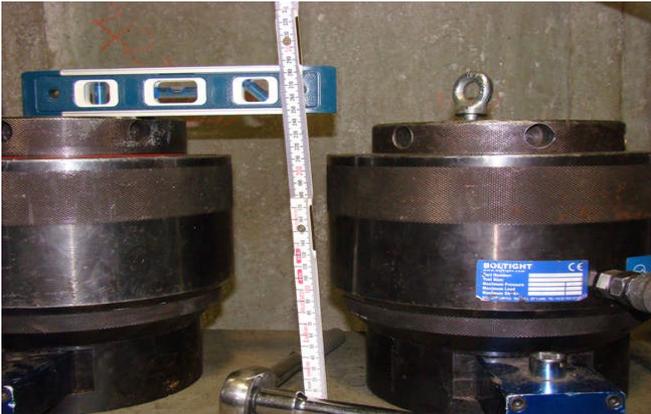
At 3:45pm ABF ironworker crews mobilized in the East tower shaft on rods E73-75. While conducting the first cycle of load verification in anchor rods E70, E71, and E72 the red line of the jack "puller" was seen on rod E72. The first cycle was tried again with the same result then the jack was then taken off of this rod and rods E70 and E71 were verified separately. A couple more attempts were conducted with the jack back on rod E72 connected in series with E70 and E71. The nut for E72 has seized up and will not turn either way on the rod. This rod will have be addressed at another time.

Jack puller redline seen while stressing anchor rod E72 on the left with E71 on the right, notice the difference in ram stroke.

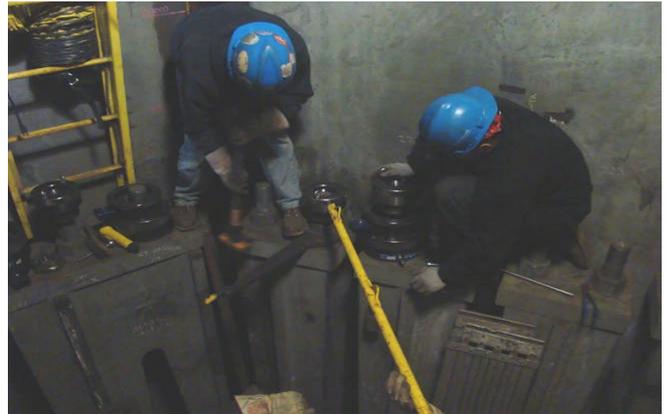
It was known that anchor rods b1(E)05,06,11,&12 were never stressed due to access for electroslag welding. ABF ironworkers cleaned,filed down, sprayed WD40, used a thread chaser and dye to prepare the threads of these four rods. However the jack "puller" couldnt be fastened all the way to the jack "tensioner or jack ram" on rod b1(E)11. The rods in this pair 11 and 12 would be addressed at a later date since it was taking too much time to get the jack puller onto rod 11. It was observed that while stressing anchor rods b1(E)09 and 10 that the pump was not working properly. The ABF ironworker foreman bled off the compressed air hose to release the condensation in the hose, which appeared to resolve the issue of the pump. The pressure cycles observed while stressing anchor rods b1(E)05 and 06 for the first time were 4.0ksi, 8.5ksi, 13.1ksi, and 13.2ksi. Elongations for anchor rod 5 was 223-239 = 16mm, and for rod 6 the change in length was from 227-243 = 16mm.

ABF ironworkers trying to place the jack puller onto the tensioner or jack ram for rod b1(E)11 today.
