SAS Superstructure

Daily Diary Report by Bid Item

Contract No.: 04-0120F4

04-0120F4
04-SF-80-13.2/13.9
Self-Anchored
Suspension Bridge

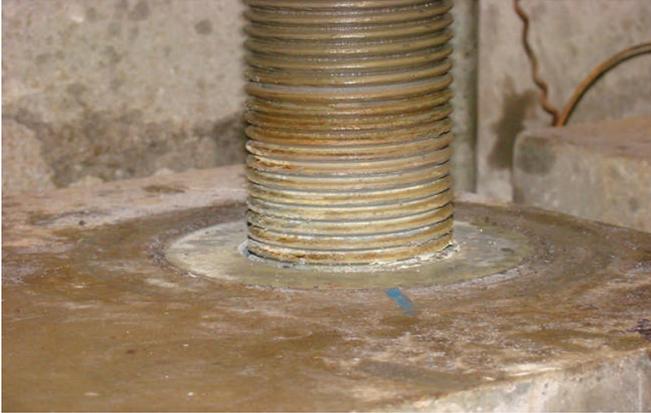
Rust seen on the rod threads of S05 which were cleaned after destressing the rod and removing the nut.

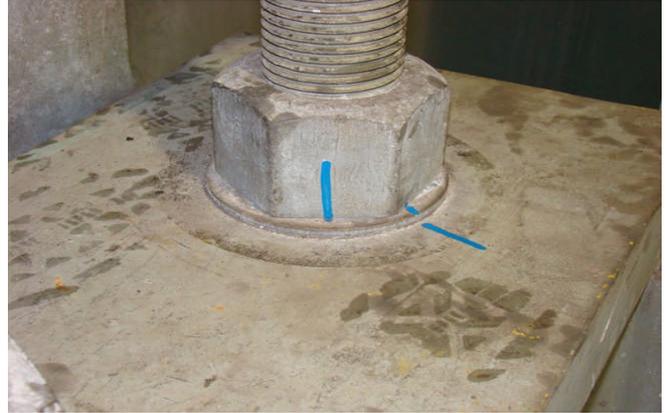
Match marks made on the nut and bearing plate for anchor rod S72 to show how much the nut would turn after tightening when brought up to 105% Pjack.
