SAS Superstructure

Daily Diary Report by Bid Item

Diary #: 207 Const Calendar Day: 311 Date: 11-Apr-2013 Thursday

04-0120F4
04-SF-80-13.2/13.9
Self-Anchored
Suspension Bridge

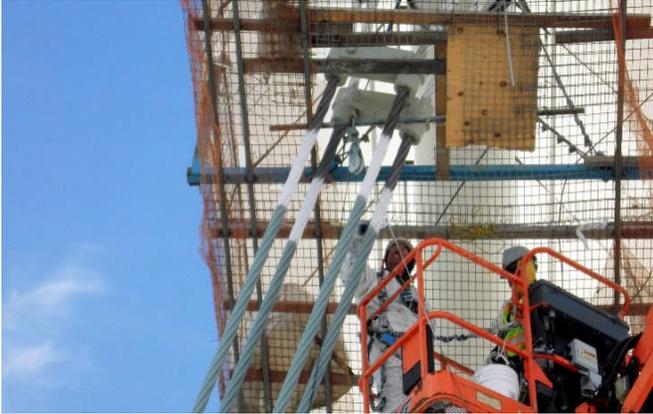
- * CCC also need fix N78 - SE rop at top half area for Pegalink repair & N80-SE rop at top half Blue Gray repair before Gravel Gray coating spray.
- * Two painters (Jorge & Danial) were repairing pegalink coating on N86 & N84 top ropes until 14:20 PM.

Painters were repairing Pegalink coating @ top ropes of N86 & N84 area.

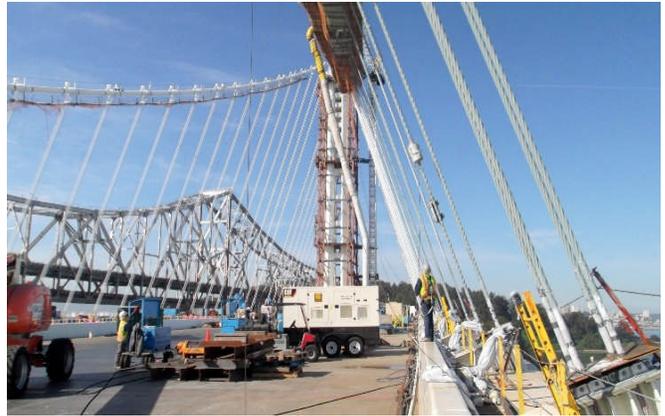
- * We walked to NMS area, crew (Jorge Diega, Daniel Duran & Manual Barrios) were performing water rinsing on N76 area.
- * Talked to Manny, he said he will performe water rinsing all remaining suspender ropes from N76 to N88 and repair the holidays listed by QC/QA by Blue Gray coating checking performed on yesterday.

Crew performed water rinsing on N76 area started at 08:15 AM.

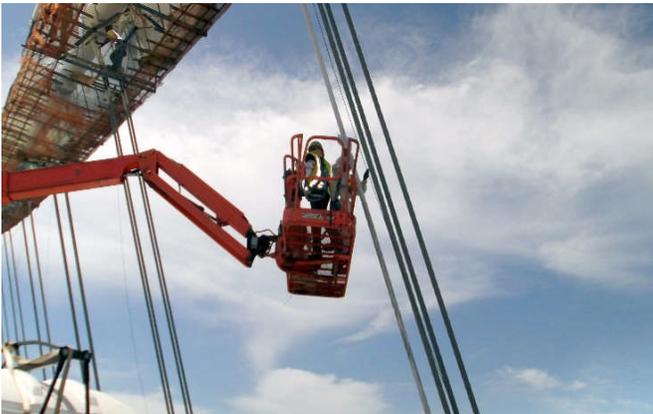
- * At 12:45 PM, crew started repairing Pegalink coating (Bottom up to 20 ft area) on SW rope of N88. At 13:15 PM, Rex & Jorge were checking Pegalikh repair on N88, results showed that the repair was OK. CCC need wait for 16 hours in order to apply Blue Gray on N88 (Rex measured temperatures were: Tss = 58 F < 75 F).

QA Rex with Jorge checking Pegalink repair work at N88 SW rope
