Daily Diary Report by Bid Item

Contract No.: 04-0120F4

Diary #: 827 Const Calendar Day: 317 Date: 17-Apr-2013 Wednesday

04-0120F4
 04-SF-80-13.2/13.9
 Self-Anchored
 Suspension Bridge

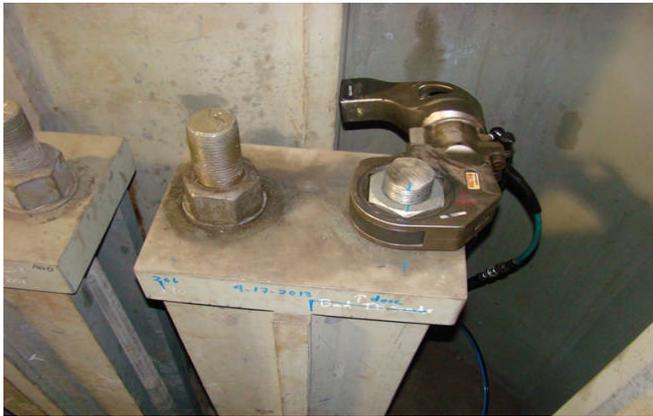
The first task was to stress anchor rods W60 and W61 together, see photos below for more details. It was decided between ABF engineer Andre Markarian, Sami, and myself to stress these two rods in steps. Anchor rod W61 was stressed to 2.0ksi with the Boltight system. Then W60 was "snugged" tight followed by 1/2 turn at a pressure of 2.4ksi of the nut using the Hydratight hydraulic torque wrench. The gauge number of the Hydratight torque wrench pump was 25564-38B21 which had a calibration sticker denoting the last test was done on 03-01-13. Once the 1/2 turn was completed on anchor rod W60, three more cycles with the Boltight system at 7.2ksi, 12.5ksi, and 13.2ksi were executed on anchor rod W61 to achieve the required 105% Pjack force. Then the Hydratight torque wrench completed the full turn of the nut on anchor rod W60 at a pressure of 5.6ksi. Sami took the measurement on these two anchor rods stressed today. The elongation of anchor rod W61 was 190mm - 206mm = 16mm, and the match marks were acceptable for the 1 whole turn on anchor rod W60.

Tower anchor rods W60 and W61 with the Hydratight torque wrench placed on anchor rod W60.

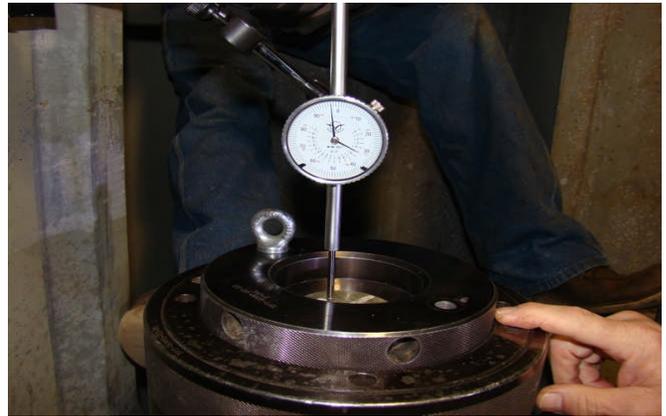
As the pressure was being verified on anchor rod W73 (around 1:15pm) the Boltight pump mentioned above stopped working. A new pump from the Pier 7 warehouse was shipped to Pier T1 at 2:00pm and force verification operations for the tower anchor rods resumed. The second Boltight pump was number 70254-2222000757, gauge number 12906134/8. The first tower anchor rod force verification/determination where the nut seized on the rod threads was W13, located on the outer perimeter of the tower shaft. ABF engineer Andre Markarian had an dial gauge used to measure anchor rod lift off. It was agreed that the anchor rod lift off was 1/2 turn of the dial or 0.05" (1.27mm). The estimated measured gauge length of 0.05" is the estimated amount of rod elongation in the jack puller prior to lift-off of the nut on the washer/bearing plate. The lift off pressure of anchor rod W13 was found to be 11.0ksi, similarly the lift off load for W73 and W75 was 9.0ksi. As in previous days the jack ram was monitored for movement at lift-off by Sami. The lift-off load/pressure is difficult to observe on the Boltight pump gauge since the dial undergoes oscillating back and forth inflections as the pressure is increased.

Dial gauge used to assess the moment of lift off on the top of the tower anchor rod (W73 in the photo).

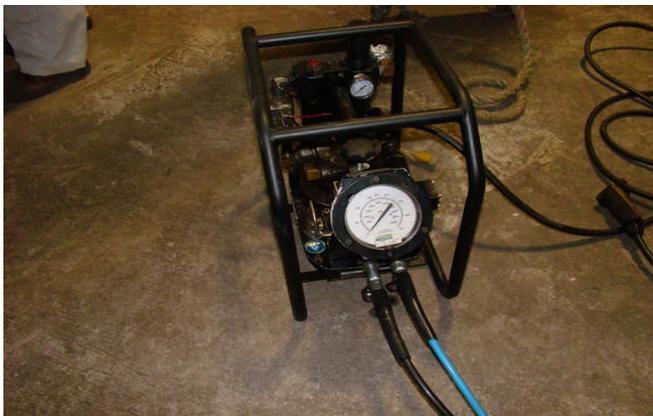
Hydratight pump used for turning the nut on tower anchor rod W60 one full turn.

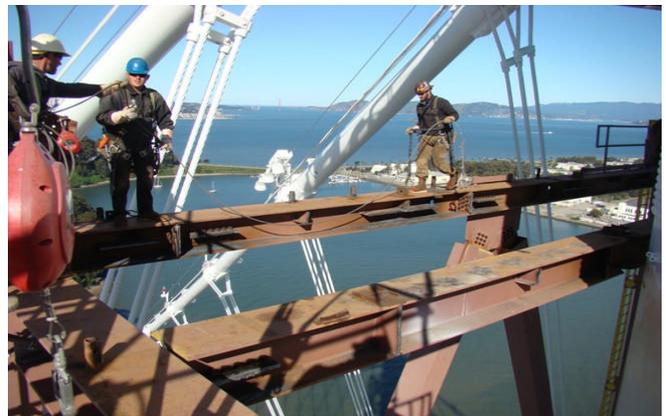
ABF ironworkers preparing to remove bracing of the T1 erection tower.
