Daily Diary Report by Bid Item

Diary #: 004 Const Calendar Day: 358 Date: 28-May-2013 Tuesday
 Inspector Name: Gagnier, Pamela Title: Transportation Engineer
 Inspection Type: Intermittent
 Shift Hours: 07:00 AM 07:30 PM Break: Over Time:

04-0120F4
 04-SF-80-13.2/13.9
 Self-Anchored
 Suspension Bridge

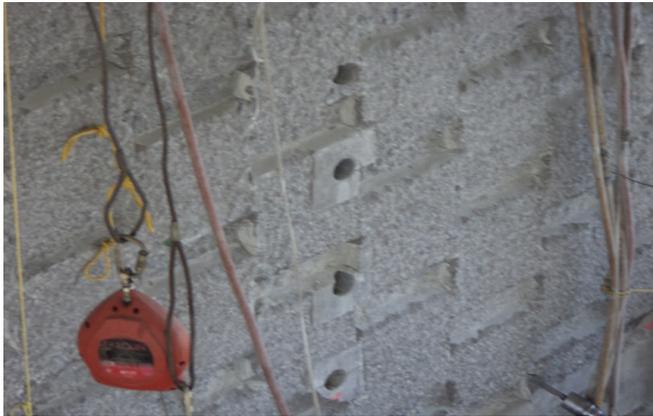
I observed on E2W east side the keyways were chipped out at 7 of the through cap tendons opening causing an uneven and roughened surface for mounting 20mm cover plate. Discussed with Conco and they were not informed to leave surface around holes smooth and even until after these 7 were chipped around. (See photos below.)

Through Cap PT Holes East Side E2W

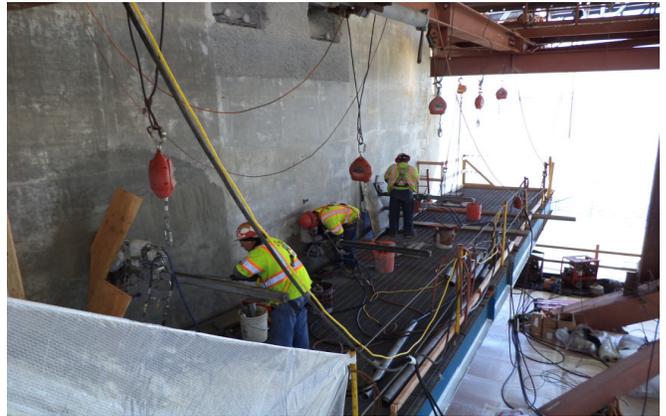
Penhal is saw cutting for the shear keys on the east vertical face of E2E. They also continue coring for the Through Cap Tendons on E2E West Face. As of 3 pm the 1st core was through at the north location.

Penhal Core Drilling E2E West Face

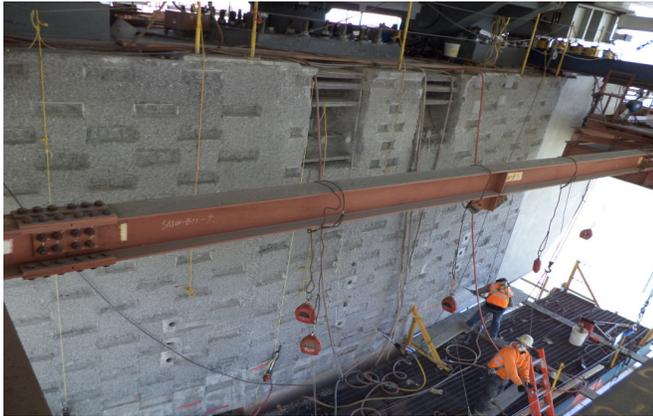
Carpenters installing walkway between E2 hanging platform, E2E and E2W.
 Laborers are preparing (bushing/hammering) the vertical surface E2W East side. See photo below.

Roughened Vertical Surface E2W East Face

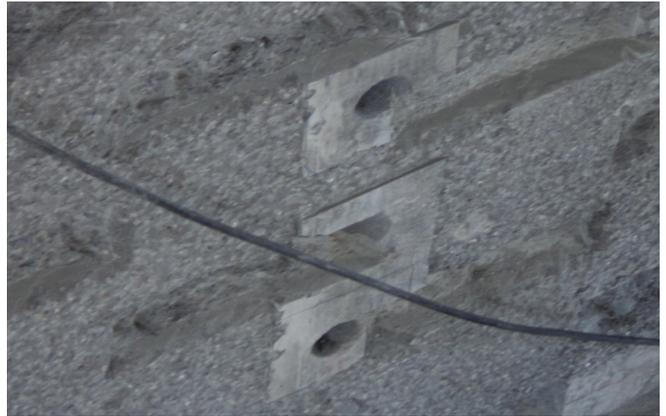
Through Cap PT Holes East Side E2W
