SAS Superstructure

Daily Diary Report by Bid Item

Contract No.: 04-0120F4

04-0120F4
04-SF-80-13.2/13.9
Self-Anchored
Suspension Bridge

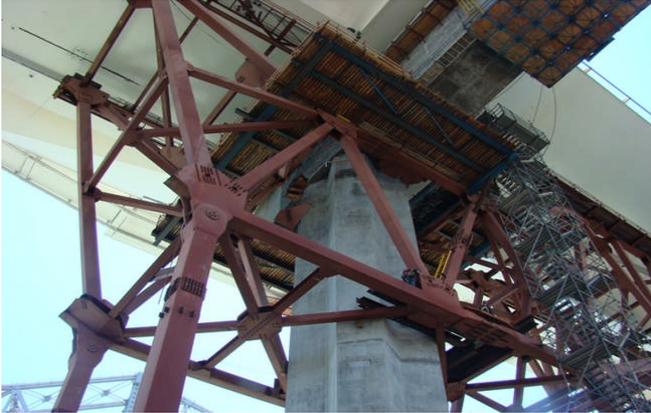
ABF ironworkers lowering sections of the E-Line temporary truss to enable falsework beam erection.

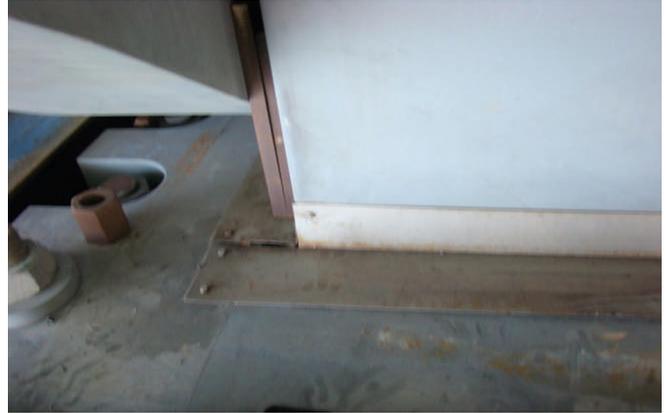
- Measured the gaps of the permanent bearings at the E2 cap beam requested by Paul Jefferson and TY-Lin. It should be noted that it was difficult to get a tape in the very top area detailed in the sketch so I just took three measurements along the gap height. Also the dust covers were secured preventing "Type A" measurements. Emailed the measurement summary to pertinent personnel related to the Shear Key retrofit work.

Dust covers on the permanent Bearings which prevented measurements of the gap between the lower base and stub.

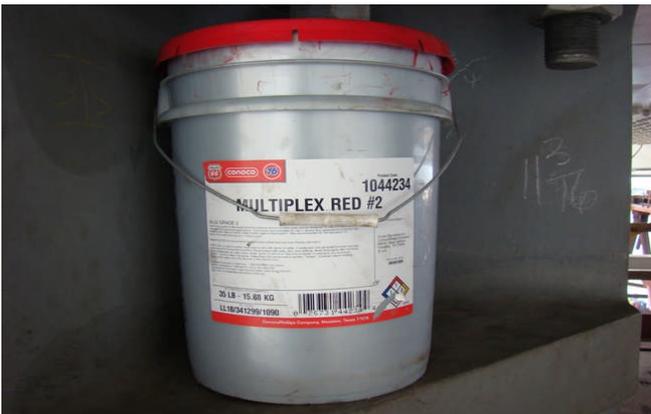
Multiplex Red #2 is being used as a lubricant and rust preventative substance while waiting for saddles and painting operations.

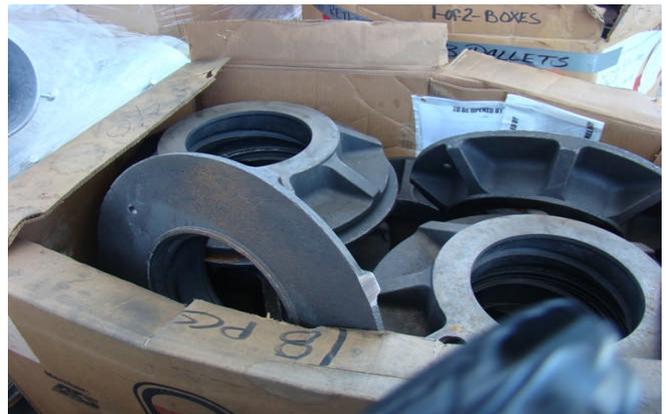
- See Pamela Gagnier's diary for the S1/S2 Shear Key modification work today as she is tracking the labor, equipment, and work progress of Conco, IPMC, and other ABFJV personnel. Today I retrieved Orange tags B10-171-13 (PT bearing plates) and B7-991-13 (pipe with studs) on the barge moored near the new E2 foundation. Briefly checked the materials and it appeared to be in good condition with minimal or no rust. Spoke with Caltrop welding inspector Danny Reyes regarding the E2 Shear Key retrofit work specifically the studded plates near the bottom of the bearing rods. I mentioned that the plates were welded to the anchor rod bearing plates and he responded that ABF will provide a detail for that connection. Finally I spoke to ABF engineer Levi Gatsos about the red substance seen in the bolt holes on the Shear Key lower bases. He informed me that Multiplex Red #2 is being used as a lubricant and a rust preventative substance while waiting for saddles and painting operations.

Bearing plates seen onsite down on the barge for Orange tag B10-171-13.

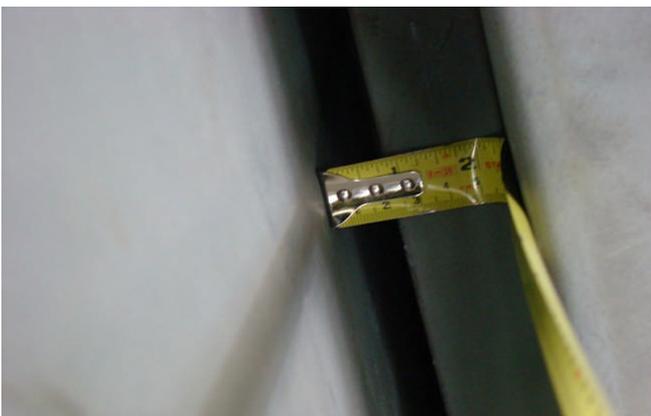
Measurement with the tape in between the lower housing stub ring

plate and upper housing to measure the gap.

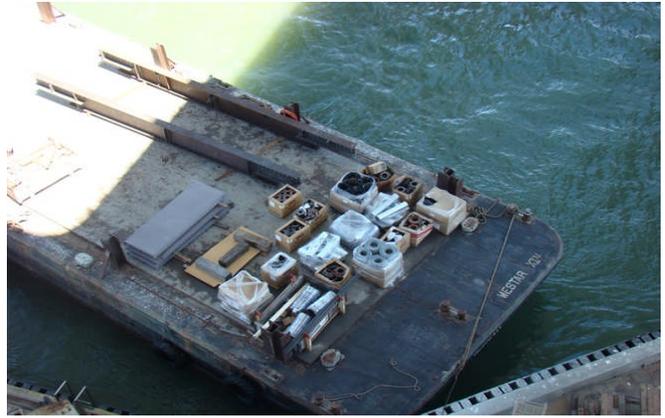
Materials for post tensioning tendons for the E2 Shear Key retrofit.
