SAS Superstructure

Daily Diary Report by Bid Item

Diary #: 872 Const Calendar Day: 402 Date: 11-Jul-2013 Thursday

04-0120F4
04-SF-80-13.2/13.9
Self-Anchored
Suspension Bridge

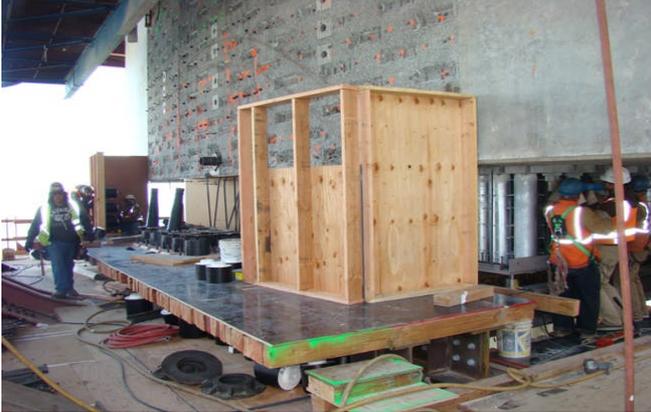
Conco carpenters beginning to construct formwork and place blockouts on the S1 Shear Key west soffit.

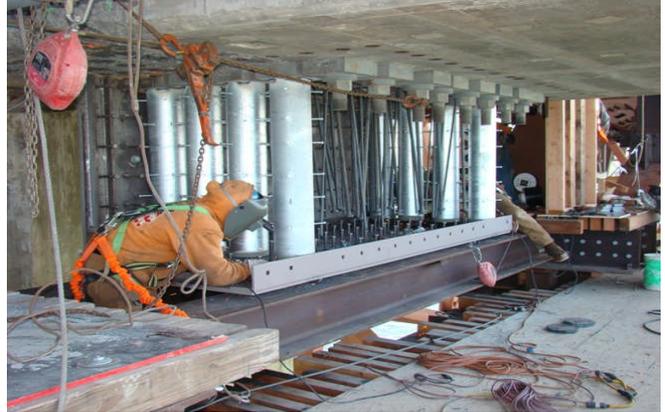
ABF welders grinding the cut holes in the bottom steel plate.

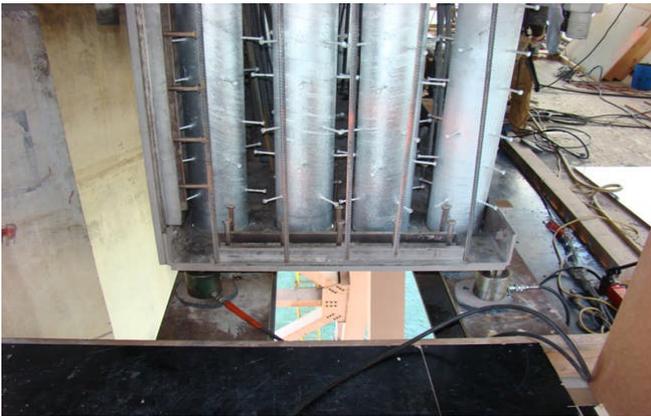
Bearing B3 west anchor rod blockout pipes with Nelson studs looking east, clearance with PT duct was checked by ABF engineer Adam Reeve.

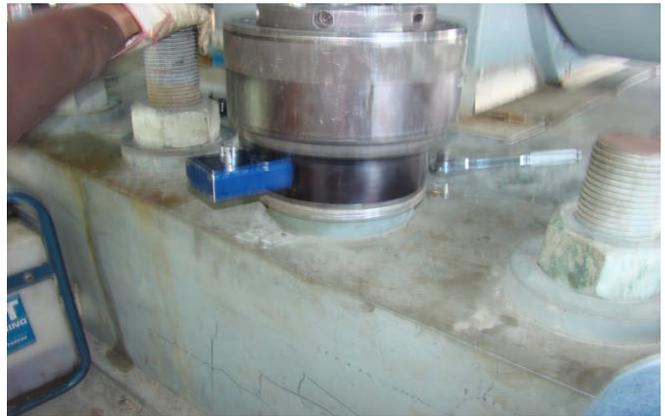
Today the operation to detension, raise, and retension the permanent bearing anchor rods per RFI3329R00 was officially completed. Anchor rods B1B1 and B1C1 previously couldn't be completed last week because the nut couldn't be fully turned due to partial bearing of the jack stool on the permanent washer. ABF engineer Adam Reeve had two beveled washers fabricated to enable the nut on these two anchor rods to be turned. The following Boltight equipment was used to hold the Pjack pressure of 19.5ksi in the anchor rods:

The previous Pjack values for B1B1 and B1C1 was 15.0ksi and 17.0ksi. It took 4 iterations to bring anchor rod B1C1 to the Pjack load then lift off was done twice to ensure the nut was locked. Similar for anchor rod B1B1 2 iterations were needed to bring the rod up to Pjack with 3 turns on the wratchet box of the Boltight jack bridge the first time and 1 turn the second. Lift off to the Pjack pressure was done 3 times for this anchor rod.

Beveled washers used to turn the nut on Bearing B1 anchor rod B1C1 to hold the prescribed Pjack load.

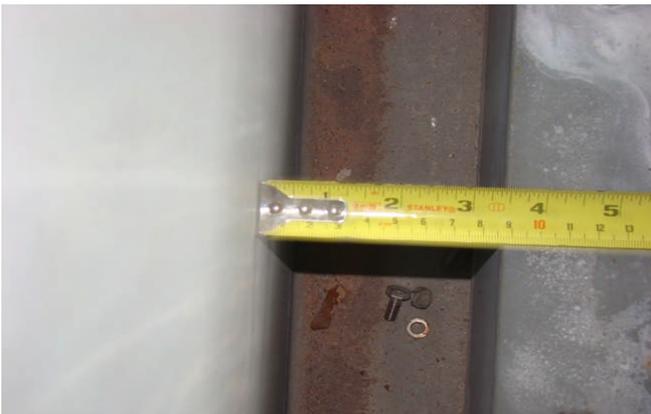
Measured gap between the lower stub of a permanent bearing to lower base section.

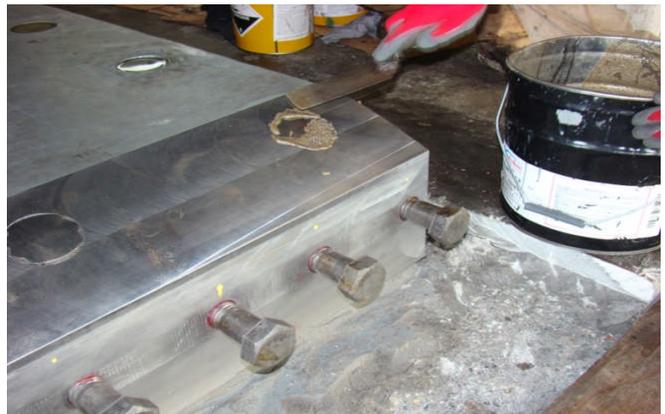
ABF laborers spreading Sikadur 35 LV epoxy with sand in the mix to seal voids around the cut rods near the break on the S2 lower base section.
