SAS Superstructure

Daily Diary Report by Bid Item

Contract No.: 04-0120F4

04-0120F4
04-SF-80-13.2/13.9
Self-Anchored
Suspension Bridge

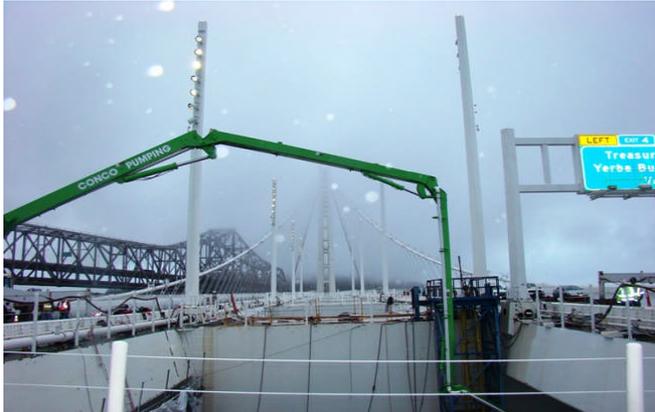
Conco pump setup on the E-Line OBG near crossbeam 18 which was used for the entire concrete placement operation.

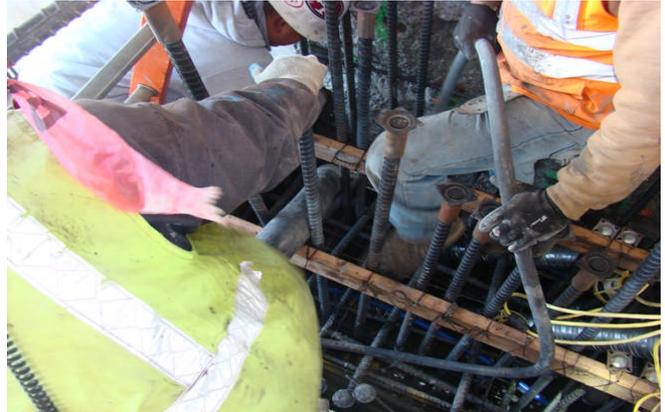
Concrete placing operations on the S2 side were completed at 6:30pm. Similarly to the S1 side it was a struggle to get concrete to flow under the existing concrete. Vibrators were used to push the concrete under the E2 cap beam intermittently with care to not segregate the mix. Also vibrators were used to awaken/sting previous lifts due to the slow delivery of concrete and during times when the pump lines were blocked. This was done to ensure that the previous lift in the S2 soffit beam didn't set up creating an undesired cold joint.

Conco laborers using a vibrator to awaken or sting the previous concrete lift in an attempt to prevent a cold joint on the West side of S2 Shear Key.

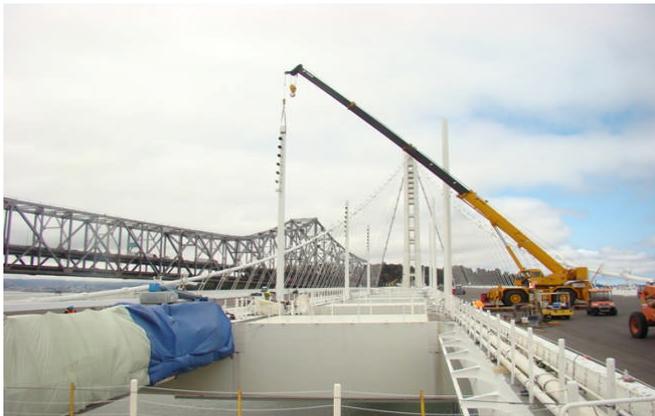
- Briefly checked on the progress of correcting the base plate shims for light poles 1032-1 and 2032-1 as ABF and Bleyco were adjusting the poles today to be within the plumb vector tolerance of 75mm. Talked with Bill Shed and Bill O'Sullivan regarding this issue.

ABF ironworkers adjusting the 2032-1 light pole to bring it closer to being plumb.

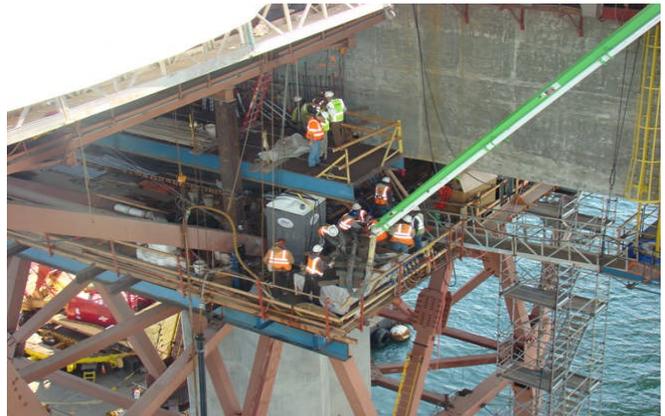
3.) As concrete placement of the S2 Shear key commenced at 1:00pm as the delivery of concrete trucks began to slow down. This created some issues with the concrete pump as there were several instances of the pump being blocked. To my knowledge a concrete truck was sent away by Conco representative Gary Brandt due to bad properties of the mix.

Conco carpenters and laborers seen in the process of clearing the pump line of concrete blocking the flow during the S2 SK soffit beam pour.

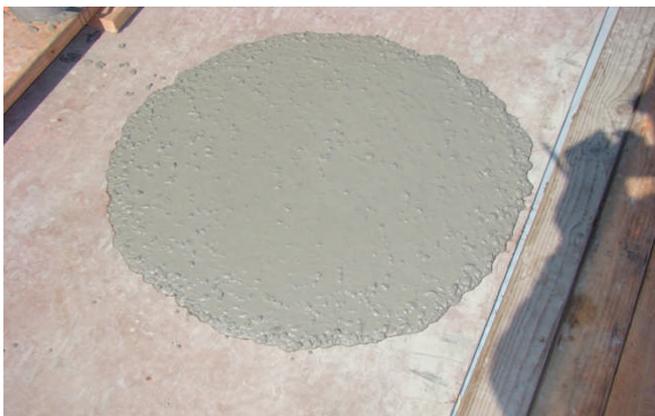
Smith Emery technicians left the jobsite at 1:30pm which was not acceptable since other truck loads should have been tested especially after the questionable mix from Load#11 which was placed in the forms. Subsequent loads 14 and 15 were also questionable but Chris performed an impromptu slump flow test on both trucks. Load #14 had an average diameter of 700mm and Load #15 had a diameter 685mm. Even though Load #14 had a passing slump flow diameter Chris sent the truck away due to a questionable VSI rating of 2 borderline 3.

Impromptu slump flow test done by Central Concrete representative

Chris of Load #15 due to suspect properties of the mix shipped to the jobsite.

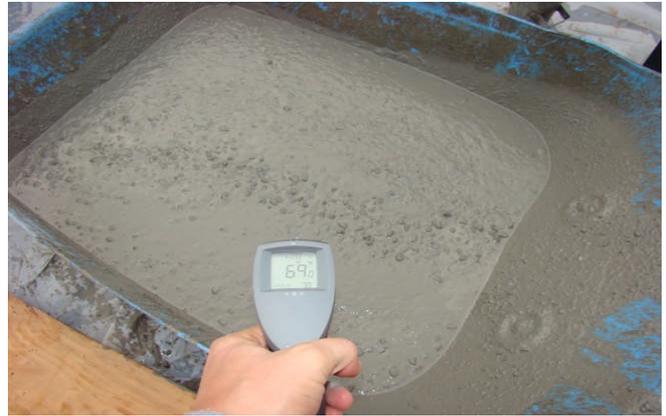
1.) First concrete truck arrived at 7:11am on the E-Line OBG as two concrete pumps were onsite, the other on the W-Line that wasn't used all day. The slump flow diameter of the 1st truck load was 740mm and 690mm for an average of 715mm. Target slump flow diameter is 700mm +/- 50mm as this is acceptable. Concrete temperature of this truck was 69F with an ambient temperature at the time of 59F under cloudy skies. See PJ and Damon's diaries for other truck slump flows, temperatures, and atmospheric conditions.

Concrete temperature of the first truck delivered onsite of 69F with and ambient temperature of 59F under cloudy conditions.

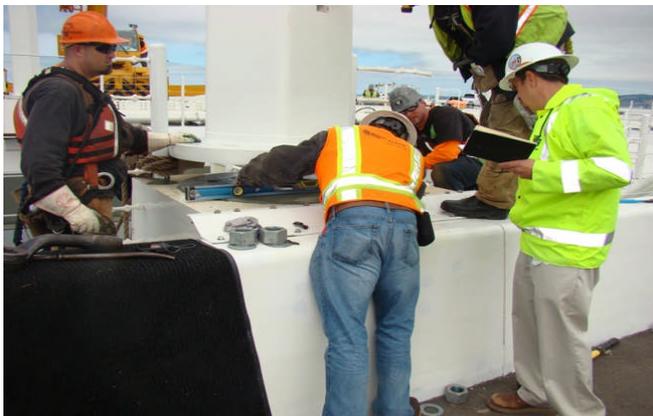
ABF engineer Bill O'Sullivan checking the 2032-1 shim plate for being level in the longitudinal direction of the SAS bridge.

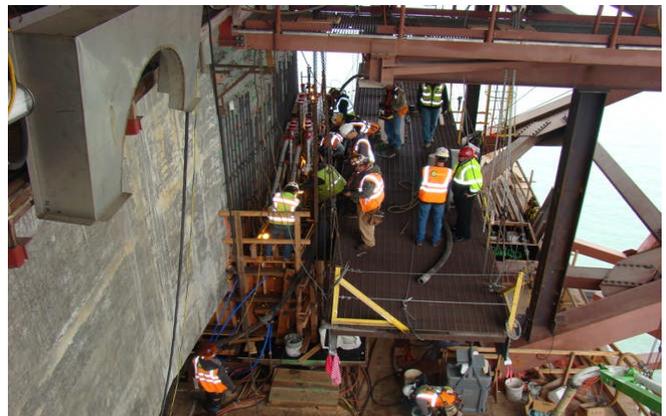
2.) Placement of concrete began at 7:30am on the low side of the S1 Shear Key in the SE corner. Only one pump was running during the entire placement of the soffit beam for S1. Concrete placing operations were completed on this side at 11:45am. There was only one issue regarding S1 concrete placement operation to note. When concrete was injected into the south side inlets, it appeared that the concrete placed from the top rose above the inlets making it harder/slower to place from these inlets. Crews concentrated on getting concrete to flow under the existing E2 concrete to prevent air pockets and bonding of the new lift to the existing concrete. Finally the water cooling system was turned on at 9:10am with a pressure of 22psi and a water temperature of 67F.

Concrete placing operations of the soffit beam on the East side of the S1 Shear Key retrofit.

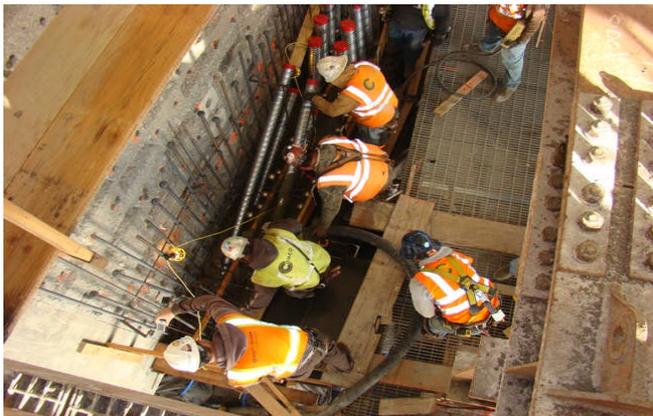
S1/S2 Shear Key retrofit soffit beam concrete placement was completed at 6:30pm in the NW corner of S2.

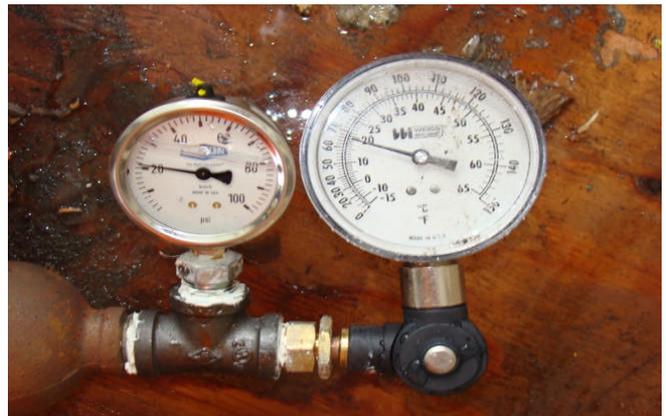
Initial water cooling system pressure of 22psi and water temperature of 66F seen for the S1 Shear Key retrofit soffit beam concrete.
