Daily Diary Report by Bid Item

Contract No.: 04-0120F4

04-0120F4
 04-SF-80-13.2/13.9
 Self-Anchored
 Suspension Bridge

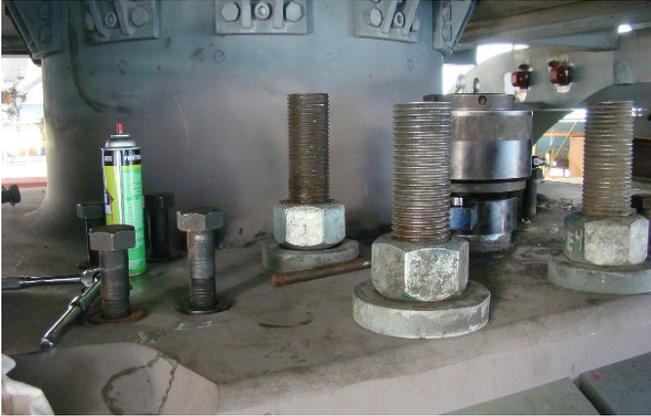
- ABF ironworkers started the 10hr shift by attempting to stress the S1 Shear Key 2008 anchor rods to 0.4Fu per RFI#3492R00. While stressing the first rod S1E2 to 0.4Fu the anchor rod broke approximately at a gauge pressure of 6.0Ksi. All stressing operations were suspended to inform management personnel of this issue prior to proceeding on what to do with the rods identified in RFI#3492R00.

Broken anchor rod S1E2 in the far left corner of the photo after being stressed to 0.4Fu.

The nut on all of these anchor rods came loose on average at 10.5ksi and then had to be recycled to remove the nut on average at 2.4ksi. After further discussion the decision at the end of the day was to cut all remaining 2008 S1/S2 anchor rods and extract all the entire anchor rod S1E2 in labeled sections.

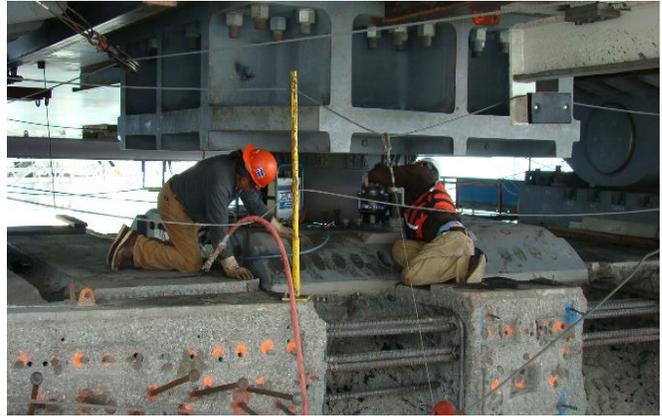
The decree issued by management was to detension the remaining rods identified in RFI#3492R00 which was completed today. The following rods were detensioned today after rod S1E2 broke:

S1D2, S1D1, S1D7, S1D8, S2D2, S2D1, S2D7 & S2D8

ABF ironworker and engineer detensioning the anchor rods at the S2 Shear Key lower base.

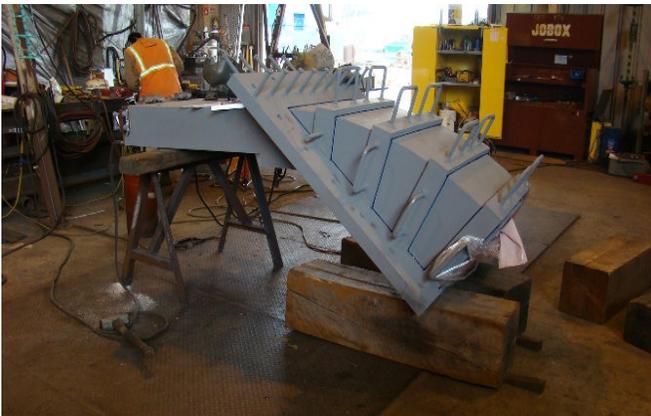
SE Lower saddle section for the S1 Shear Key retrofit in the Pier 7 warehouse as splice plates are being welded to the end.

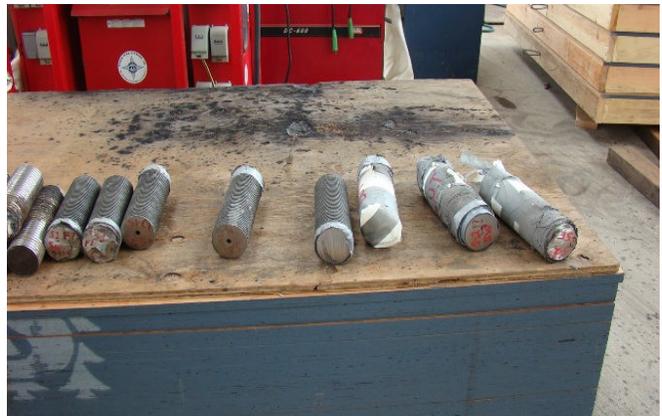
Cut 2008 anchor rods from the S1 and S2 Shear Keys labeled and ready for testing.
