SAS Superstructure

Daily Diary Report by Bid Item

Contract No.: 04-0120F4

04-0120F4
04-SF-80-13.2/13.9
Self-Anchored
Suspension Bridge

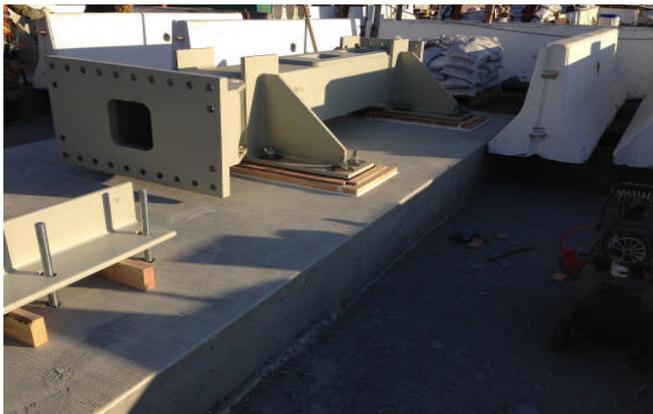
The second layer of formwork was placed around test rig feet's for grouting.

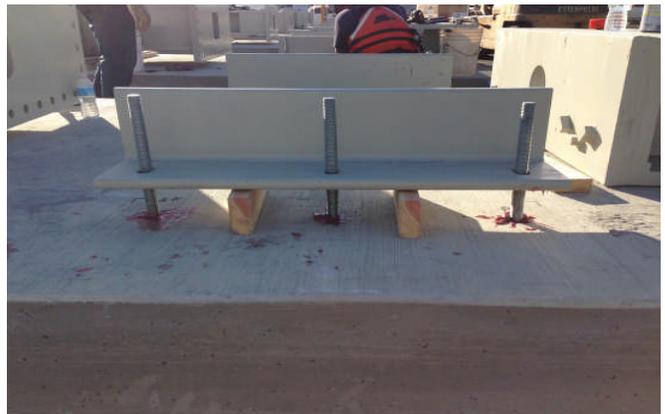
Epoxy curing after it was applied at anchor rods holes for guide angles.

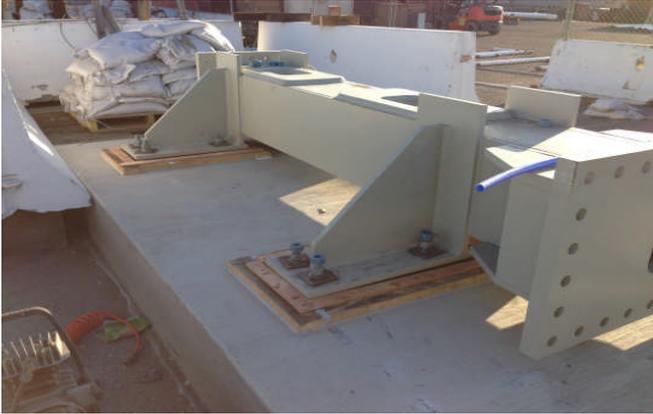
Top blue nuts were mistakenly installed at test rig # 5. These nuts are not made for the 1" anchor rods.
