**DEPARTMENT OF TRANSPORTATION**

Quality Assurance and Source Inspection

Contract #: 04-0120F4Cty: SF/ALA Rte: 80 PM: 13.2/13.9File #: 99.15**SOURCE INSPECTION REPORT****Resident Engineer:** Pursell, Gary**Address:** 333 Burma Road**City:** Oakland, CA 94607**Report No:** SIR-000328**Date Inspected:** 17-Dec-2008**Project Name:** SAS Superstructure**OSM Arrival Time:** 700**Prime Contractor:** American Bridge/Fluor Enterprises, a JV**OSM Departure Time:** 2300**Contractor:** Zhenhua Port Machinery Company, Ltd (ZPMC), Changxing Island**Location:** Changxing Dao, Shanghai

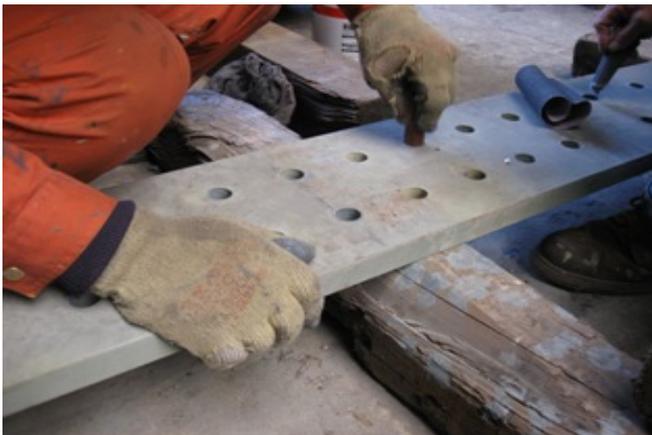
The contractor began to repair the floor beam connection plates that were showing rust in the bolt holes and appeared to have been touched up previously using an unidentified coating. Sandpaper was used to remove the rust and coating from inside the holes. Interzinc 52 was used for the repairs. Repairs were made under the constant supervision of ABF QC. QA verified the repairs were being made and witnessed the method. It appeared that the holes were free of rust and coating prior to applying the primer.

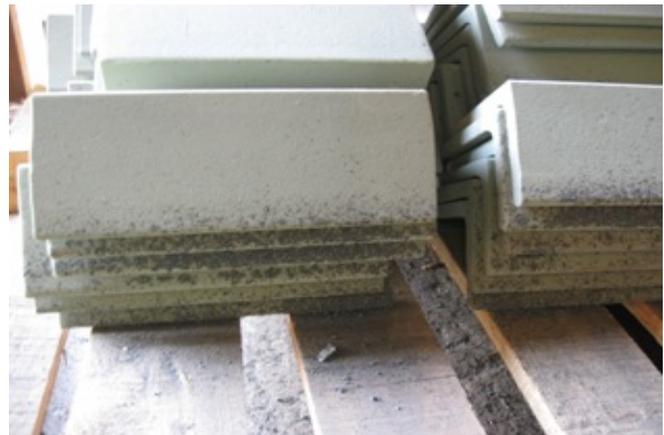
Connection plates stacked near a work area were covered with grinding debris from an adjacent operation. When this was pointed out to the ABF QC he instructed the paint crew to clean the plates and cover or move them to protect the plates from damage.
