DEPARTMENT OF TRANSPORTATION

Contract #: 04-0120F4Cty: SF/ALA Rte: 80 PM: 13.2/13.9File #: 69.15**SOURCE INSPECTION REPORT****Resident Engineer:** Pursell, Gary**Address:** 333 Burma Road**City:** Oakland, CA 94607**Report No:** SIR-000517**Date Inspected:** 11-Apr-2009**Project Name:** SAS Superstructure**OSM Arrival Time:** 0**Prime Contractor:** American Bridge/Fluor Enterprises, a JV**OSM Departure Time:** 12**Contractor:** Zhenhua Port Machinery Company, Ltd (ZPMC), Changxing Island**Location:** Changxing Dau, Shanghai

Other: Surface Preparation and Coatings Application**Bridge No:** 34-0006**Component:** OBG 1BE, OBG 6BE, Misc. Metal, Bike Path**Bid Item:** 79**Lot No:** B226**Summary of Items Observed:****OBG 1BE**

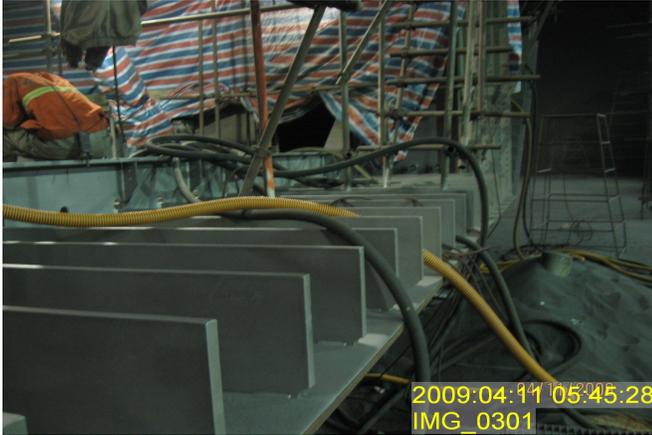
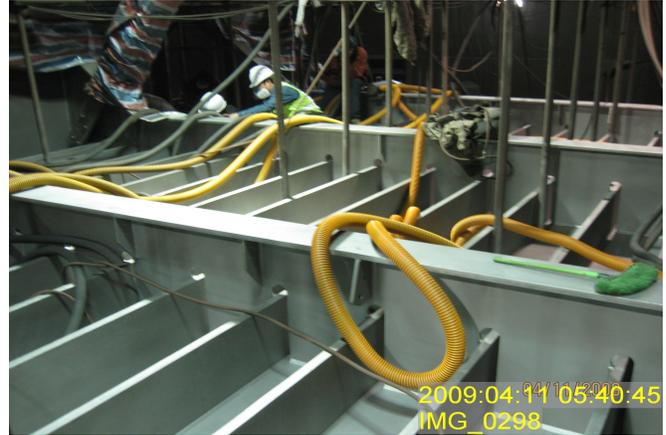
Yesterday afternoon Caltrans QA Coatings Inspector James Lumley reported that ZPMC personnel were inside the bike path parts performing grinding according to the Caltrans Approved RFI. Caltrans QA Coatings Inspector Jordan pointed out to ABF and ZPMC QC personnel that the RFI addressed areas that are not accessible. If the

workers can physically get inside the box in the assembly bay and grind they can access it for abrasive blasting and priming. ZPMC stopped working inside the boxes. It is clear that no attempt will be made to work on these items until after the covers are installed making them inaccessible.
